RE: Structure Relocation Assessment  
Dougherty Ranch Building  
3285 Flynn Ln., Missoula, MT.

## Limited Structural Conditions Assessment–Relocation Feasibility Dougherty Ranch House – 3285 Flynn Lane, Missoula, Mt.

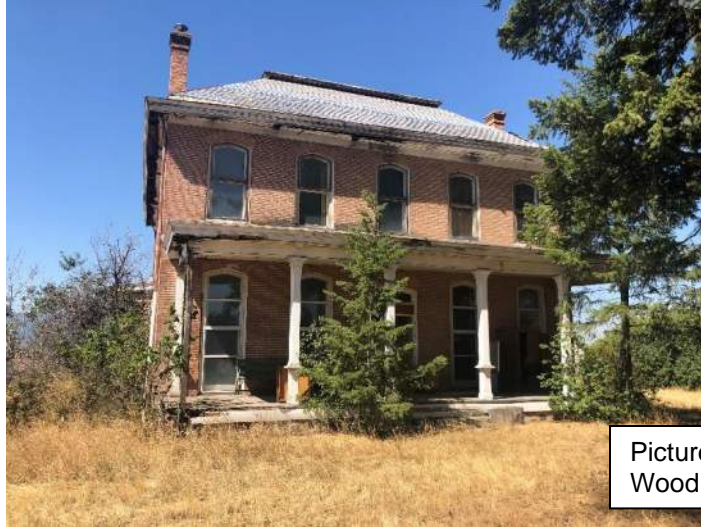
Wood framed elements exists on East side (Main Porch – See Pic #1), North side (Entry Roof – See Pic. #3 & #5) and West side (Small Side Porch). These wood framed exterior roofs and porches are in poor condition.

Picture #1 – East Elevation W/  
Wood Framed Porch

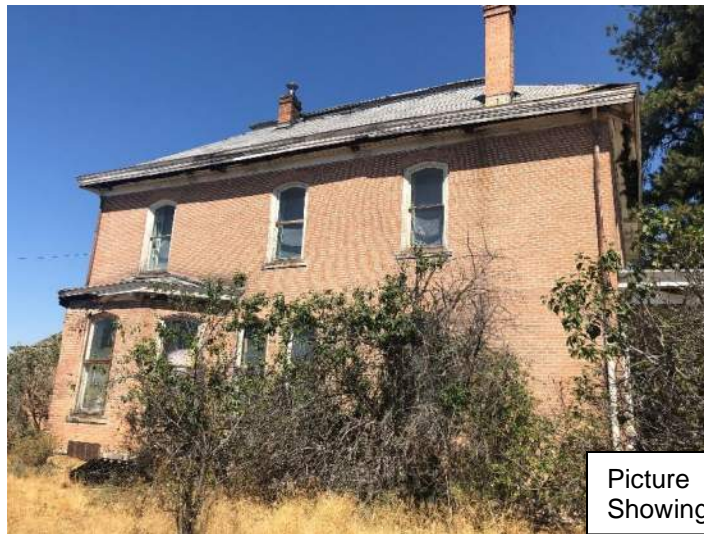
Brick Chimneys: There are two, in-wall chimneys (See Pic. #2) and a main interior fireplace on the southeast side. The interior fireplace extends through the attic (See Pic #12).

Picture #2 – South Elevation  
Showing Bay Corner

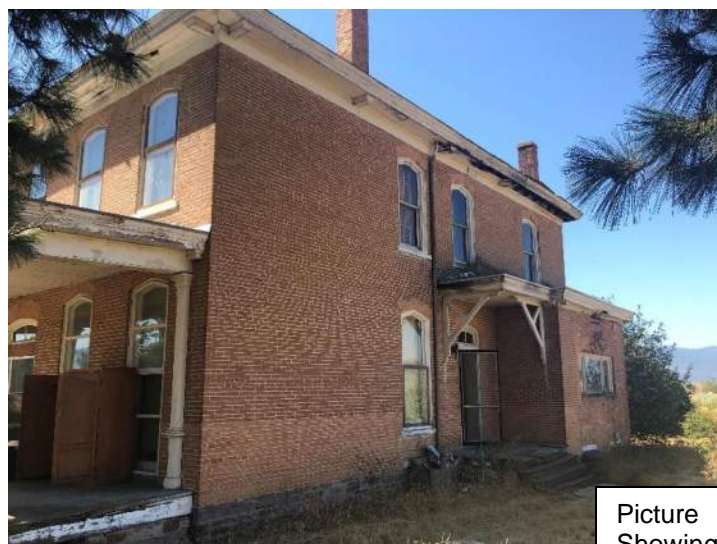
Picture #3 – North Elevation  
Showing Bump-out

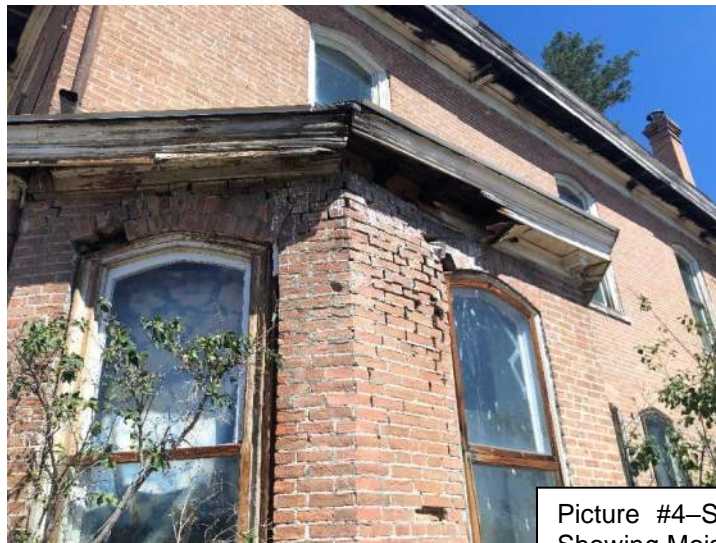
The exterior walls are 24' high, quad-wythe unreinforced brick (approx. 18" thick). With the exception of the north bump-out and southwest bay, the brick and mortar are in fair to good condition. Degradation of the brick on the north bump-out is extensive. (See Pic #6). There is evidence of differential settlement and moisture deterioration of the brick on the southwest bay (See Pic #4).

Picture #4–SW Bay Bump-out  
Showing Moisture Infiltration

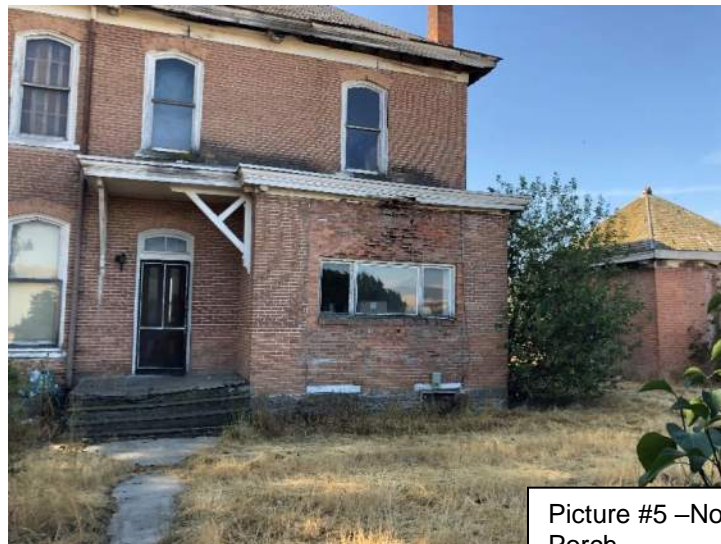
Picture #5 –North Bump-out and  
Porch

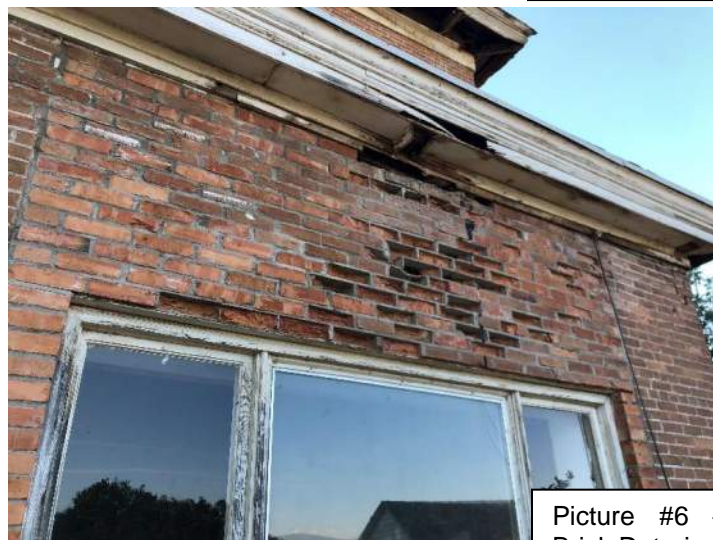
Picture #6 –North Bump-out  
Brick Deterioration

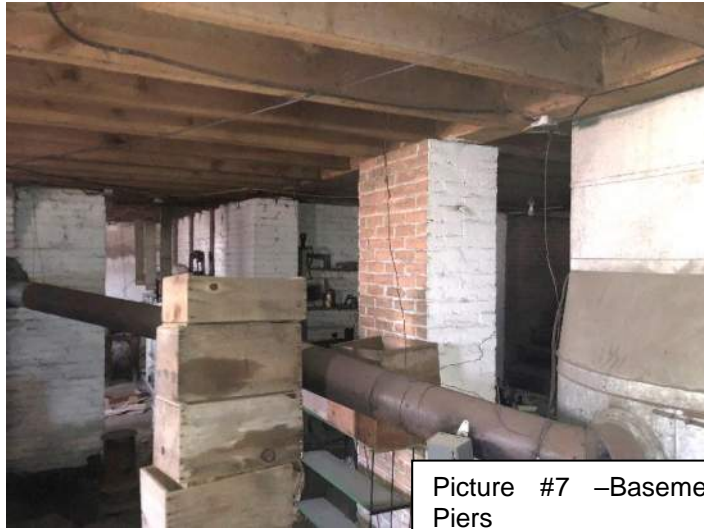
Picture #7 –Basement Brick Piers

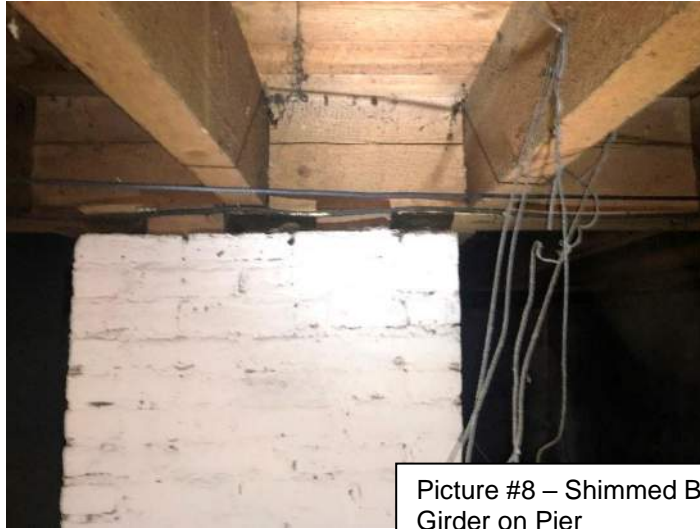
Picture #8 – Shimmed Bearing – Girder on Pier

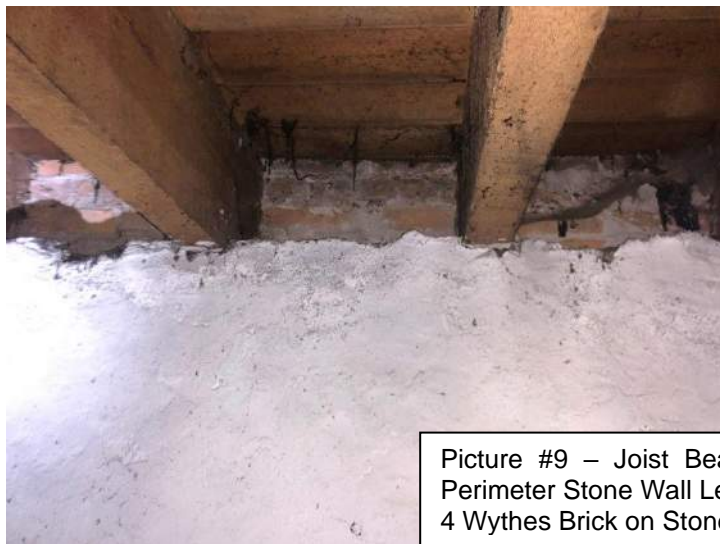
As with any structural relocation, the interface connections between the floors and walls along with the roof and walls will need to be justified. The main floor structure is not connected to the brick walls (Sitting on a foundation ledge – Pic # 9). But the jacking beams will accommodate bearing for the main floor and brick walls. The second floor joist are pocketed into the brick walls where joist run perpendicular. Where joist are parallel, there is minimal to no positive connection. A connection will need to be established prior to a move. The roof structure is not positively connected to the walls (See Pic #10). Connections can easily be installed, along with attic bracing prior to a move.

Picture #9 – Joist Bearing on Perimeter Stone Wall Ledge.  
4 Wythes Brick on Stone Wall

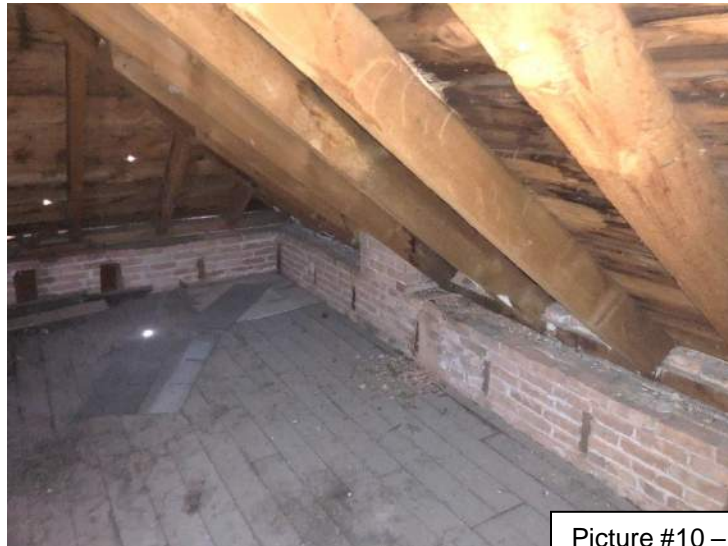
The roof structure has an approx.. 6:12 pitch. The hipped roof creates a common eave line all around the perimeter. There are 3x7 rafters at 24" o/c spanning from the exterior brick walls (See Picture #10) to an intermediate double 3x8 girder line (All four sides – See Picture #11). The girders are supported on 10 - double 2x7 posts which bear on distribution plates bearing on the attic floor framing. The posts are offset from the bearing wall below, however the distribution plates and attic floor joist are adequate to distribute the roof bearing offset. Please reference the Roof Framing Plan, SK-4 showing the roof configuration.

Picture #10 – Rafters Bearing on Exterior Brick Wall

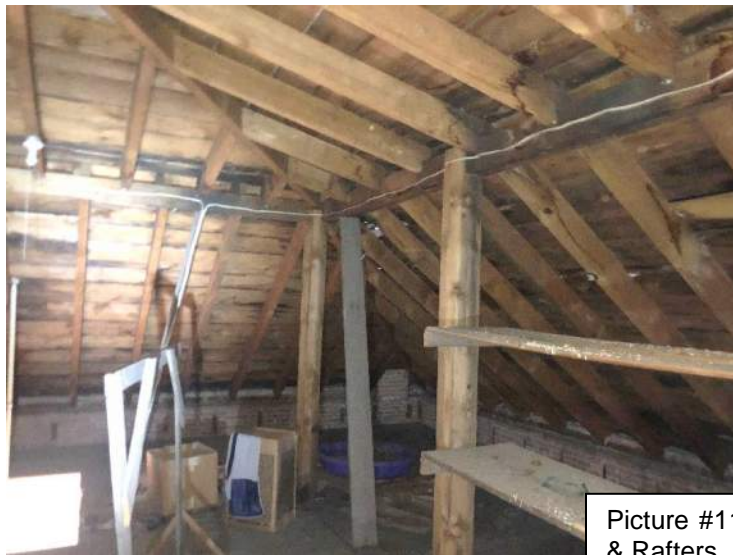
Picture #11 – Attic Girder/Posts & Rafters

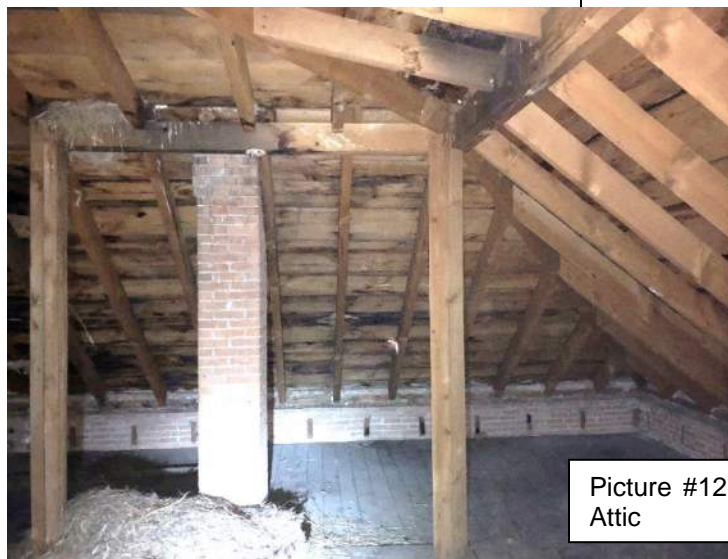
Picture #12 – Brick Chimney in Attic

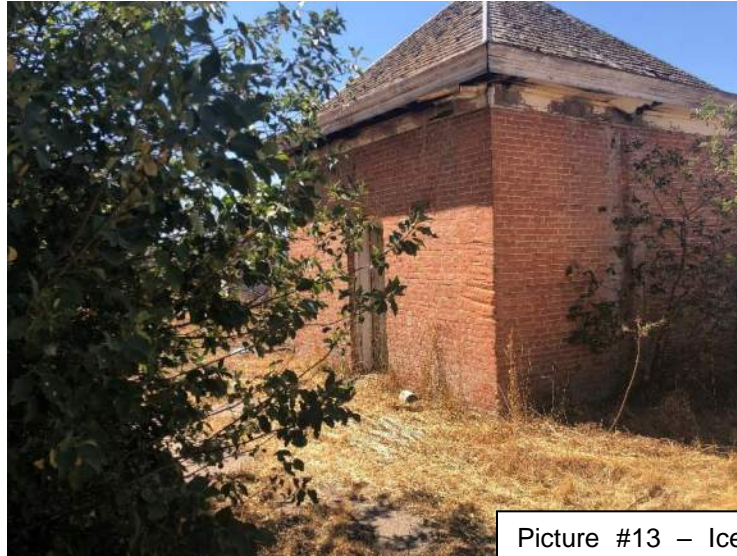
The Ice House building has a 16' square footprint. There are 10' high, triple wythe brick walls with an approximate 5' high pyramid, hip roof atop for around 15' overall height from grade. There exists a thin concrete floor at grade level. The building is in poor condition. The eave lines at several locations show serious moisture deterioration. There are several diagonal crack lines in the brick walls which evidence differential settlement. A large, through-wall crack is located over the door on the east side (See Pics #14 & #15).

Picture #13 – Ice House NW Elevation

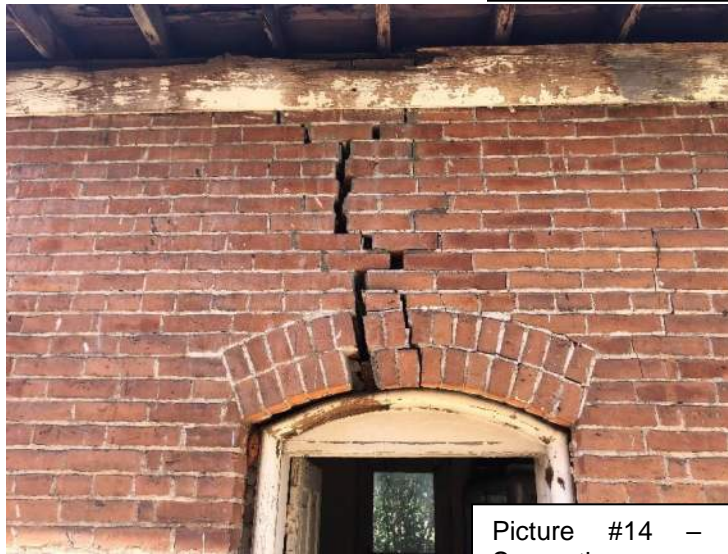
Picture #14 – East Wall Separation

The walls of the Ice House weigh around 36 ton. The roof weight is incidental. With the separation crack on the east side, any relocation effort will require steel cable banding for stabilization. The base of the brick walls is directly at grade. So a jacking and raising effort will require excavation for beams, jacks etc. The small footprint and height make this building relocatable. The weight, condition of brick and relationship to ground work against that effort.

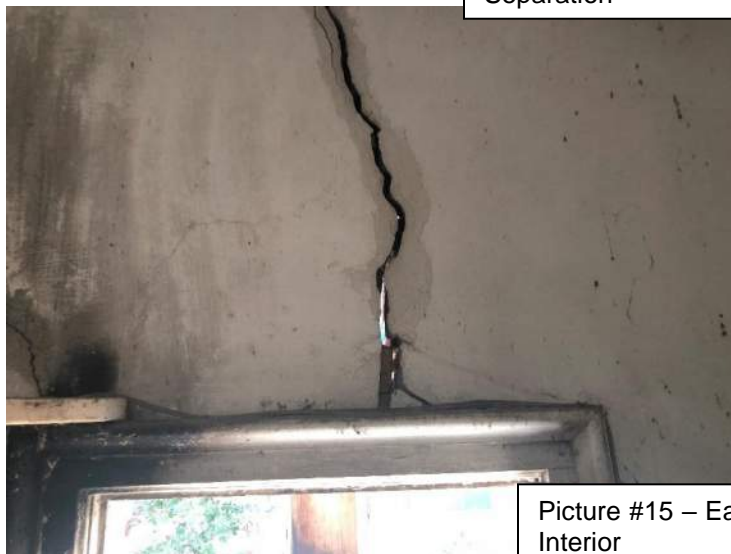
Picture #15 – East Wall Crack – Interior
