Alternatives Analysis Report

Missoula Development Park Regional Stormwater System

Prepared for
City of Missoula

August 14, 2024

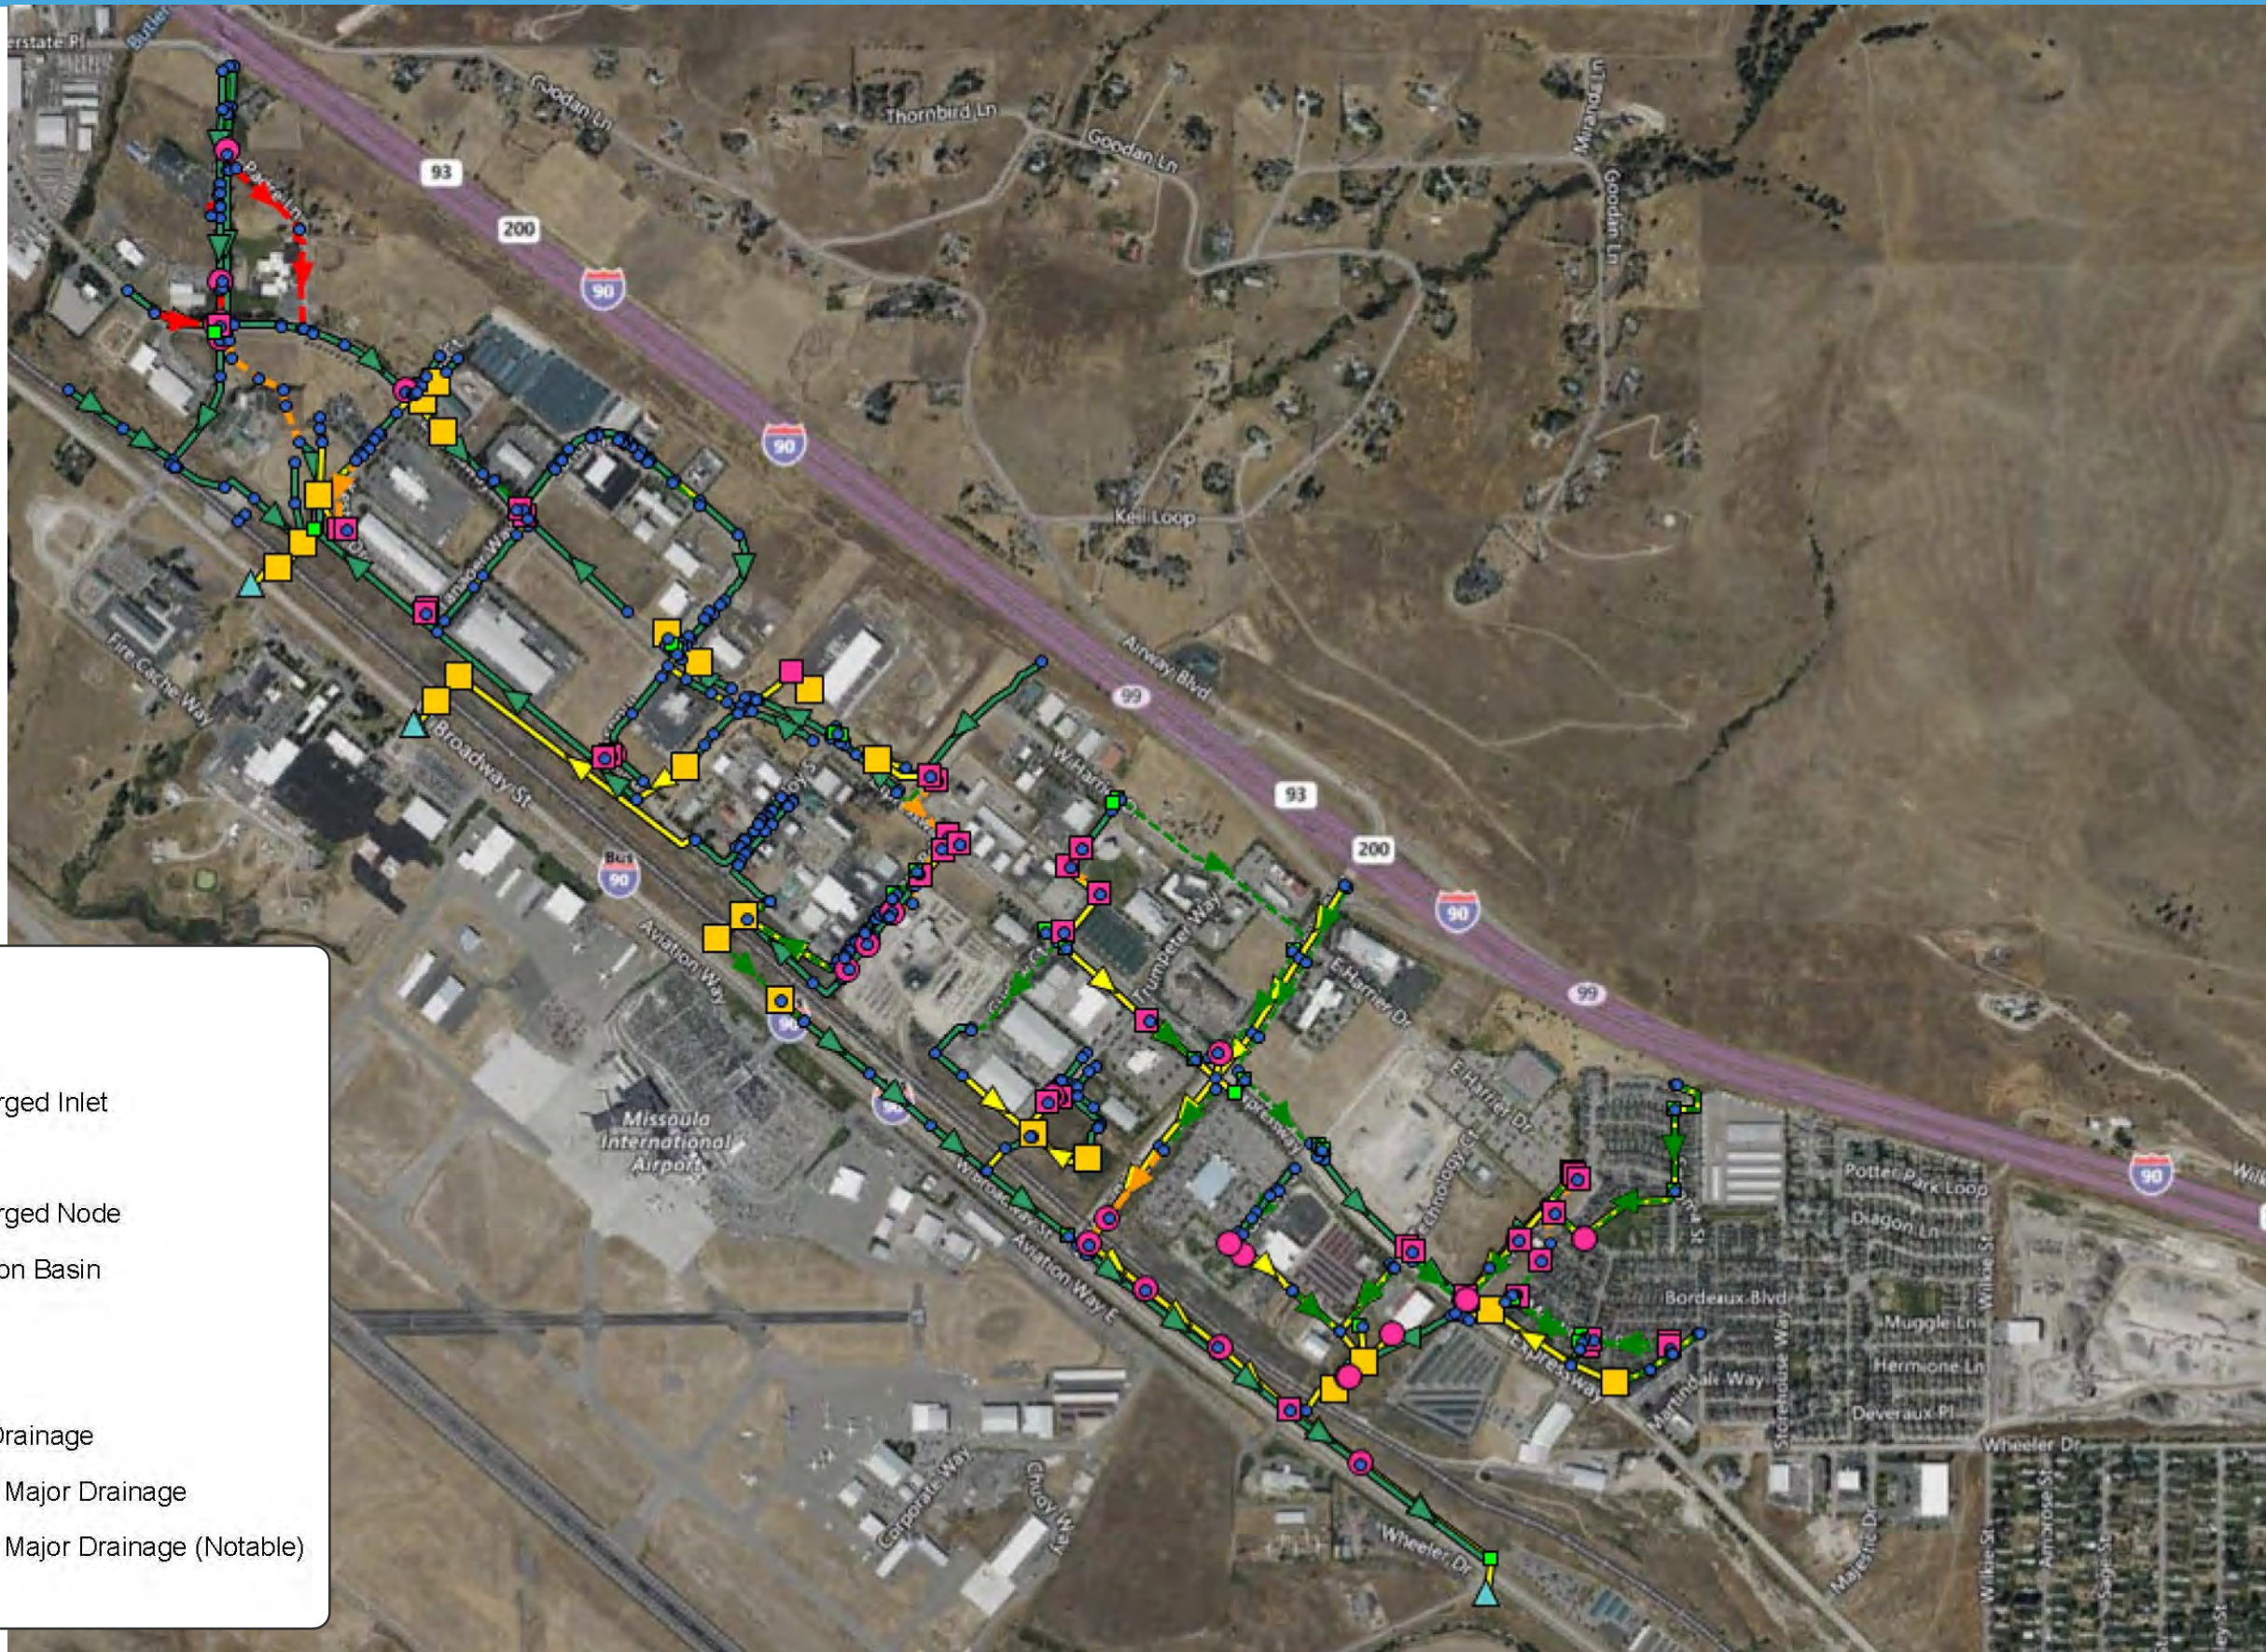
Figure 5.
Missoula Development Park Surcharged Nodes During 5-Year Storm Event.

Surcharging was observed throughout the study area during the 5-year storm as shown in Figure 5. Flooding was observed in both the 5-year and 100-year storm events and is shown in Figure 6 through 12. Flooding areas not meeting the standards defined in Table 1 are detailed in the sections below. The capacity analysis was generally limited to conveyance owned by the City. Some conveyance elements mapped as owned by "other" or "unknown", such as catch basins located within a public roadway, are included in the capacity analysis on a case by case basis.

Surcharged and flooded conditions were observed in the model run of the 5-year storm event as shown in Figure 5 and Figure 6. Areas of flooding that did not meet the maximum street spread requirements, had potential to inundate buildings at the ground lines, or were otherwise noteworthy are described below, and are detailed in Table E.1 in Appendix E. The model showed that detention facilities (denoted as “basins” in the City GIS data) in the Development Park had sufficient capacity during the 5-year storm event.

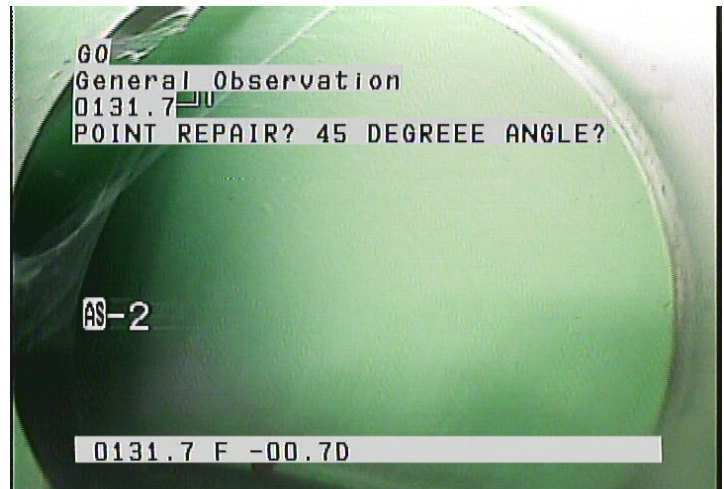
GO - General Observation @ 131.7 ft.
POINT REPAIR? 45 DEGREEE ANGLE?

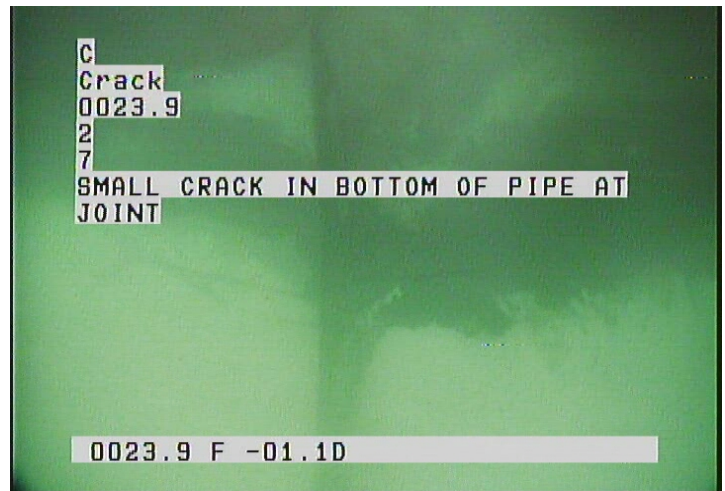
C - Crack @ 23.9 ft. SMALL CRACK IN BOTTOM OF PIPE AT JOINT

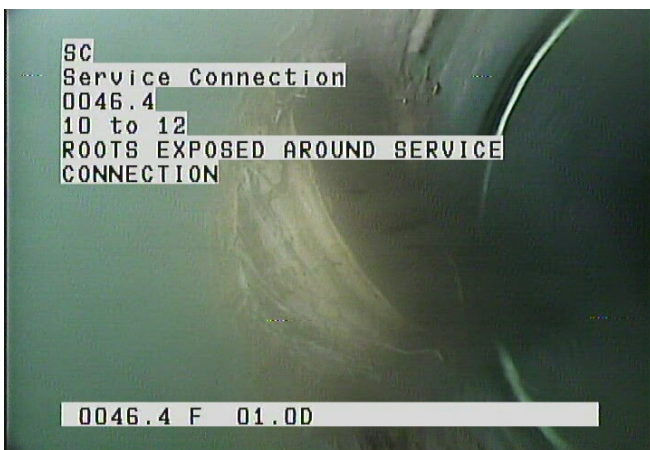
SC - Service Connection @ 46.4 ft. ROOTS EXPOSED AROUND SERVICE CONNECTION

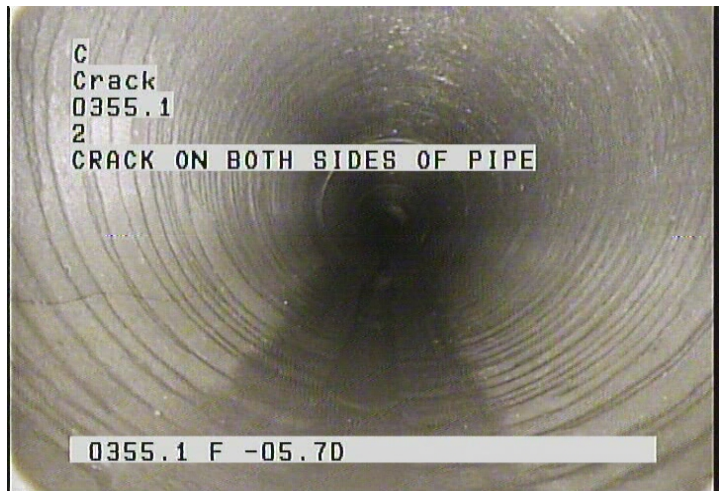
C - Crack @ 355.1 ft. CRACK ON BOTH SIDES OF PIPE

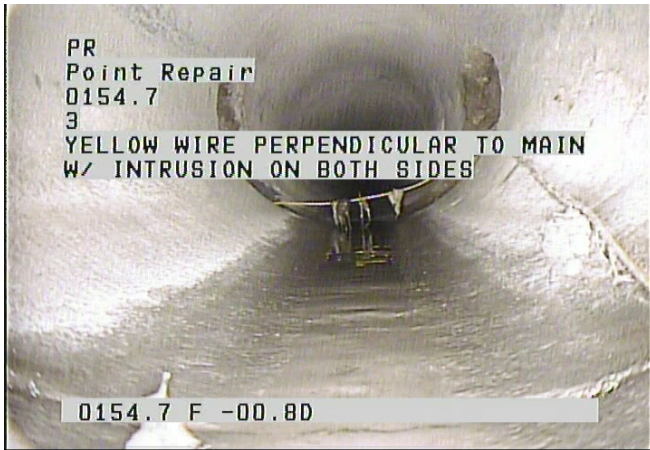
PR - Point Repair @ 154.7 ft. YELLOW WIRE PERPENDICULAR TO MAIN W/ INTRUSION ON BOTH SIDES

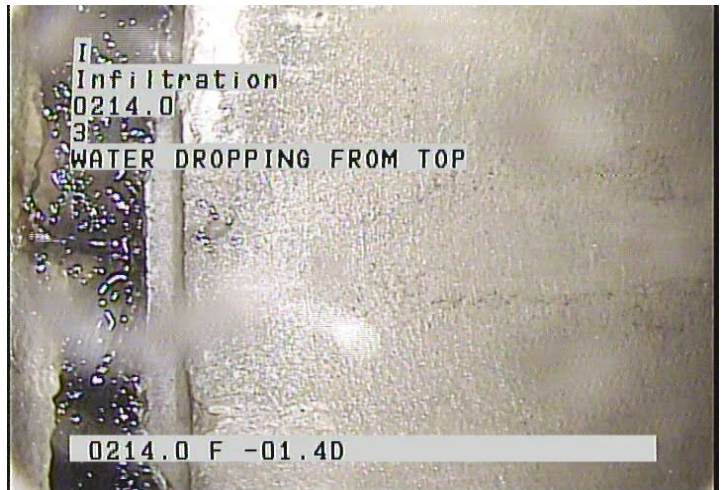
I - Infiltration @ 214.0 ft. WATER DROPPING FROM TOP

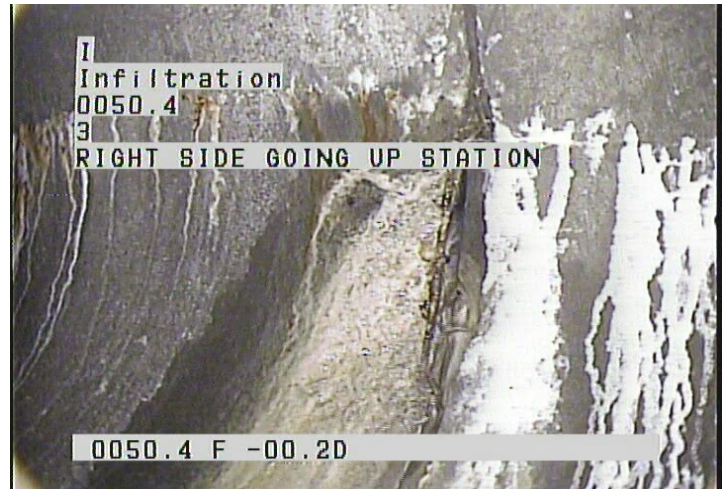
I - Infiltration @ 50.4 ft. RIGHT SIDE GOING UP STATION

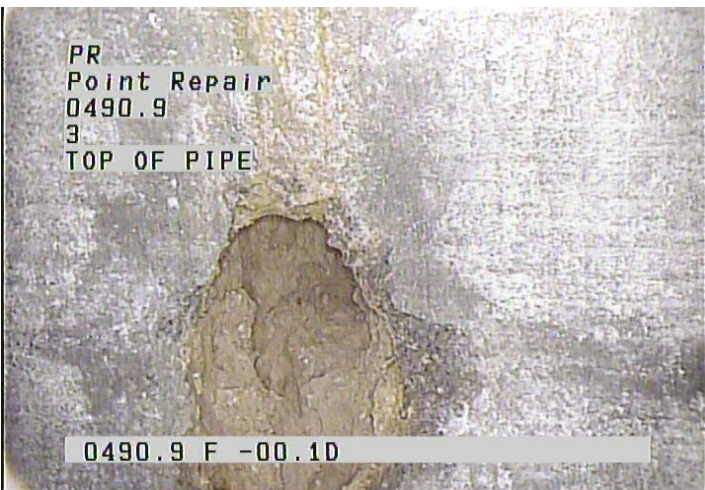
PR - Point Repair @ 490.9 ft. TOP OF PIPE
