UPDATED GEOTECHNICAL EVALUATION REPORT

Mass Grading, Utilities, and Roadways Hillview Crossing – Missoula Missoula, Montana Project 15-3338G

December 3, 2015 Project 15-3338G

Re: Updated Geotechnical Evaluation for Mass Grading, Utilities, and Roadways, Hillview Crossing – Missoula, Missoula, Montana

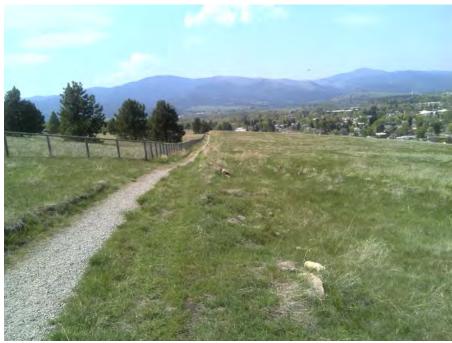
SE corner of site, looking west

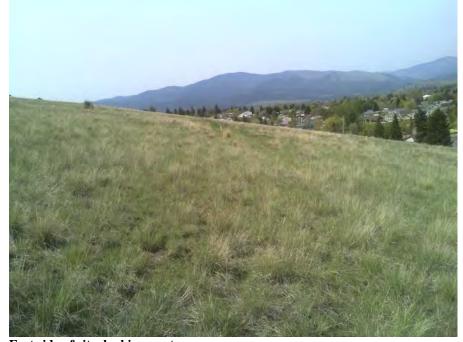
East side of site, looking west

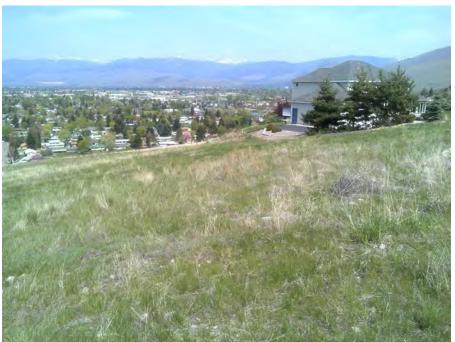
The ground surface observations indicate the current slopes are stable and signs of current instability were not observed. We did observe somewhat lusher grass present near the southeast corner of the subdivision. It is our opinion this is most likely due to the presence of more clay soils being present on this side of the subdivision that can better retain surface water, allowing lusher vegetation to establish. The western two-thirds of the subdivision appear to be more gravelly near the surface, which is less likely for lush vegetation to establish.

The water level measurements indicate, at a minimum, perched groundwater does exist during wetter periods. It is our opinion the perched water is likely related to surface water that infiltrates down through the surface through sand or gravel layers and then becomes perched on less permeable silt or clay layers. This water then travels laterally until it encounters a more permeable sand or gravel layer and can infiltrate downward. Alternatively, the water can exit the slope face which may partially contribute to the more lush vegetation on the eastern side of the subdivision.

SE corner of site, looking downhill, note lusher vegetation

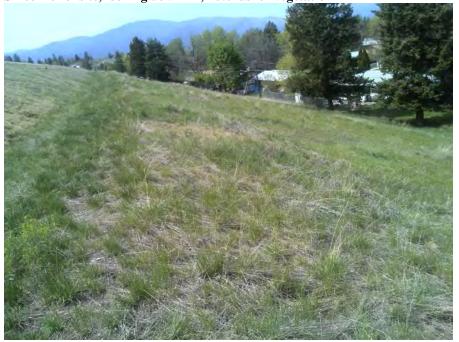
NE corner of site, looking west, note drainage swale cut into slope

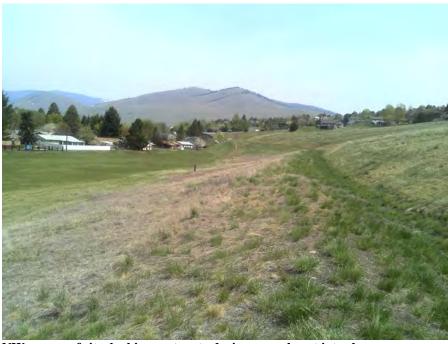
NW corner of site, looking east, note drainage swale cut into slope

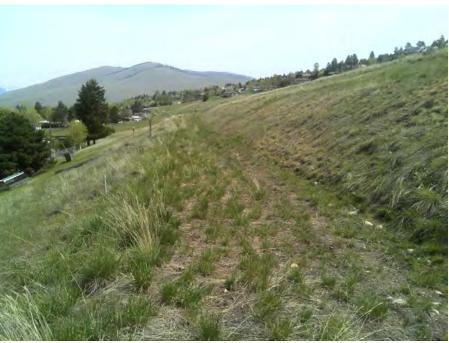
North center portion of site, note 8-foot high cut for drainage swale

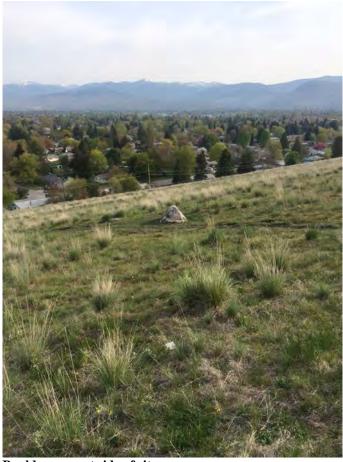
Some boulders with a maximum dimension of about 3 feet were observed in isolated areas. We also observed the existing cut slope near the northwest side of the subdivision near the end of Saranac Drive. This cut slope appeared to be about 20 feet in height and constructed at an angle of about 36 degrees

Boulder on west side of site

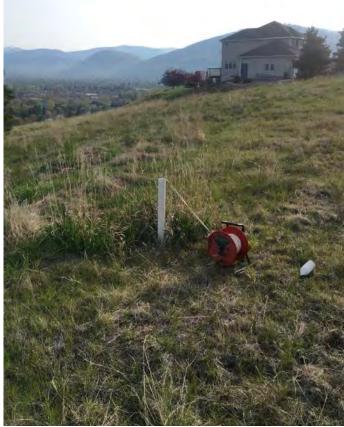
As indicated in the above table, groundwater is present at elevations ranging from about 3207 1/2 to 3323. Including the muddy soils, groundwater is also present near elevation 3295. These water levels were generally near the bottom of the piezometer and indicate groundwater may generally follow the ground surface at a depth of about 42 to 44 feet. The water levels observed also may be seasonal groundwater

Piezometer ST-1P, groundwater at 42.7 feet

that became perched on less permeable silt or clay layers that then travelled laterally until the groundwater encountered the piezometer and then accumulated near the bottom of the piezometer pipe. We recommend additional groundwater level measurements be obtained, especially in the spring and fall to evaluate groundwater fluctuations.

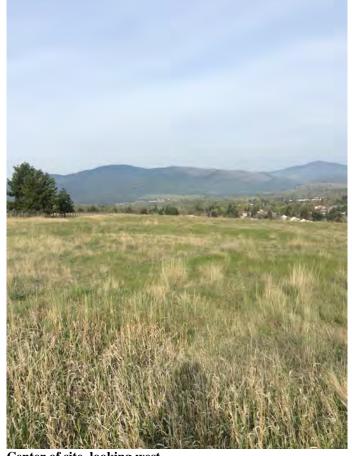
Center of site, looking west
