Cultural Resource Inventory for the Proposed Mullan BUILD Project, Missoula County, Montana.

HDR

June 2020

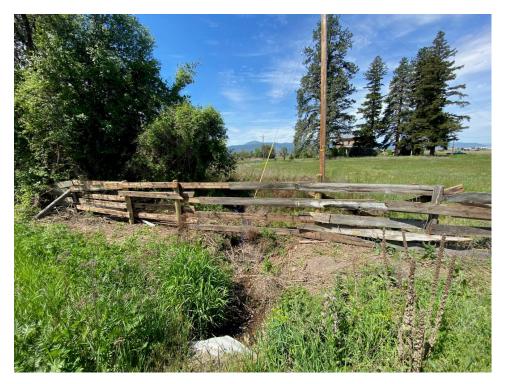
crosses under Flynn Lane (Figure 11) at the location of the Dougherty Ranch and continues west where is has been filled in just west of the Ranch eliminating its former terminus with a primary lateral of the Flynn-Lowney Ditch (24MO0550). A dilapidated and abandoned, rough-aggregate concrete headgate (Figure 12) is present just southwest of the Dougherty Ranch (24MO1781) where the extant ditch alignment turns briefly to the south.

Figure 11. The Flynn-Dougherty Ditch (24MO0901) at its culvert under Flynn Lane, view to the west. The Dougherty Ranch in pictured in the background.

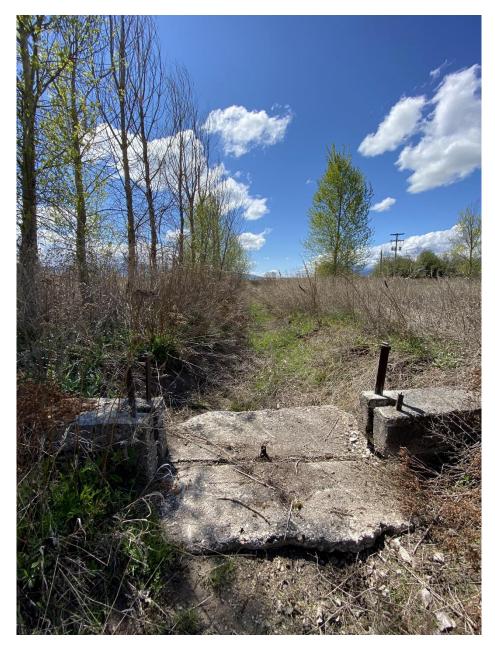
Figure 12. Abandoned headgate structure on the Flynn-Dougherty Ditch (24MO0901) at the Dougherty Ranch, view to the south.

greater ditch system itself are no longer present. RBAS concurs with the previous recommendation for this resource as being Not Eligible for inclusion in the NRHP. While some aspects of integrity remain, a majority have been compromised over time. No further work is recommended in regard to this resource.

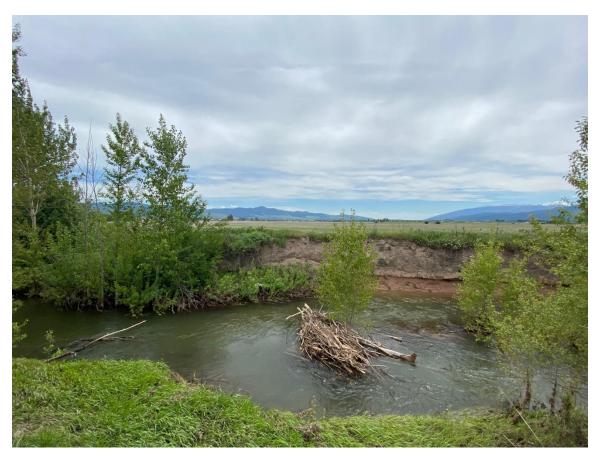
Figure 14. The Field Dougherty Ditch (24MO0902)/Grant Creek near the proposed intersection of George Elmer Dr. (north segment) and West Broadway. View to the south.

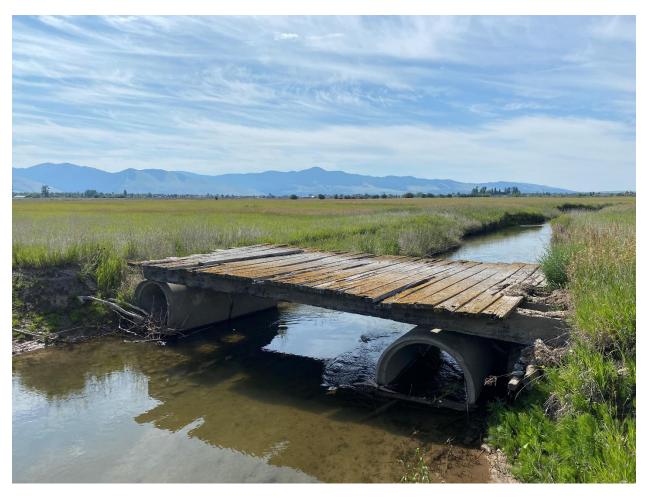
Figure 15. The Field Dougherty Ditch (24MO0902)/Grant Creek. Plank bridge originally recorded by Herbel and Beery (2006:20). View to the south.

The site has been previously recommended as not eligible for inclusion the NRHP (Herbel and Beery 2006) with concurrence by the Montana SHPO. RBAS agrees with the previous determinations for this resource as being not eligible for inclusion in the NRHP. No further work is recommended in regard to this resource.

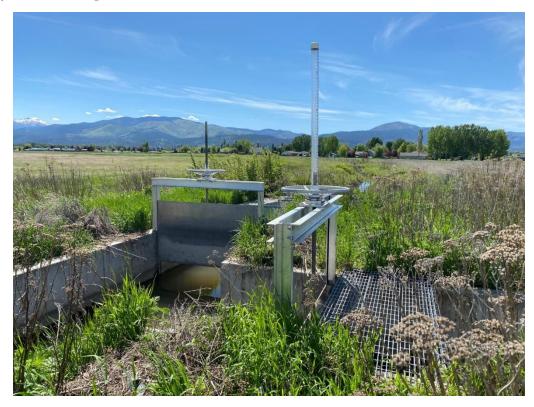
Figure 17. Newly constructed structure between George Elmer Drive and Chuckwagon Drive. View to the southwest. The headgate on the right directs flow into L2 and is a reconfiguration of the historic diversion point for L2.

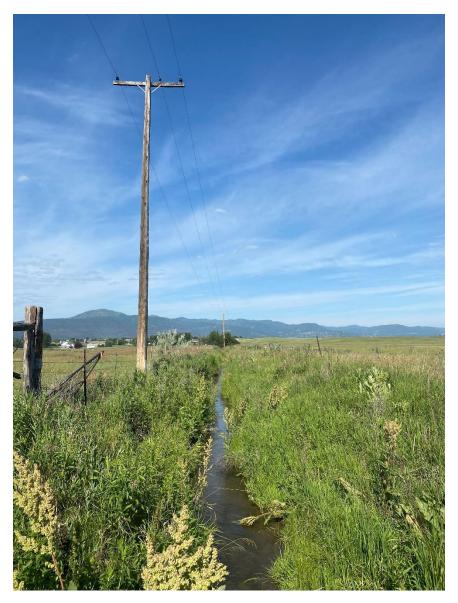
Figure 19. Photo of L2 at it is east-west run that return water to Grant Creek.

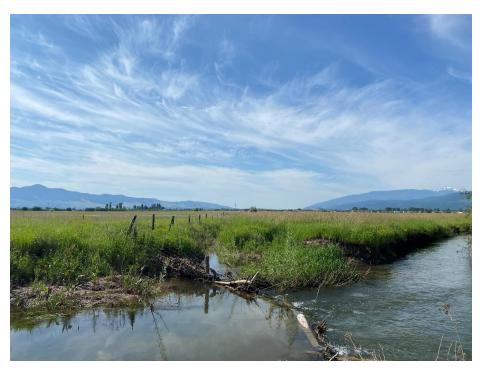
$Figure\ 20.\ Overview\ of\ the\ confluence\ of\ L1\ and\ the\ Grant\ Creek/Field-Dougherty\ Ditch\ 20MO0902.$

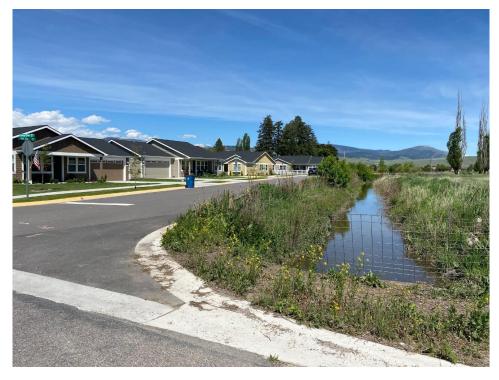
Figure 21. Overview of the Flynn-Lowney Ditch main channel at its existing culvert at George Elmer Drive. View to the east.

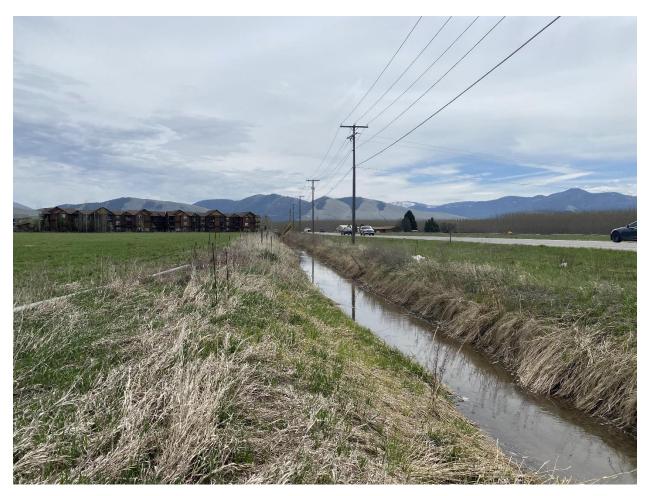
Figure 23. Overview of the Flynn-Lowney Ditch main channel at the proposed intersection of Mullan Road and the proposed extension of Mary Jane Boulevard and the location of the proposed Mullan Trail pedestrian path. View to the east.

eligibility. It is recommended that the proposed project would have No Adverse Effect to the Flynn-Lowney Ditch (24MO0550). The proposed project would involve placing approximately 125 linear feet of the ditch into a pipe to allow for the extension of Mary Jane Boulevard at its new intersection with Mullan Road. The existing ditch alignment would be perpetuated, as would its historic function, and there would be no diminution in the amount of water it carries. No mitigation is currently proposed or recommended for the effect on the Flynn-Lowney Ditch.

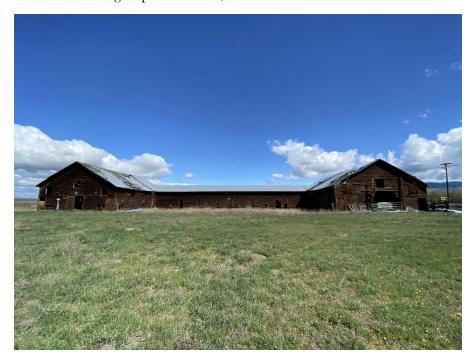
Barn: The barn is a circa 1920¹⁴ front facing compound U-plan style stock barn (Figure 27). It is one and a half stories, with a low-pitch single-end-view gable per roof line in the plan. The barn is oriented with its front to the south with each wing having front gables and the median span having a cross gable. Roofing materials consist of corrugated tin sheets covering decomposing asphalt shingles. The barn sits on an uncut stone and mortar foundation (Figure 28), likely from stones that would have been available on site or locally. Each wing measures approximately 60 by 40 ft with the central span running approximately 125 by 20 ft. The Montana Cadastral Property Record Card lists each wing at 2436 square feet (sq ft) and the center span a 3080 sq ft for a total of 7952 sq ft of a standard barn(s) that constitutes building improvements 4-6.

Figure 27. Photograph of the barn, view to the north.

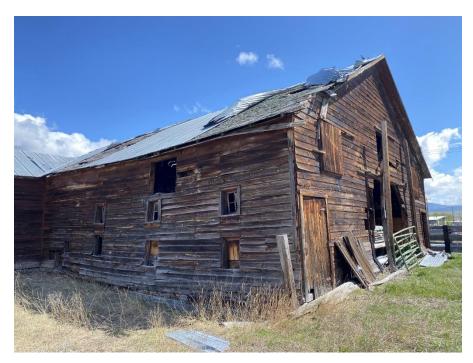
Windows are almost entirely two-over-two, four-light windows with wood casements, wood reveals, and wood sills. The west elevation of the east wing has six such windows evenly spaced with a 6 ft square opening to the upper hay loft (Figure 29). The center span, south elevation has twelve such windows, four in an upper row, with the remaining an even spacing below. This elevation also has 3 points of entry, vertical plank wooden doors with wood casements. The east elevation of the west wing (Figure 30) is identical the east wing with the exception of one additional window, a horizontal three-over-three six-light window with the same casement, reveal, and sill.

Figure 29. Photograph of the southwest corner of the east wing, view to the northeast.

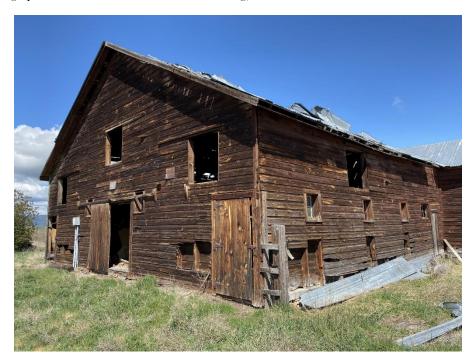
Figure 30. Photograph of the southeast corner of the west wing, view to the northwest.

The south elevation of the wings both possess a series of three, six ft square sliding doors as entry to the upper loft and two primary entry doors that are identical to those found on the south elevation of the center span. The east wing has a larger central opening for vehicle access while the west wing has a smaller 8 ft square slider door.

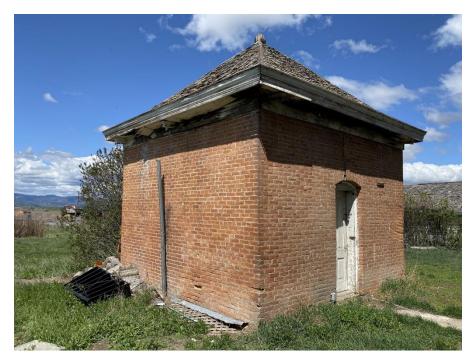
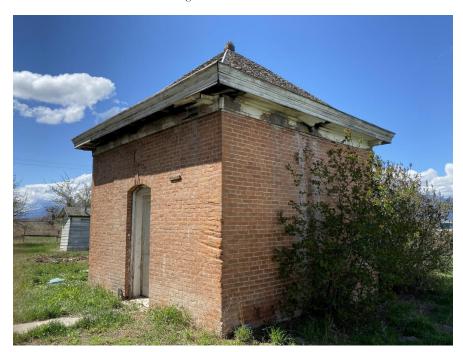
Icehouse: The icehouse a 324 square ft (18 by 18 ft), one-unit simple plan building with a normal pitch pyramidal roof line and plain wood shingles (Figure 36, Figure 37). There is a single two-panel entry door on the east elevation closest to the house. The door has a deep casement and a brick piedmont identical to the house. It also has an identical wide-eve with brackets as the house. The foundation is irregular-course cut stone and the brick pattern is English with seven rows of stretchers per header row. The west elevation is obscured by a lilac though has a single wood frame, fixed window with brick pediment. This buildings construction was likely contemporaneous with the house given array of matching features.

Figure 36. Southeast corner of the icehouse showing the south and east elevations

Figure 37. Northeast corner of the icehouse showing the north and east elevations.

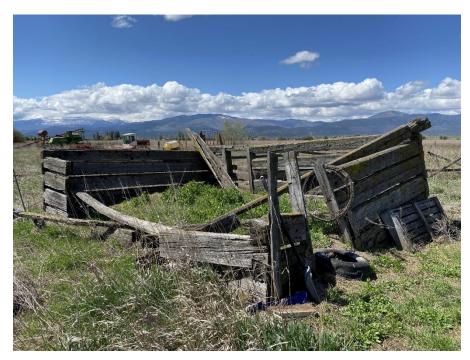
Feature 1: Feature 1 is the remains of 19 by 13 ft, six-course high log building (Figure 41). The logs are milled and dovetail notched. It is likely that this structure would have been contemporaneous to the cabin located nearby and was likely a small barn.

Figure 41. Overview of Feature 1, view to the south.

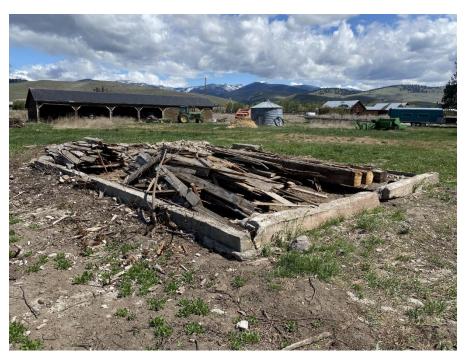
Feature 2: Feature 2 is a 20 by 30 ft cement foundation with miscellaneous building debris within (Figure 42). Earlier air photos (ca. 2016) of the site show a building present here that has since been torn down.

Figure 42. Overview of Feature 2, view to the south.

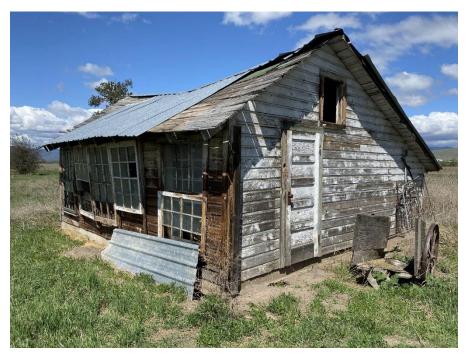
Coop/Greenhouse: This building is a 462 square ft saltbox style building with a side gable and corrugated tin roofing covering aged composited shingles. The entire south elevation is comprised of three-over-three six-light, four-over-four twelve-light, and three-over-three twelve-light windows (Figure 44). There is a small 2.5 ft by 2 ft opening in each gable face and a narrow 6 panel door on the east elevation. The interior has an array of gardening equipment and nesting boxes. Land to the north of this building is where a large garden had been present in the past.

Figure 44. Southeast corner of the coop showing the south and east elevations.

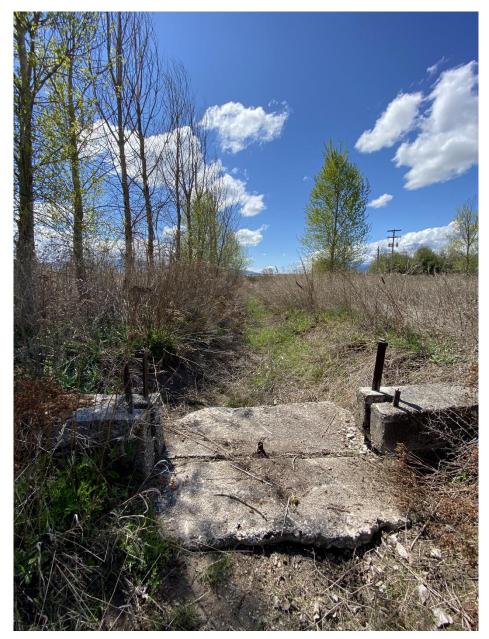
Abandoned headgate structure on the Flynn-Dougherty Ditch (24MO0901) at the Dougherty Ranch, view to the south.

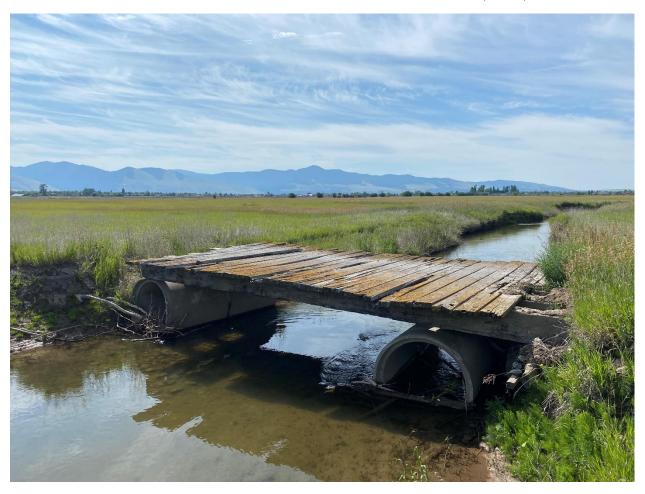
The Field Dougherty Ditch (24MO0902)/Grant Creek. Plank bridge originally recorded by Herbel and Beery (2006:20). View to the south.
