# Aquatic Resources Report

## ***Mullan BUILD Project***

*Missoula County, Montana*

**October 8, 2020**

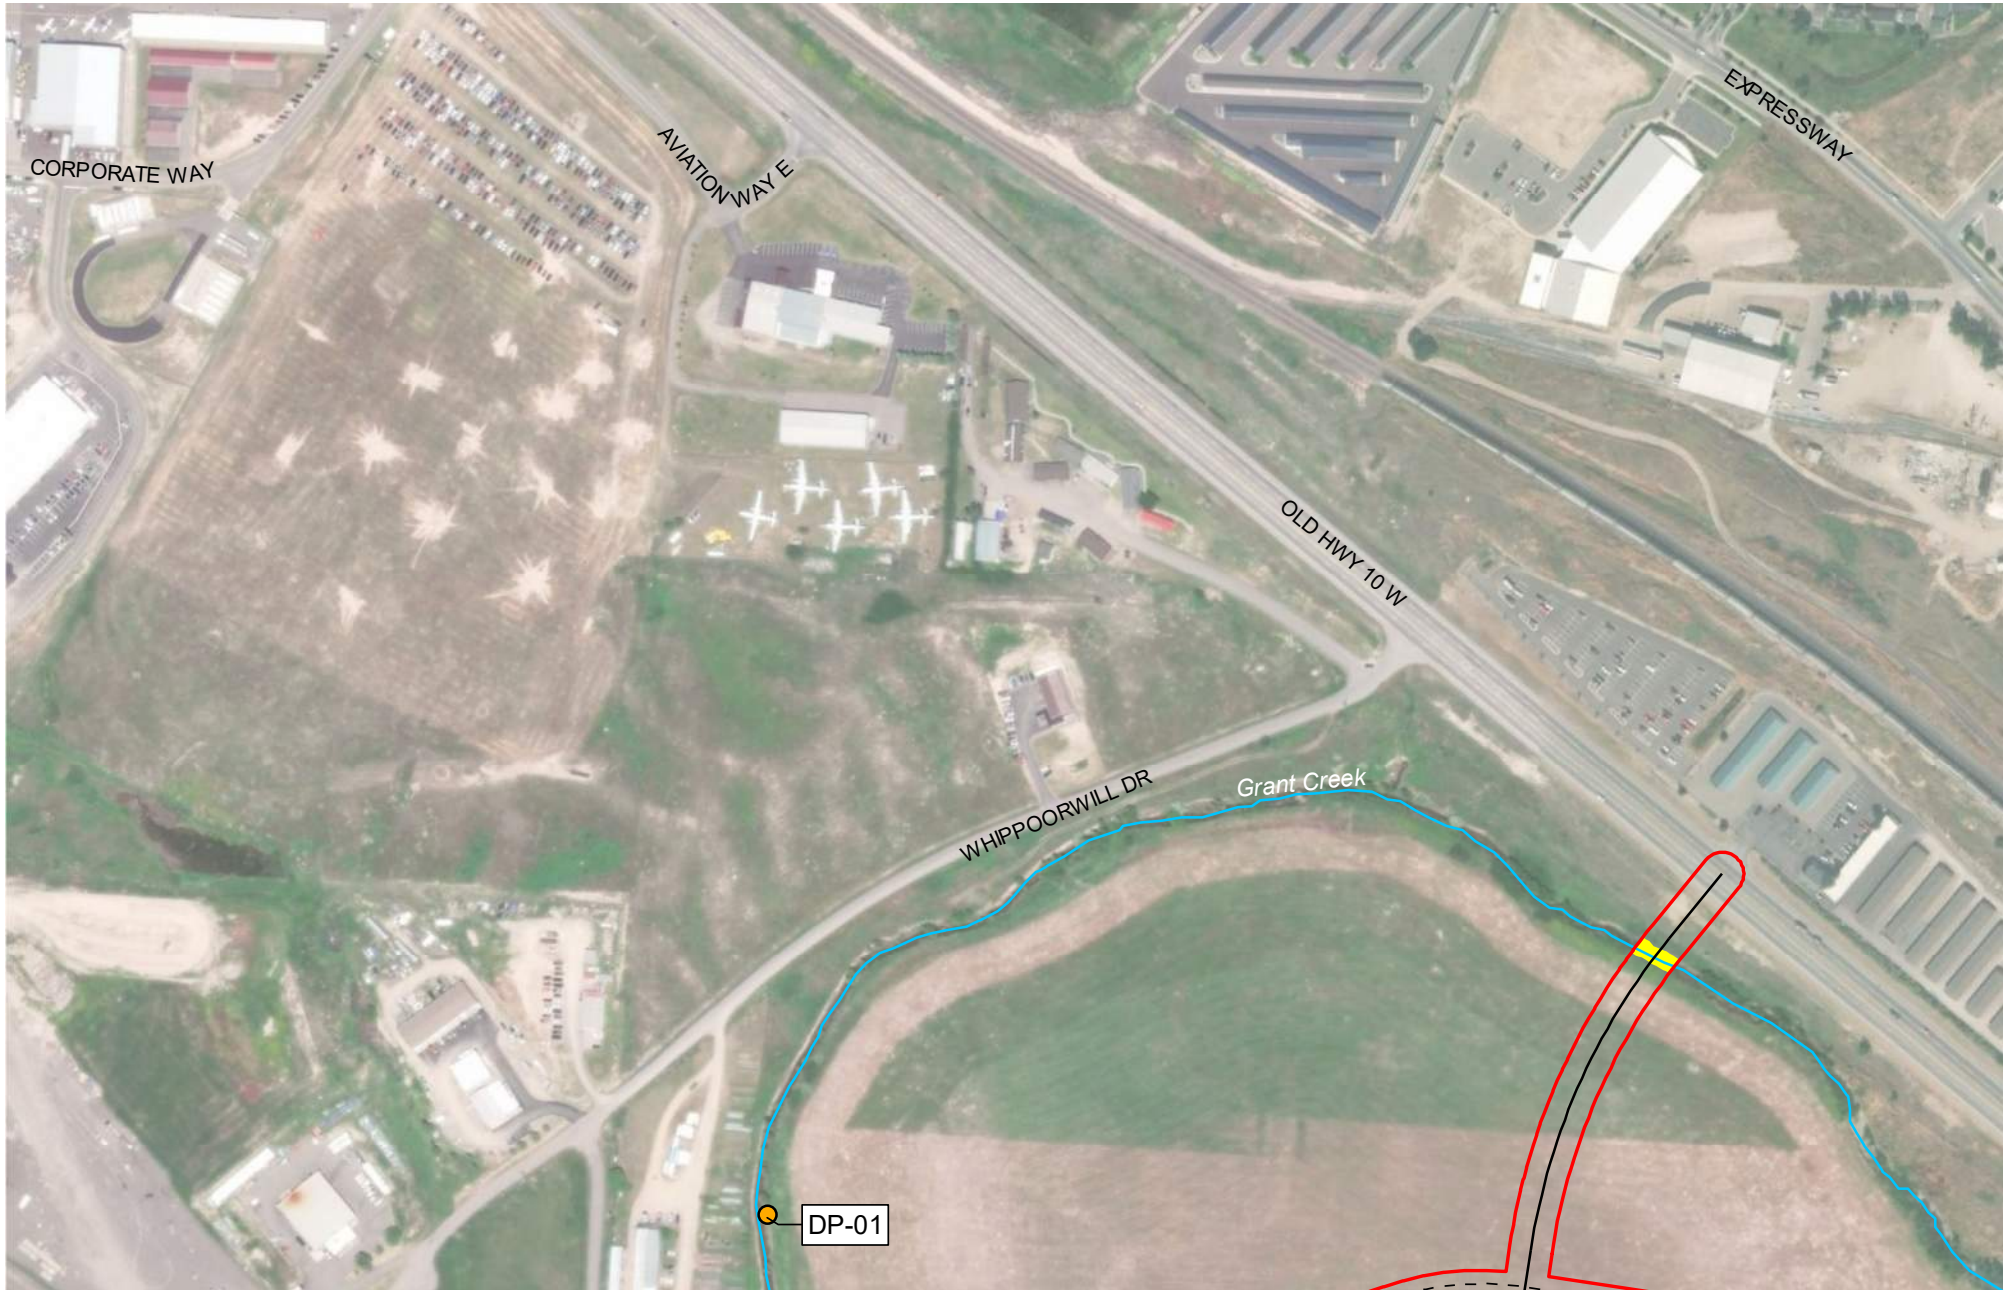
OVERVIEW MAP

- Upland Determination Form
- Stream (intermittent)
- Proposed Road
- Aquatic Resource Survey Area
- Delineated Waterway
- Proposed Trail

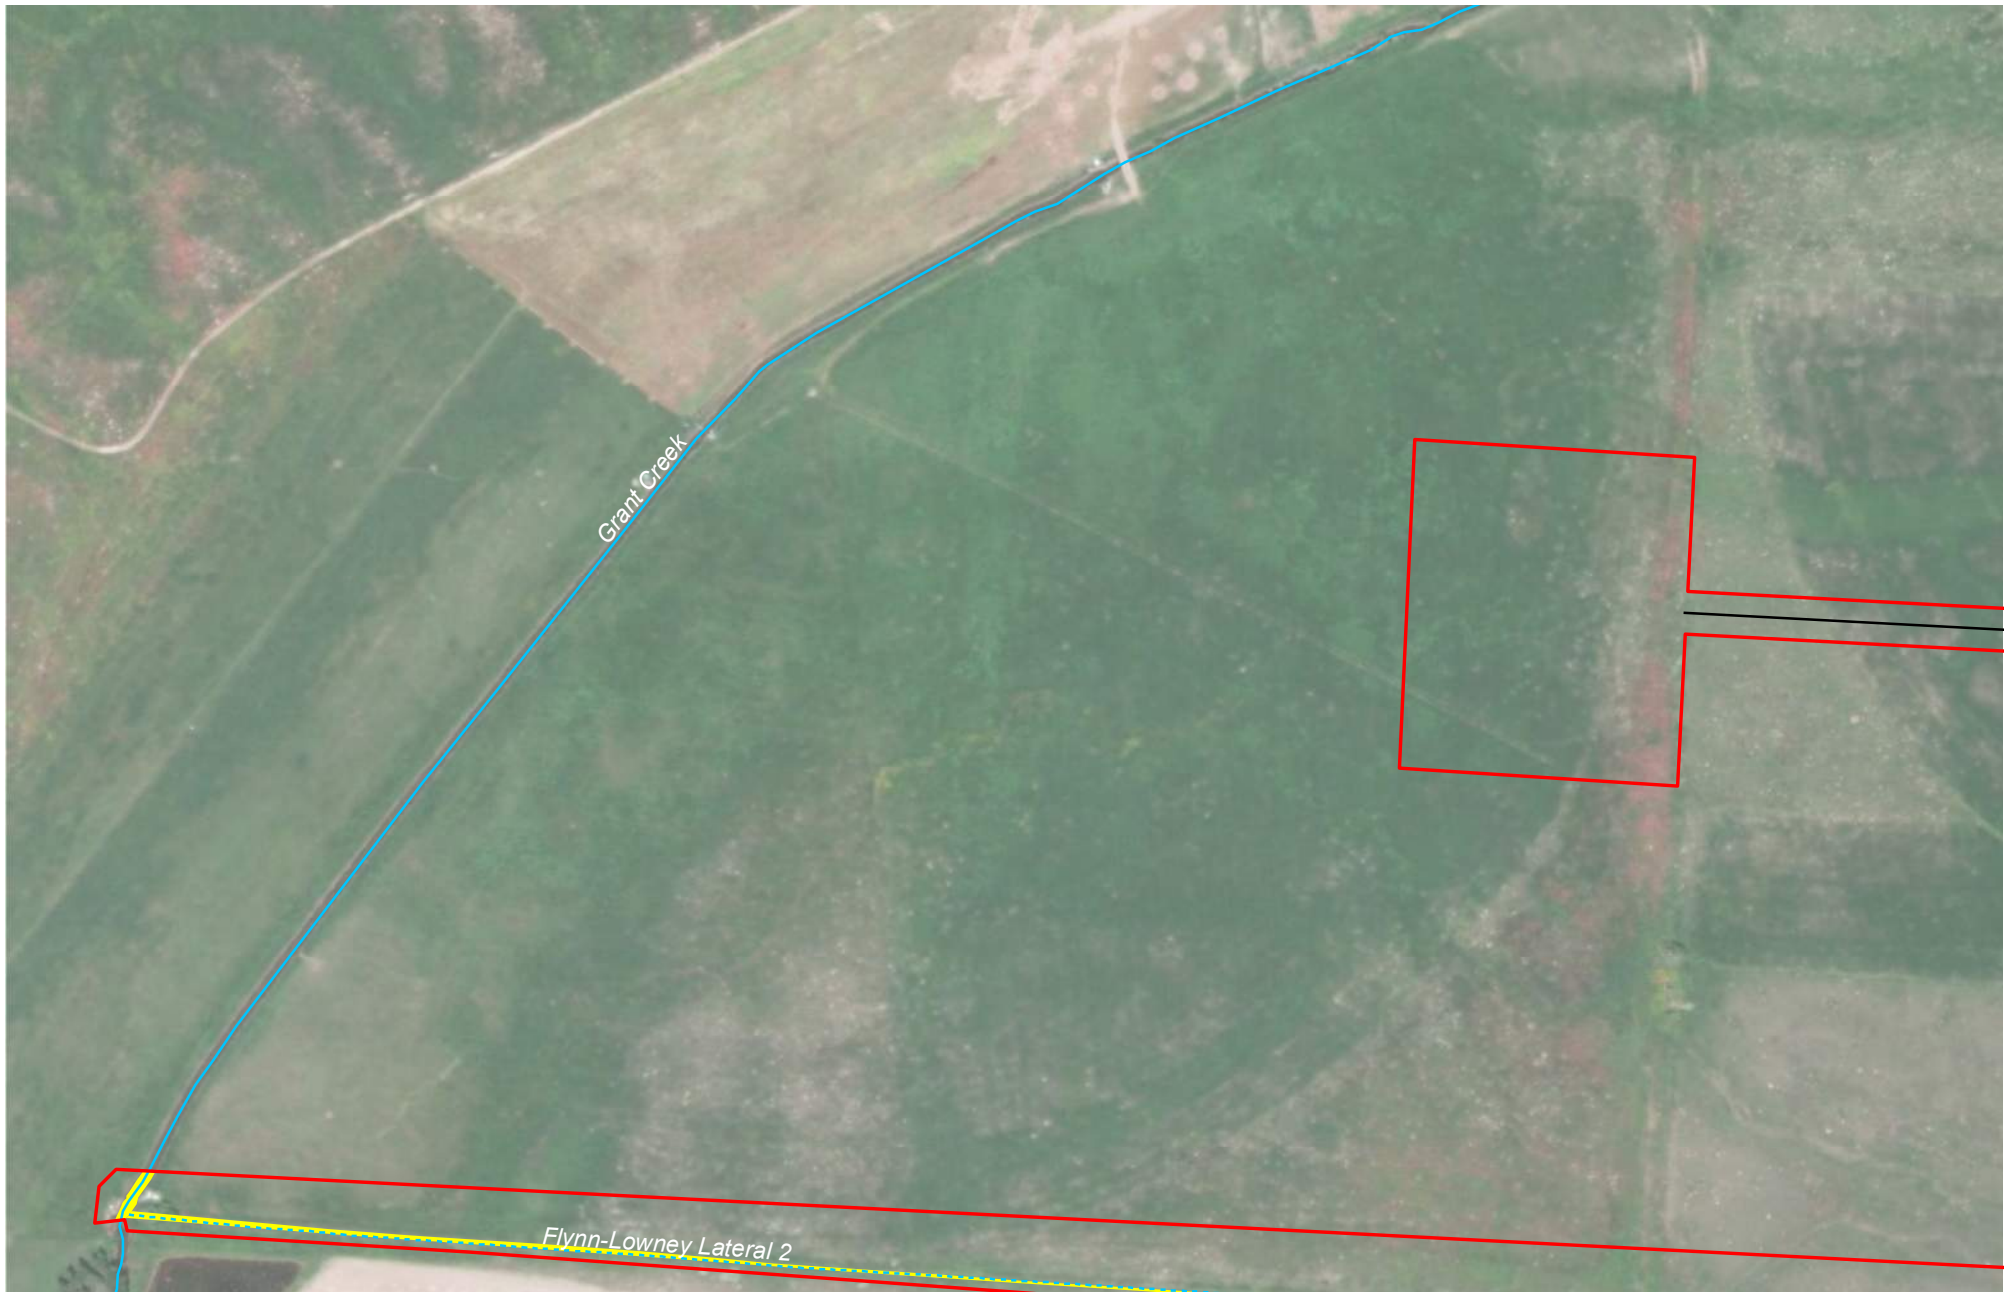
SHEET 4 OF 14

| Aquatic Resource Survey Area | Stream (intermittent) | Proposed Road |

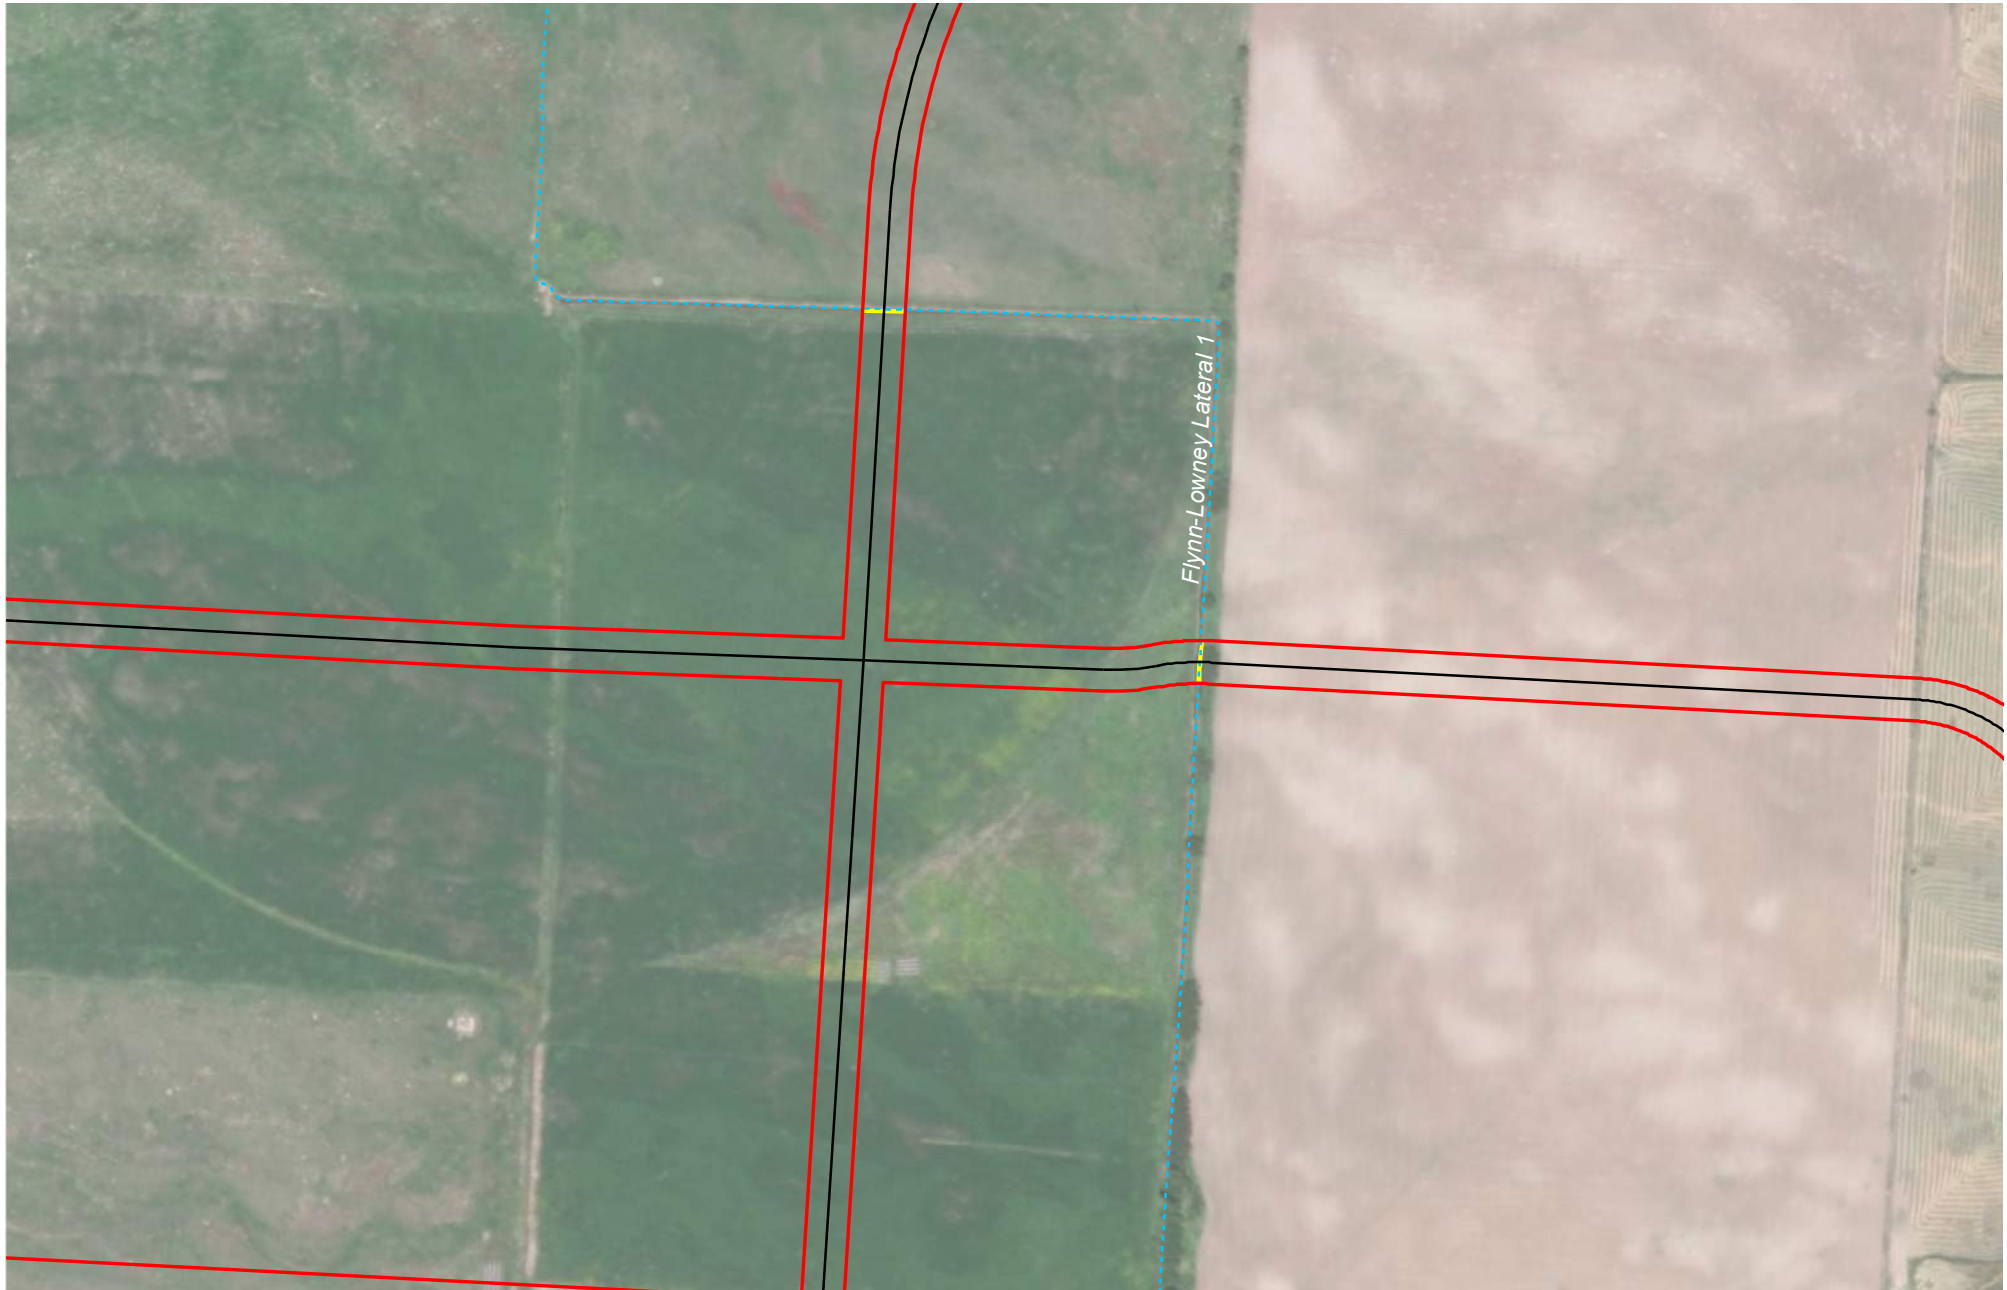
SHEET 5 OF 14

- Aquatic Resource Survey Area
- Ditch/Canal
- Proposed Road
- Delineated Waterway

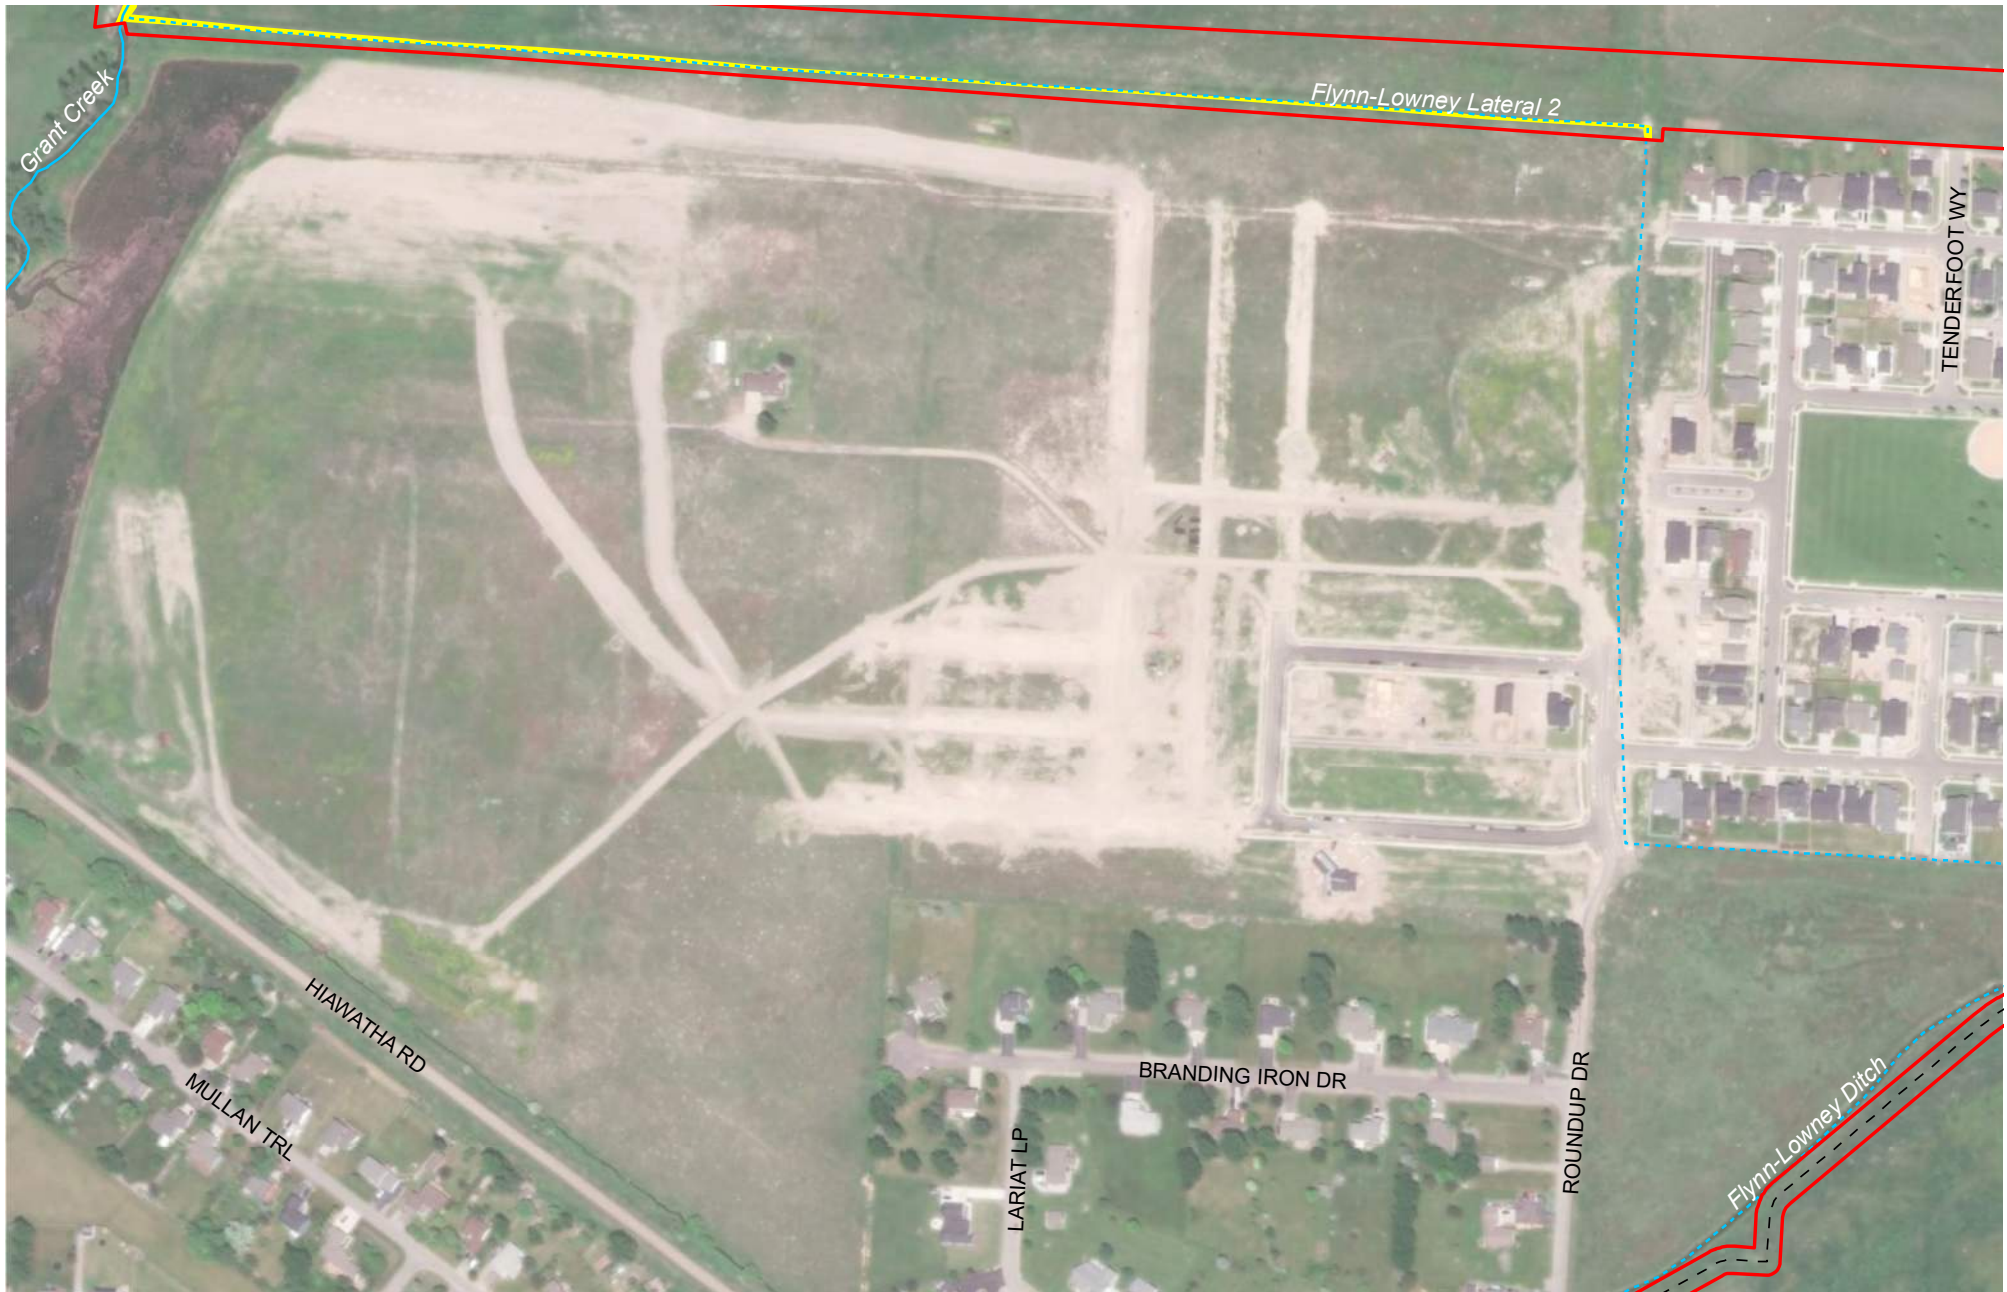
SHEET 7 OF 14

- Aquatic Resource Survey Area
- Delineated Waterway
- Stream (intermittent)
- Ditch/Canal
- Proposed Trail

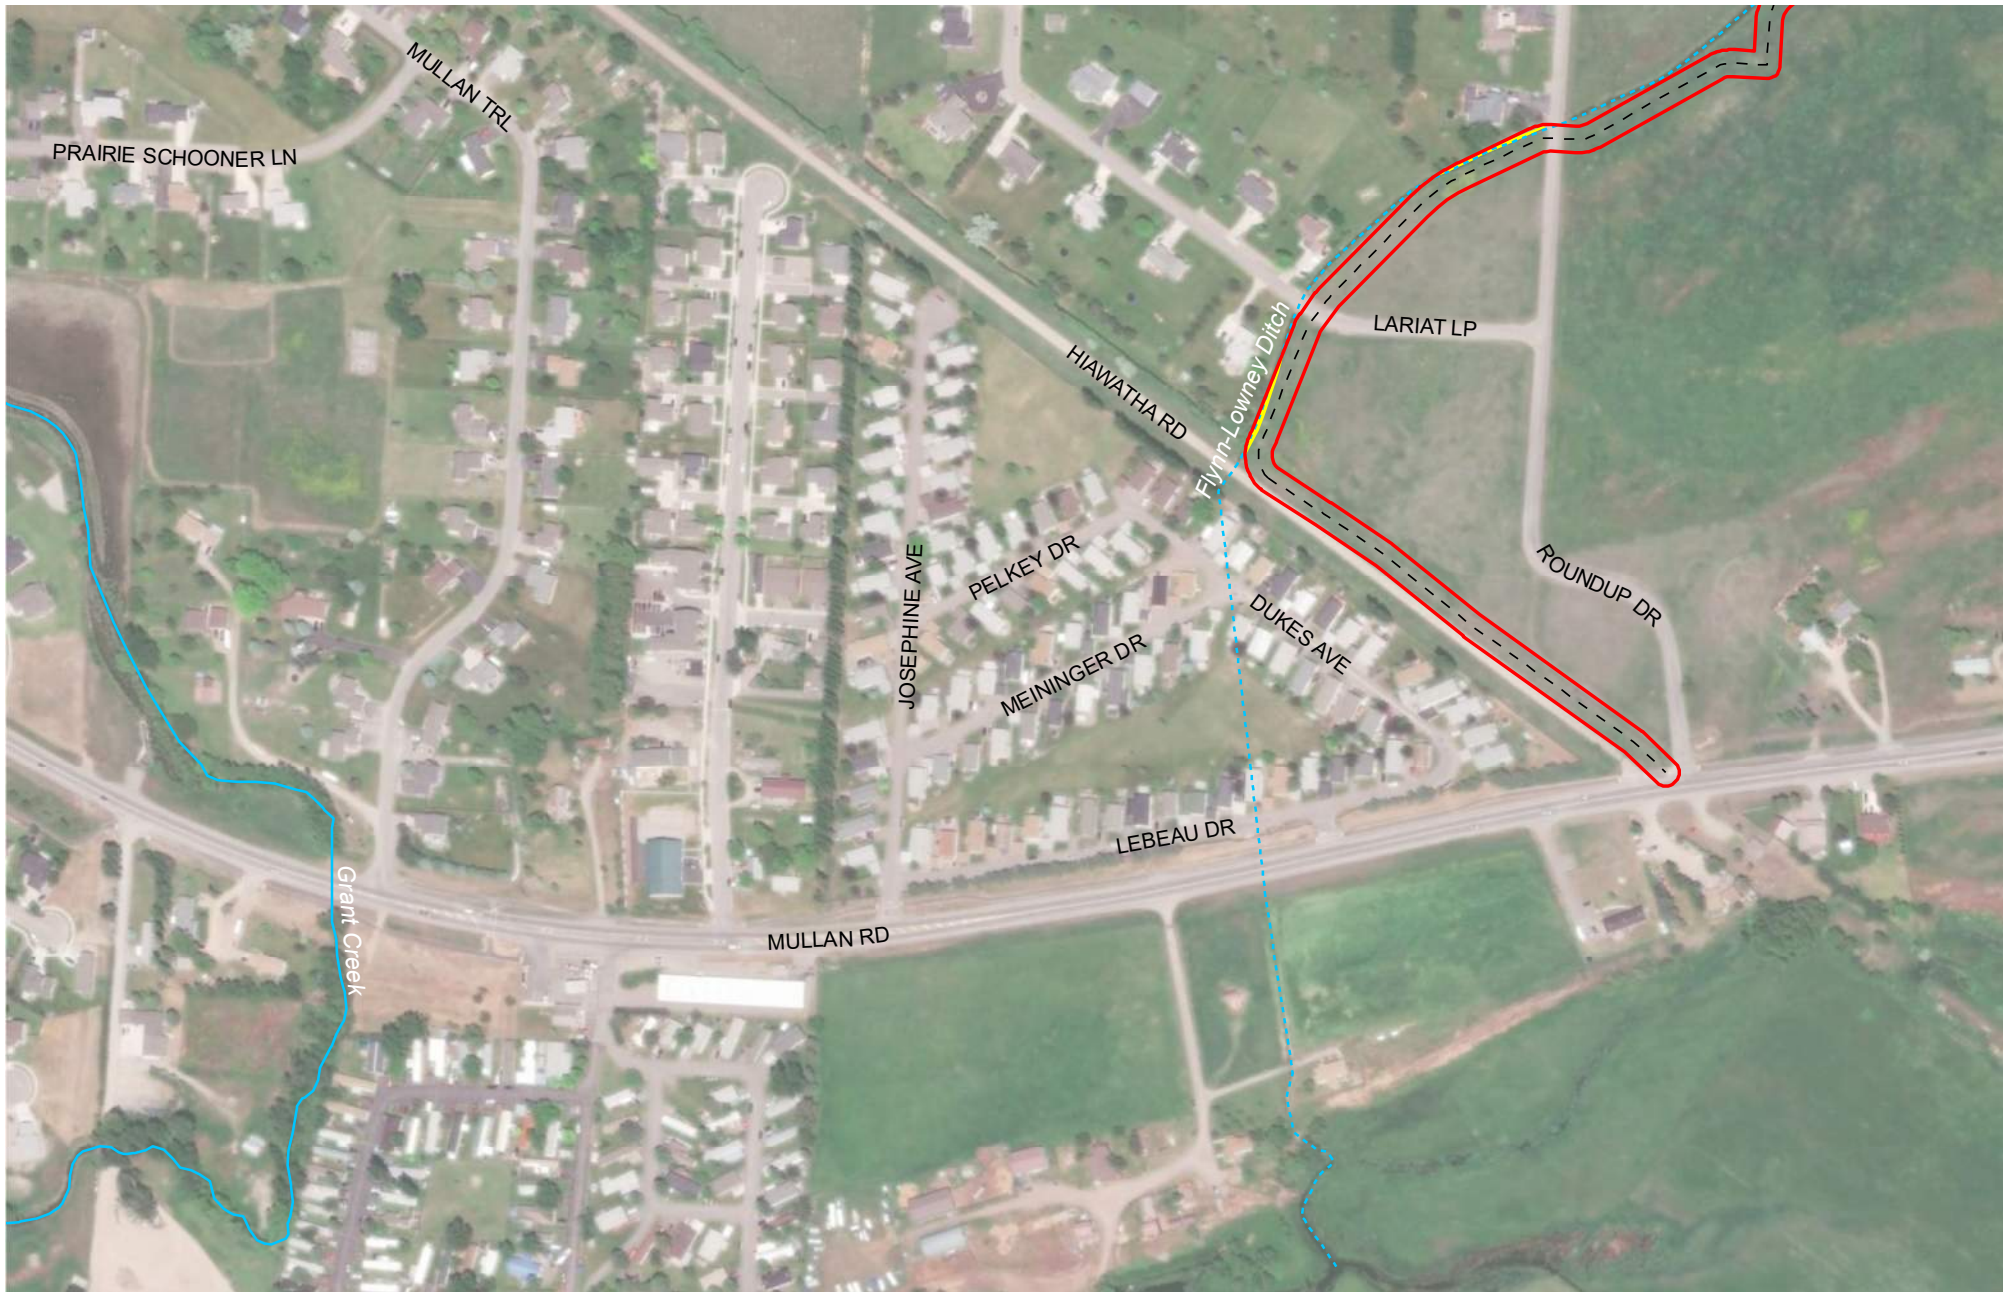
SHEET 10 OF 14

- Aquatic Resource Survey Area
- Delineated Waterway
- Stream (intermittent)
- Ditch/Canal
- Proposed Trail

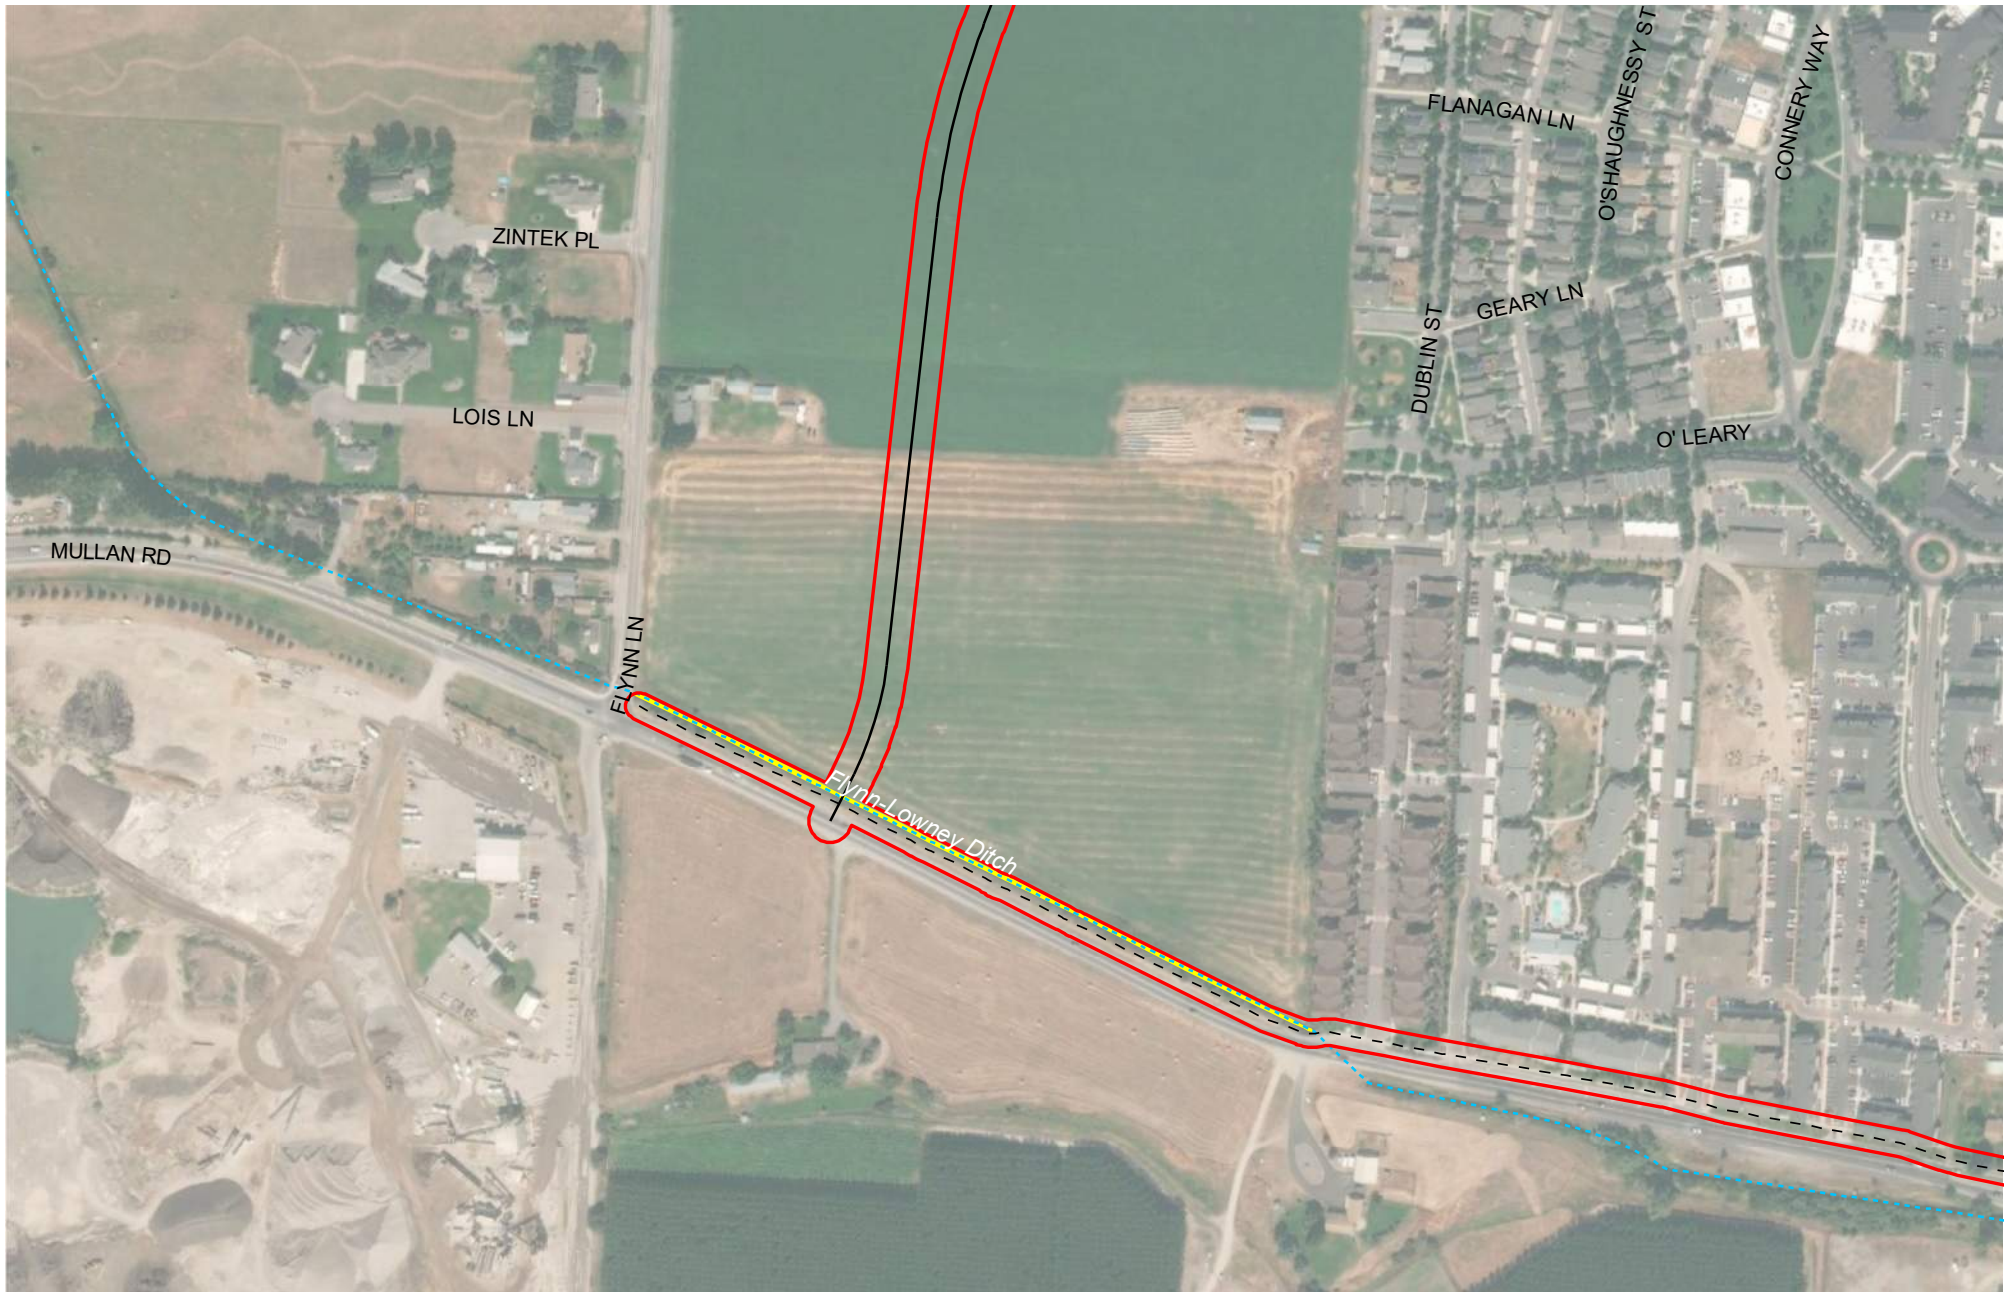
SHEET 12 OF 14

- Aquatic Resource Survey Area
- Ditch/Canal
- Proposed Road
- Delineated Waterway
- Proposed Trail

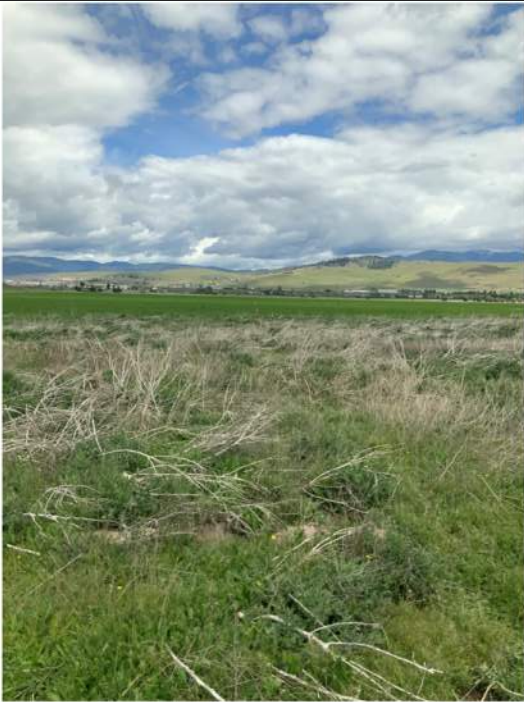
Photo 1. Agricultural field located along the proposed George Elmer Drive alignment, looking north.

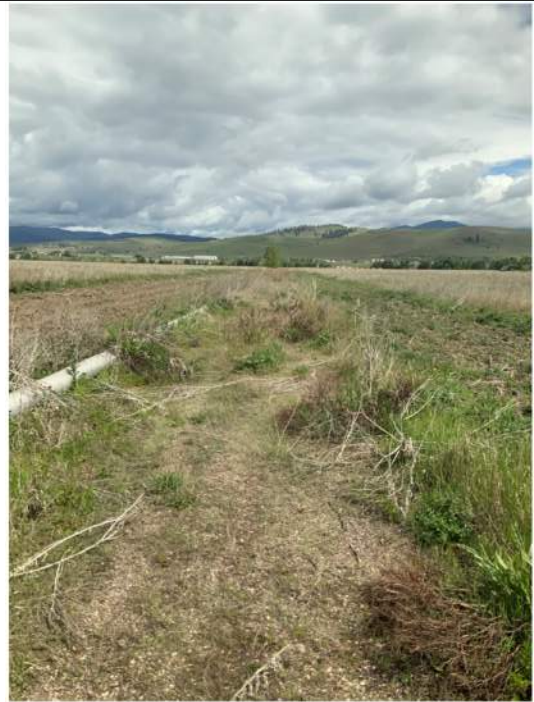
Photo 2. Agricultural field located along the proposed England Boulevard alignment, looking east towards Flynn Lane.

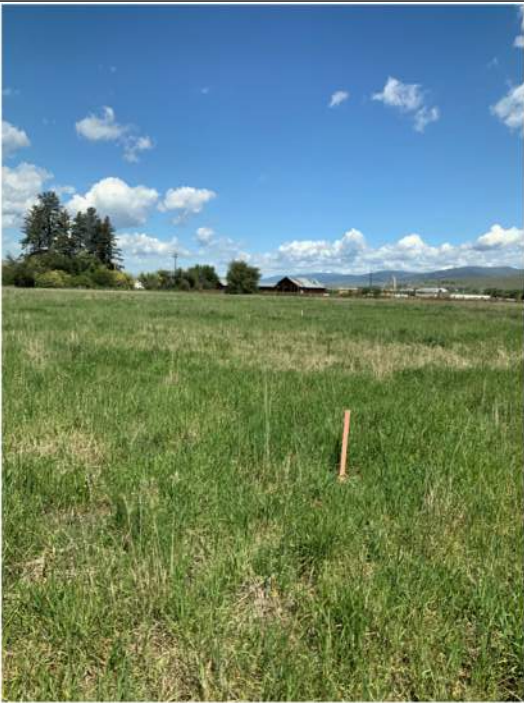
Photo 3. Agricultural field located along the proposed northern extension of Mary Jane Boulevard alignment, looking west.

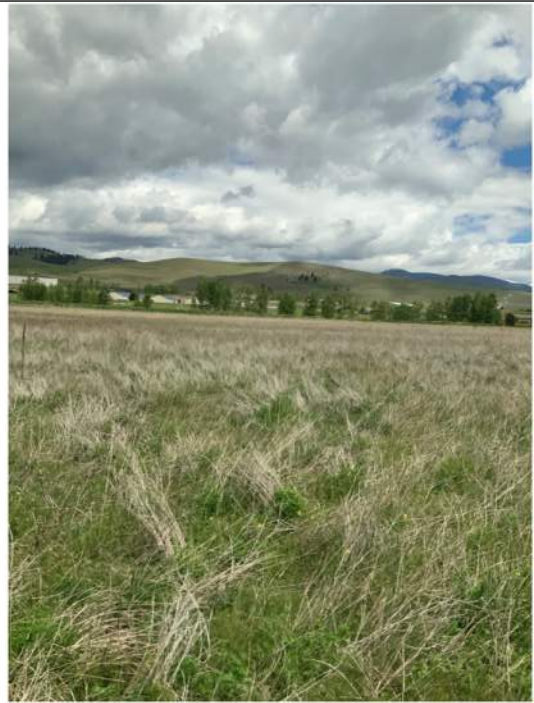
Photo 4. Agricultural field located at the proposed crossing of George Elmer Drive and the realigned Grant Creek, looking north.

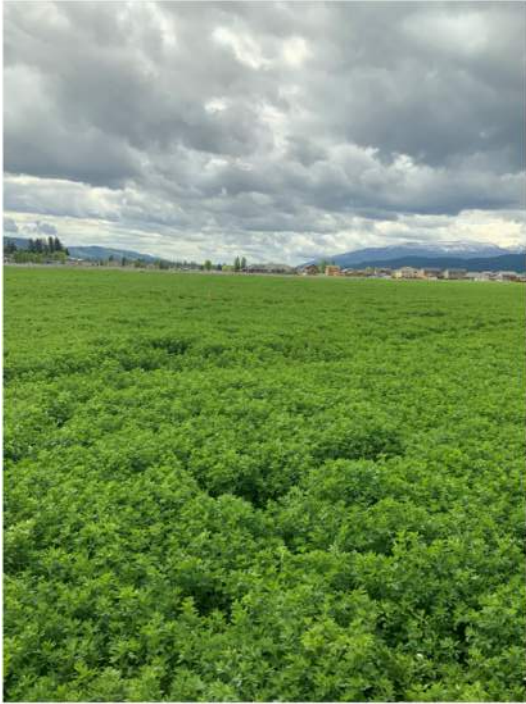
Photo 5. Agricultural field located along the proposed intersection of George Elmer Drive and England Boulevard, looking south.

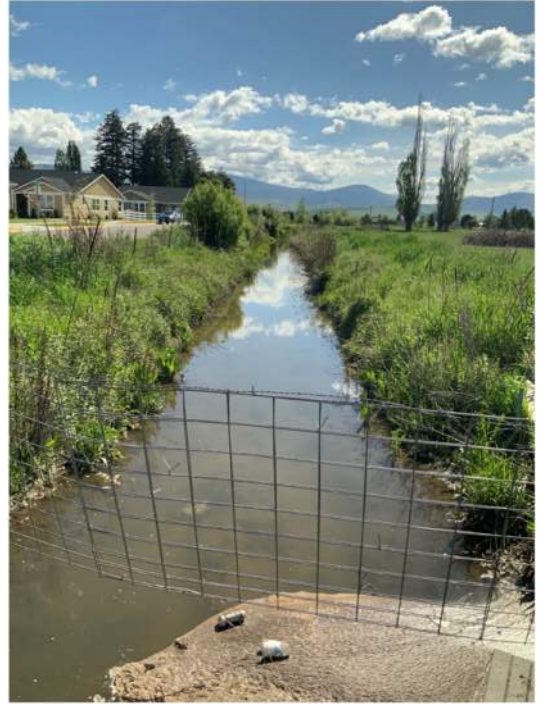
The Flynn-Lowney Ditch originates at a river diversion along the north side of the Clark Fork River between the Orange Street and Russell Street bridges. The water is conveyed along Mullan Road to just west of Flynn Lane where the ditch travels in a northwesterly then southwesterly direction through the study area. The Flynn-Lowney Ditch ranges from approximately 6 to 20 feet wide and has near vertical banks. The vast majority of the ditch as observed within the study area is un-vegetated. The vegetation along the banks of the ditch typically consists of upland grasses and substantial concentrations of weeds, with the exception of a few various locations where wetland vegetation (i.e., *Carex spp.*, *Schoenoplectus spp.*) was observed along the inside of the ditch banks.

Photo 6. Flynn-Lowney Ditch near the intersection of the proposed Tipperary Way Trail and the existing George Elmer Drive, looking east.

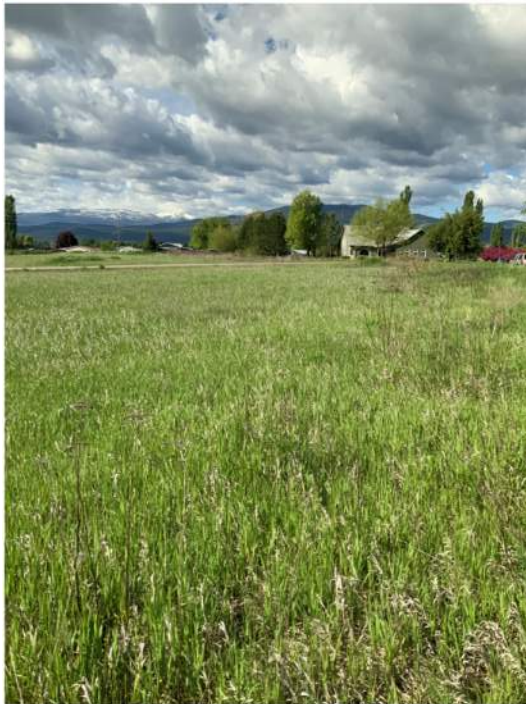
Photo 7. Vacant field located between Roundup Drive and Lariat Loop at the location of the proposed Tipperary Way Trail.

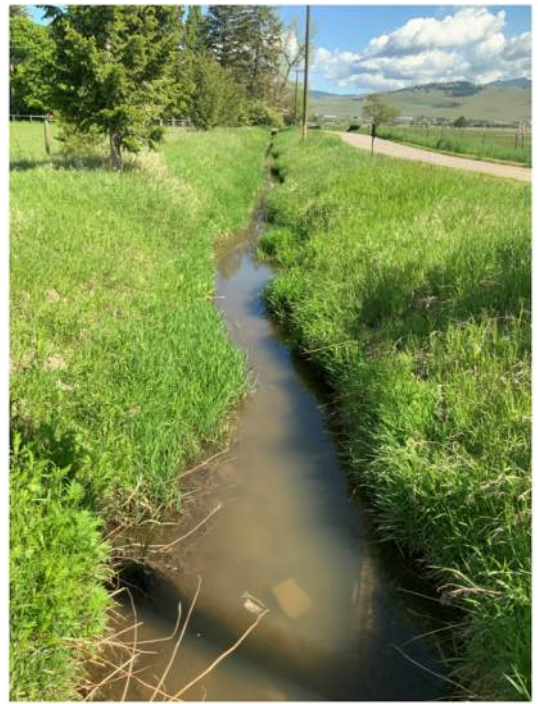
This ditch is a narrow lateral ditch ranging approximately 3 to 6 feet in width that begins at a diversion of the Flynn-Lowney Ditch just west of George Elmer Drive. The lateral ditch flows in a northerly direction for approximately 170 feet, turns west for 880 feet, flows north for 0.25 mile, then flows west approximately 0.5 mile into Grant Creek. This lateral is crossed by the project by the proposed Tipperary Way Trail and the proposed extension of England Boulevard and George Elmer Drive. The north-south segment of the ditch that is crossed by the proposed extension of England Boulevard contained water during the field investigation, although the ditch was not flowing. The east-west segment of the ditch crossed by the proposed extension of George Elmer Drive did not contain water during the field investigation.

Photo 8. Lateral 1 of Flynn-Lowney Ditch near Tipperary Way Road near the location of the proposed Tipperary Way Trail, looking north.

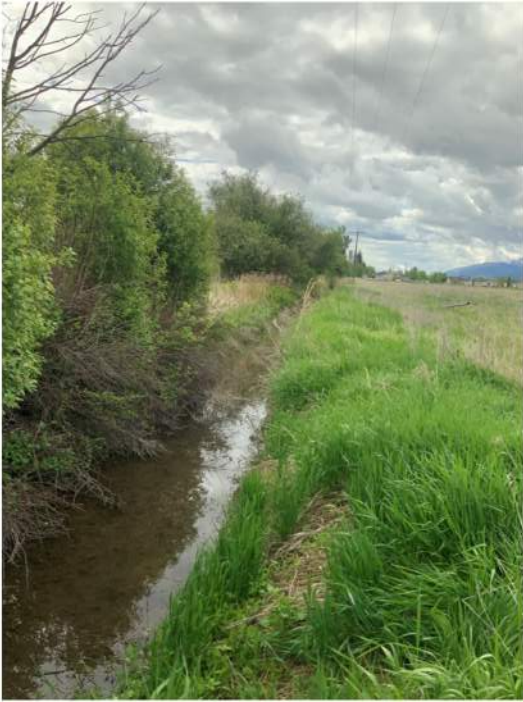
Photo 9. Lateral 1 of Flynn-Lowney Ditch at the proposed England Boulevard crossing, looking south.

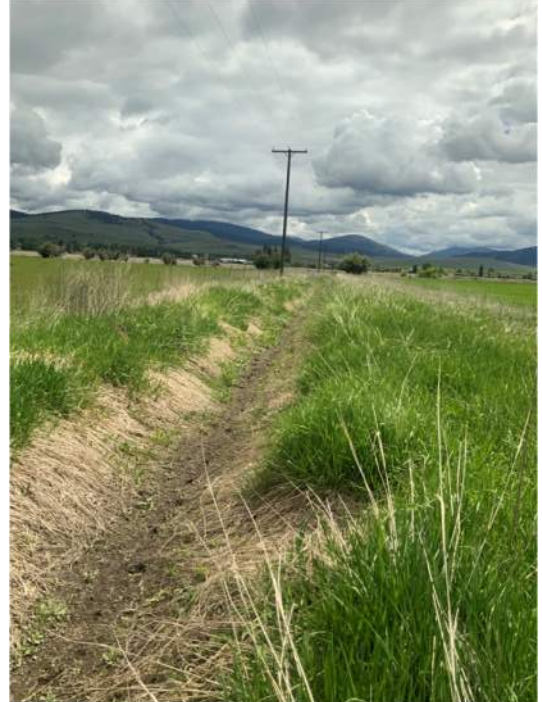
Photo 10. Lateral 1 of Flynn-Lowney Ditch at the proposed George Elmer Drive crossing, looking east.

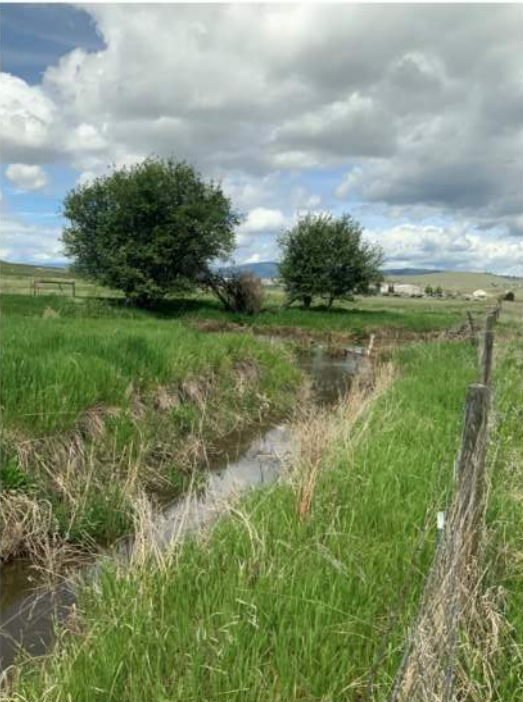
Photo 11. Lateral 1 of Flynn-Lowney Ditch where it joins Grant Creek, looking west.

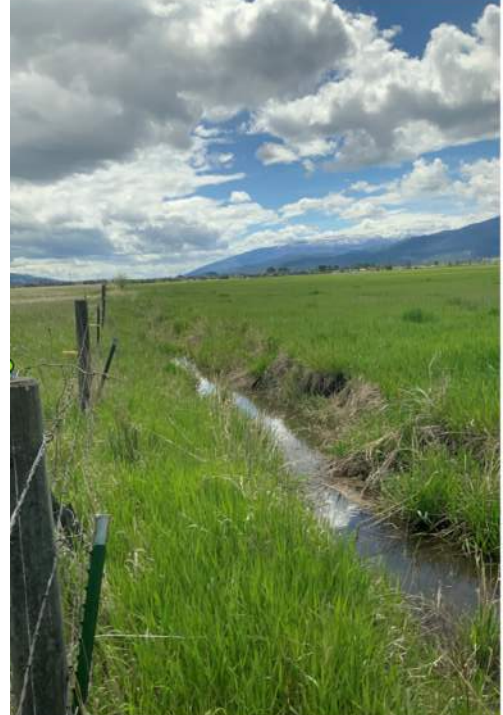
Photo 12. Lateral 1 of Flynn-Lowney Ditch near its confluence with Grant Creek, looking east.

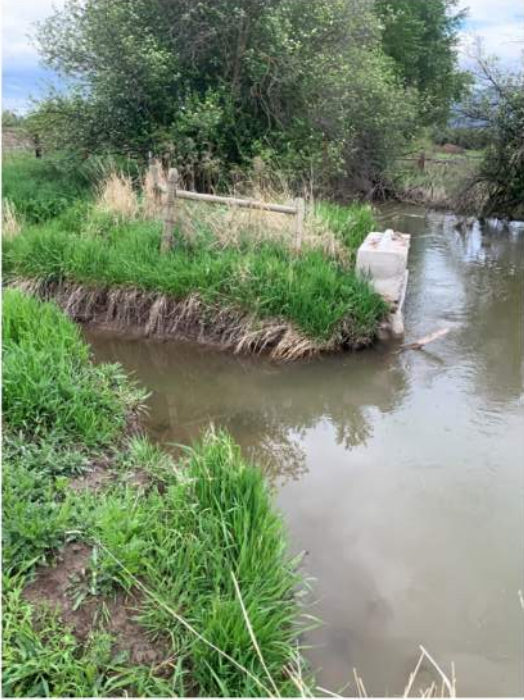
This ditch is a lateral ditch ranging approximately 4 to 10 feet in width that begins at a diversion of the Flynn-Lowney Ditch near Tipperary Way, just east of George Elmer Drive. The lateral ditch flows in a northerly direction for approximately 0.7 mile, turns west for .25 mile, then flows north for 0.25 mile and flows into Grant Creek. This lateral is not crossed by any transportation element of the project; however, there is potential that the ditch conveyance flowing west from the 44 Ranch Estates development could be used to convey stormwater from George Elmer Drive. This ditch was actively conveying water westward and flowing into Grant Creek during the field investigation.

Photo 13. Lateral 2 of Flynn-Lowney Ditch where it enters Grant Creek, looking south.

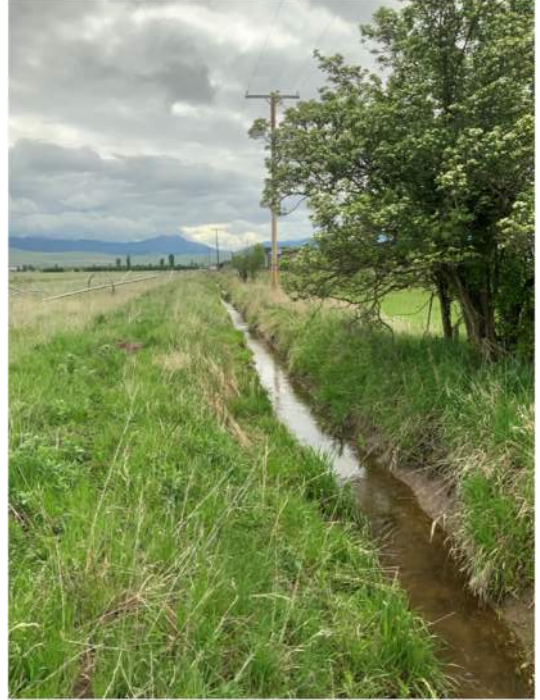
Photo 14. Lateral 2 of Flynn-Lowney Ditch, looking east.
