Cultural Resource Inventory for the Proposed Mullan BUILD Project, Missoula County, Montana.

Project Name: Cultural Resource Inventory for the Proposed Mullan BUILD Project, Missoula County, Montana.

Agency Name: Federal Highway Administration

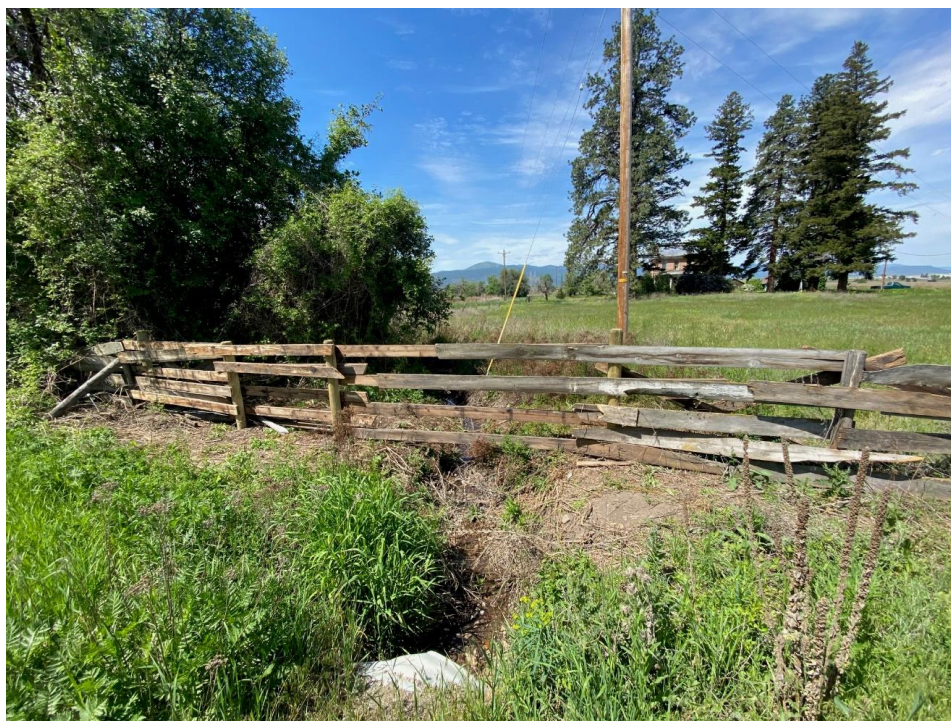
crosses under Flynn Lane (Figure 11) at the location of the Dougherty Ranch and continues west where it has been filled in just west of the Ranch eliminating its former terminus with a primary lateral of the Flynn-Lowney Ditch (24MO0550). A dilapidated and abandoned, rough-aggregate concrete headgate (Figure 12) is present just southwest of the Dougherty Ranch (24MO1781) where the extant ditch alignment turns briefly to the south.

Figure 11. The Flynn-Dougherty Ditch (24MO0901) at its culvert under Flynn Lane, view to the west. The Dougherty Ranch is pictured in the background.

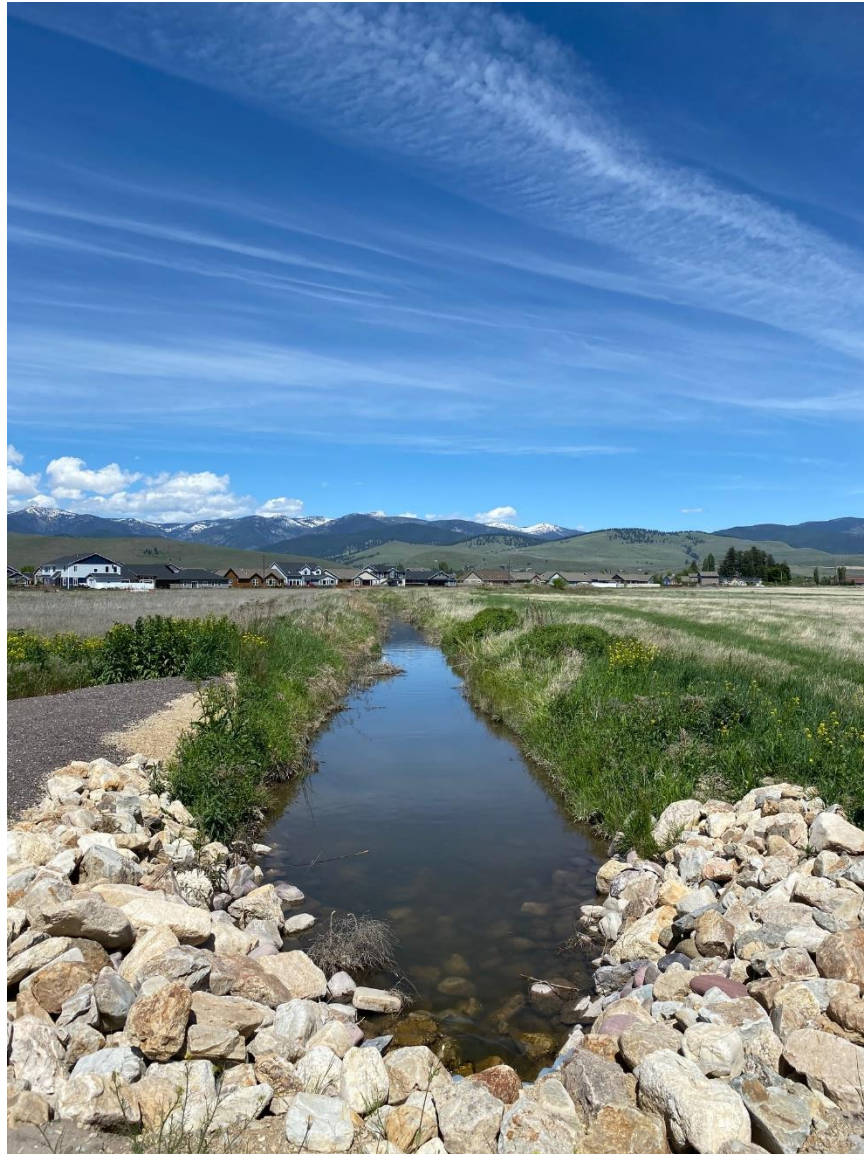
Figure 22. Overview of the Flynn-Lowney Ditch, main channel, at its existing culvert at Chuckwagon Drive. View to the northeast.

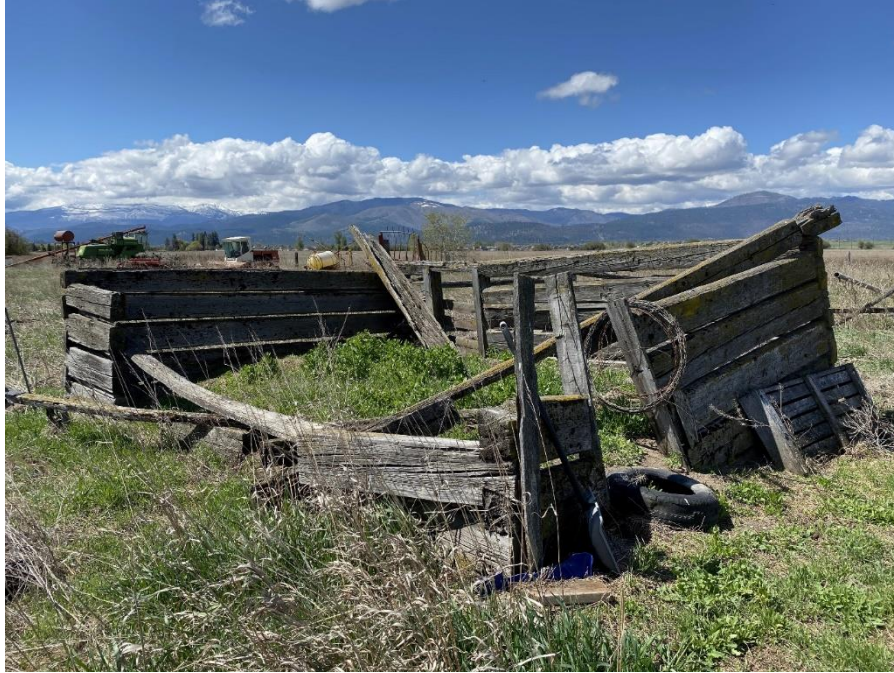
Feature 1: Feature 1 is the remains of 19 by 13 ft, six-course high log building (Figure 41). The logs are milled and dovetail notched. It is likely that this structure would have been contemporaneous to the cabin located nearby and was likely a small barn.

Figure 41. Overview of Feature 1, view to the south.
