Aquatic Resources Report

Mullan BUILD Project

Missoula County, Montana

October 8, 2020

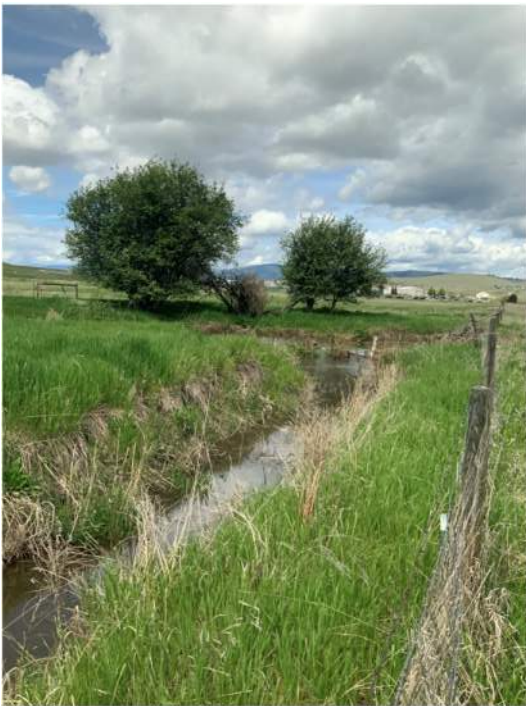
Photo 11. Lateral 1 of Flynn-Lowney Ditch where it joins Grant Creek, looking west.

This ditch is a narrow lateral ditch ranging approximately 3 to 6 feet in width that begins at a diversion of the Flynn-Lowney Ditch just west of George Elmer Drive. The lateral ditch flows in a northerly direction for approximately 170 feet, turns west for 880 feet, flows north for 0.25 mile, then flows west approximately 0.5 mile into Grant Creek. This lateral is crossed by the project by the proposed Tipperary Way Trail and the proposed extension of England Boulevard and George Elmer Drive. The north-south segment of the ditch that is crossed by the proposed extension of England Boulevard contained water during the field investigation, although the ditch was not flowing. The east-west segment of the ditch crossed by the proposed extension of George Elmer Drive did not contain water during the field investigation.

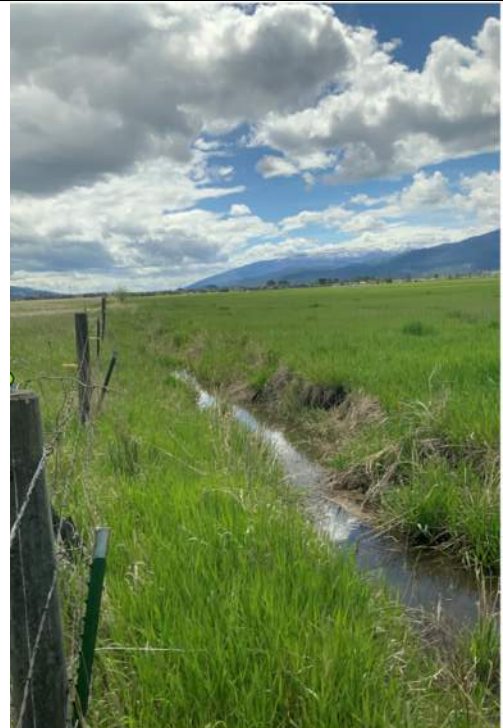
Photo 12. Lateral 1 of Flynn-Lowney Ditch near its confluence with Grant Creek, looking east.
