## MEMORANDUM

**RE:** Roseburg Phase I ESA Findings and Recommendations

This memorandum describes the findings and recommendations of the Phase I Environmental Site Assessment (ESA) completed by WGM Group, Inc (WGM) on January 30, 2024 for the Roseburg Forest Products (RFP) property. The purpose of the ESA was to identify any Recognized Environmental Conditions (RECs) for the property. A REC can be broadly described as the presence of contamination, potential presence of contamination, or threat of contamination on a property. A Controlled Recognized Environmental Condition (CREC) is a REC that has been addressed to the satisfaction of the regulatory authorities and allows the contamination to remain in place subject to implementation of required controls and/or monitoring.

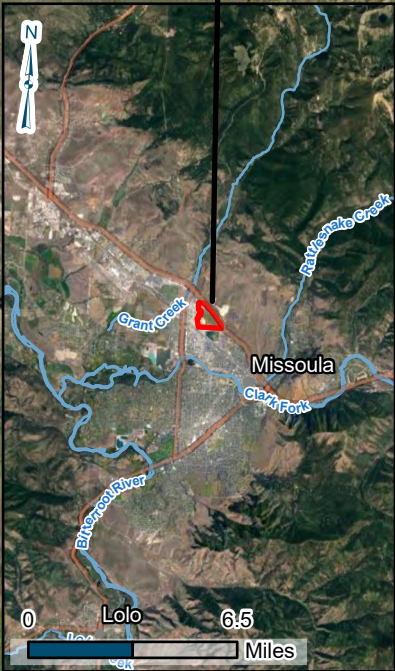
**Subject Property**

**De minimis condition:** The ESA noted disturbed ground along the northwestern boundary of the property just south of the Missoula Landfill. This location appears to have been used historically for gravel and wood fiber storage. The available maps reviewed in the ESA indicated that this location covers an area of approximately five acres. The approximate location of the gravel/wood fiber storage

is shown in **Attachment A**. This gravel/wood fiber storage area is not a considered a release, hazardous waste, or REC for the property.

The wood fiber storage along the northern boundary of the property will likely need to be removed prior to any development of the property. Since this wood fiber is present on ground surface and is not associated with residual moisture from a former log pond, it does not present a hazardous condition for methane generation. The wood fiber is considered a *de minimis* condition for potential future development of the property.

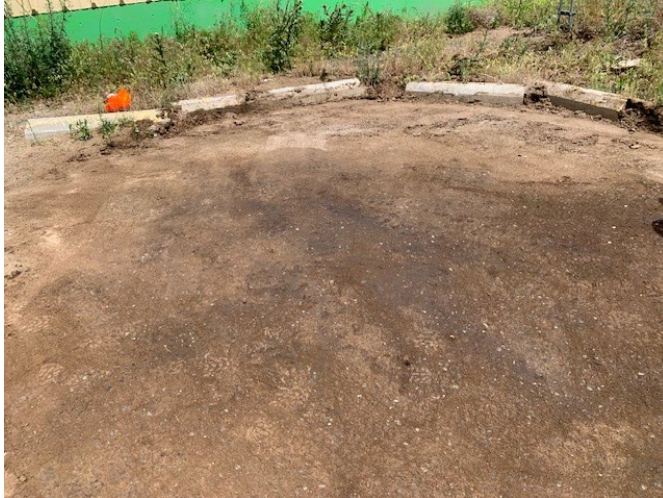
**REC #2:** A large petroleum stain was observed on surface soil adjacent-south of the Lubrication Building near two empty Intermediate Bulk Containers; this was considered a REC for the Subject Property. In June 2024, representatives for LMI Environmental removed the petroleum-stained soil from this area (less than 1 cubic yard) and discovered that the entire area was underlain by a secondary containment barrier constructed of asphalt with concrete and/or wax-bermed sidewalls. Photographs of the cleanup action and secondary containment are included in **Attachment B**.

**Asphalt pad discovered beneath the petroleum stained soil.**

The stained soil located adjacent-south of the Lubrication Building was identified as a REC for the property. All the petroleum-impacted soil has been cleaned up and no further impacts to soil are present at this location. WGM does not recommend any additional assessment or cleanup for the petroleum stained soil area. It is WGM's opinion that this REC has been sufficiently addressed through the cleanup actions completed and WGM does not consider this location to represent a presence or likely presence of a release to the environment, and therefore, is no longer a REC.

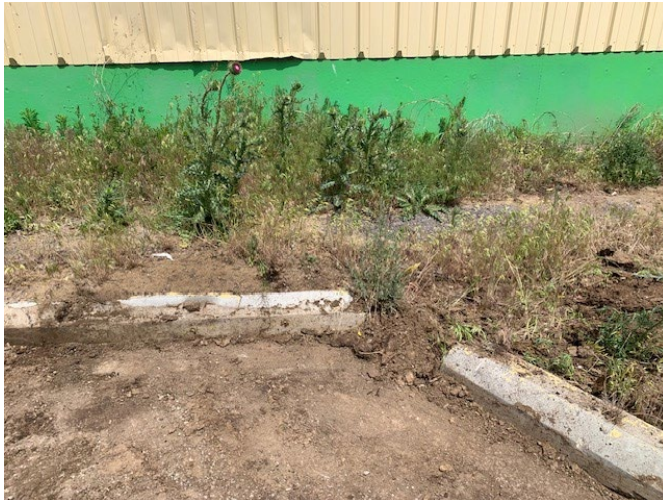
**Concrete bermed corner**

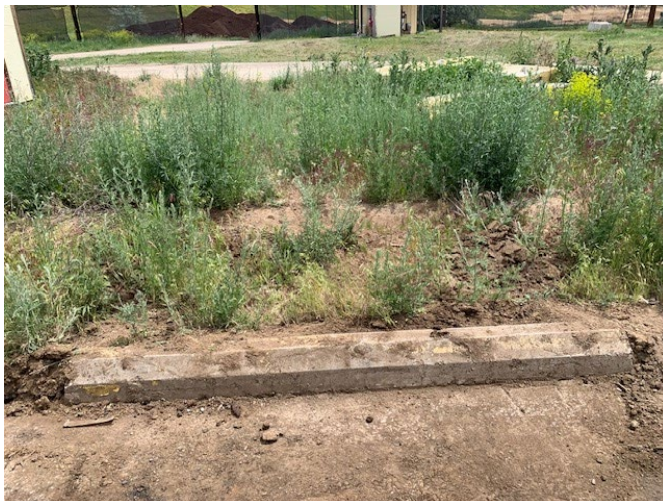
**Concrete sidewall**
