MEMORANDUM

SUBJECT: Union Block Facade Renovation (127 East Main Street)

Front Street Urban Renewal District – Second Tax Increment Request

Radio Building / Union Block Facade Reconstruction

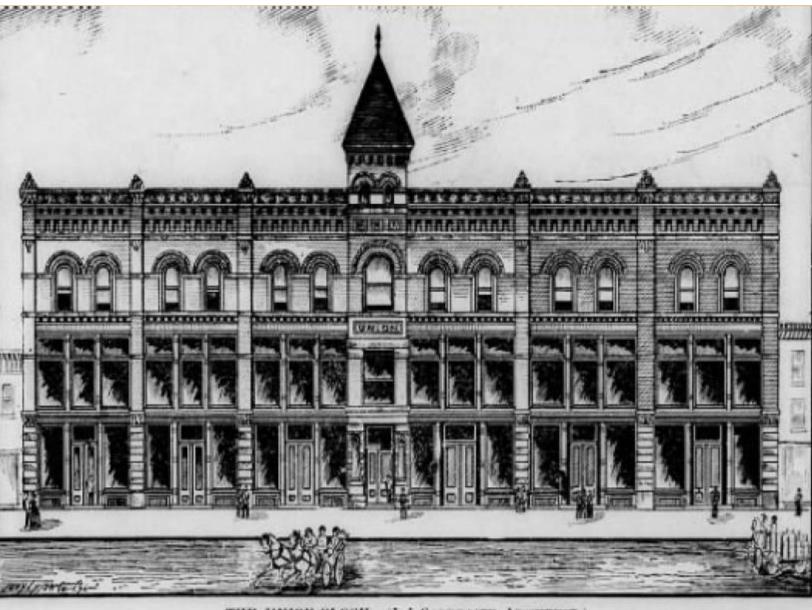
THE UNION BLOCK .- (L J. GALBRAITH, ARCHITECT.)

The Union block is being erected jointly by Messrs. F. G. Higgins, T. L. Greenough and Wm. H. Houston. The building has a frontage of 138 feet by 90 feet deep, and will cost when completed \$100,000. The foundation walls are built and as soon as the weather will permit the walls will be erected. The building is designed for store rooms, offices and flats, the basement front rooms to be used for stores or offices; the first floor for store rooms exclanively. The second story front rooms are in suites of offices, with open plate glass fronts, the large lights being swung on top and bottom pivots. The interior of each block has an open court from second story to roof, with flats of five and six rooms surrounding the courts. The entire front of the building will be of (Chicago) Anderson pressed brick, laid in black cement, and native granite, polished and carved. The front entrance tower will be supported with polished Clarks Island granite column plinths, carved caps and lintels, carried up prominently and roofed with vitrified tile. The first and second story fronts of stores and offices will be finished in polished white oak wood. All the store entrance vestibules and the main entrance vestibule will have floors alternating in black and white marble; the main entrance corridors will be finished in red oak. The building will be fitted with both passenger and freight elevators, and will be fitted up with three separate steam heating plants, lavatory rooms, closets and pantries and electric light. The structure is located on East Main street, nearly opposite the Higgins block, and will prove a valuable acquisition to that portion of the city.

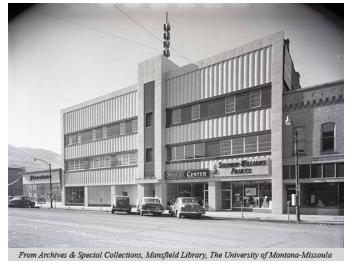
Original rendering of the Union Block. It was not completed quite as drawn or maybe a section burned and was torn down. Rafter pockets and an old roof are visible on the West façade showing some history of what existed and could have been intended.

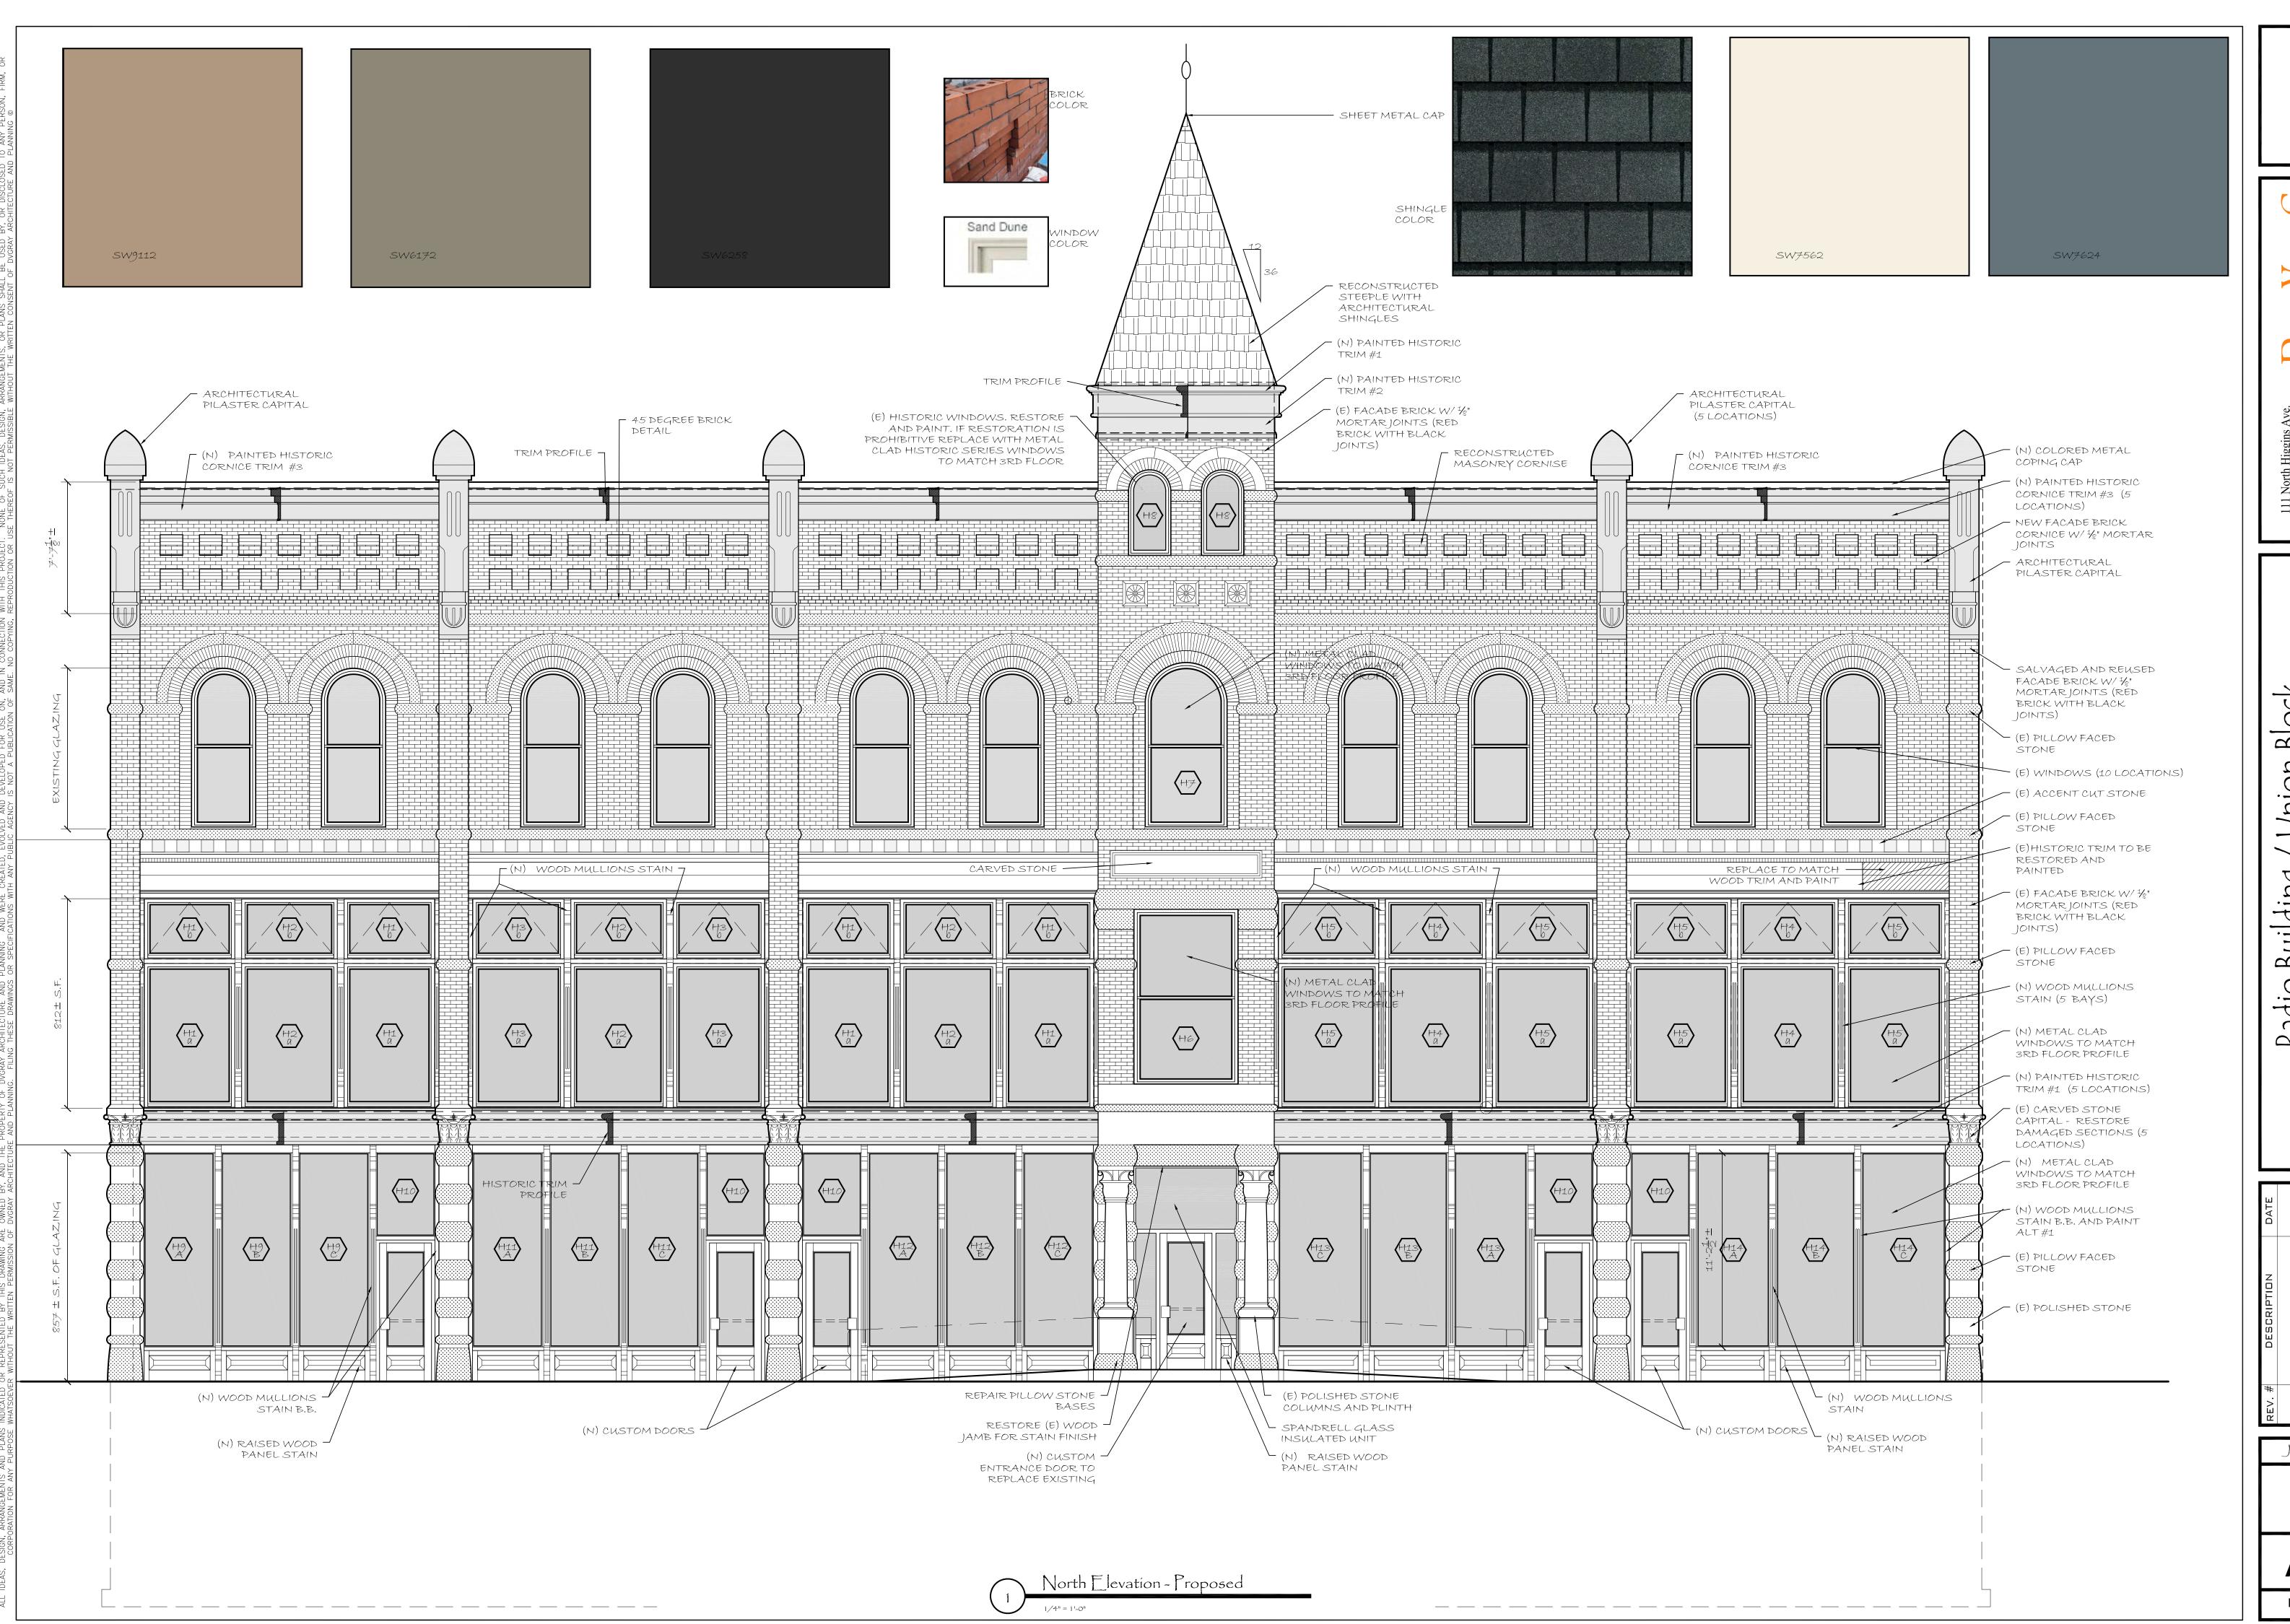
4 Details
A3.0

July 29, 2020
Elevation

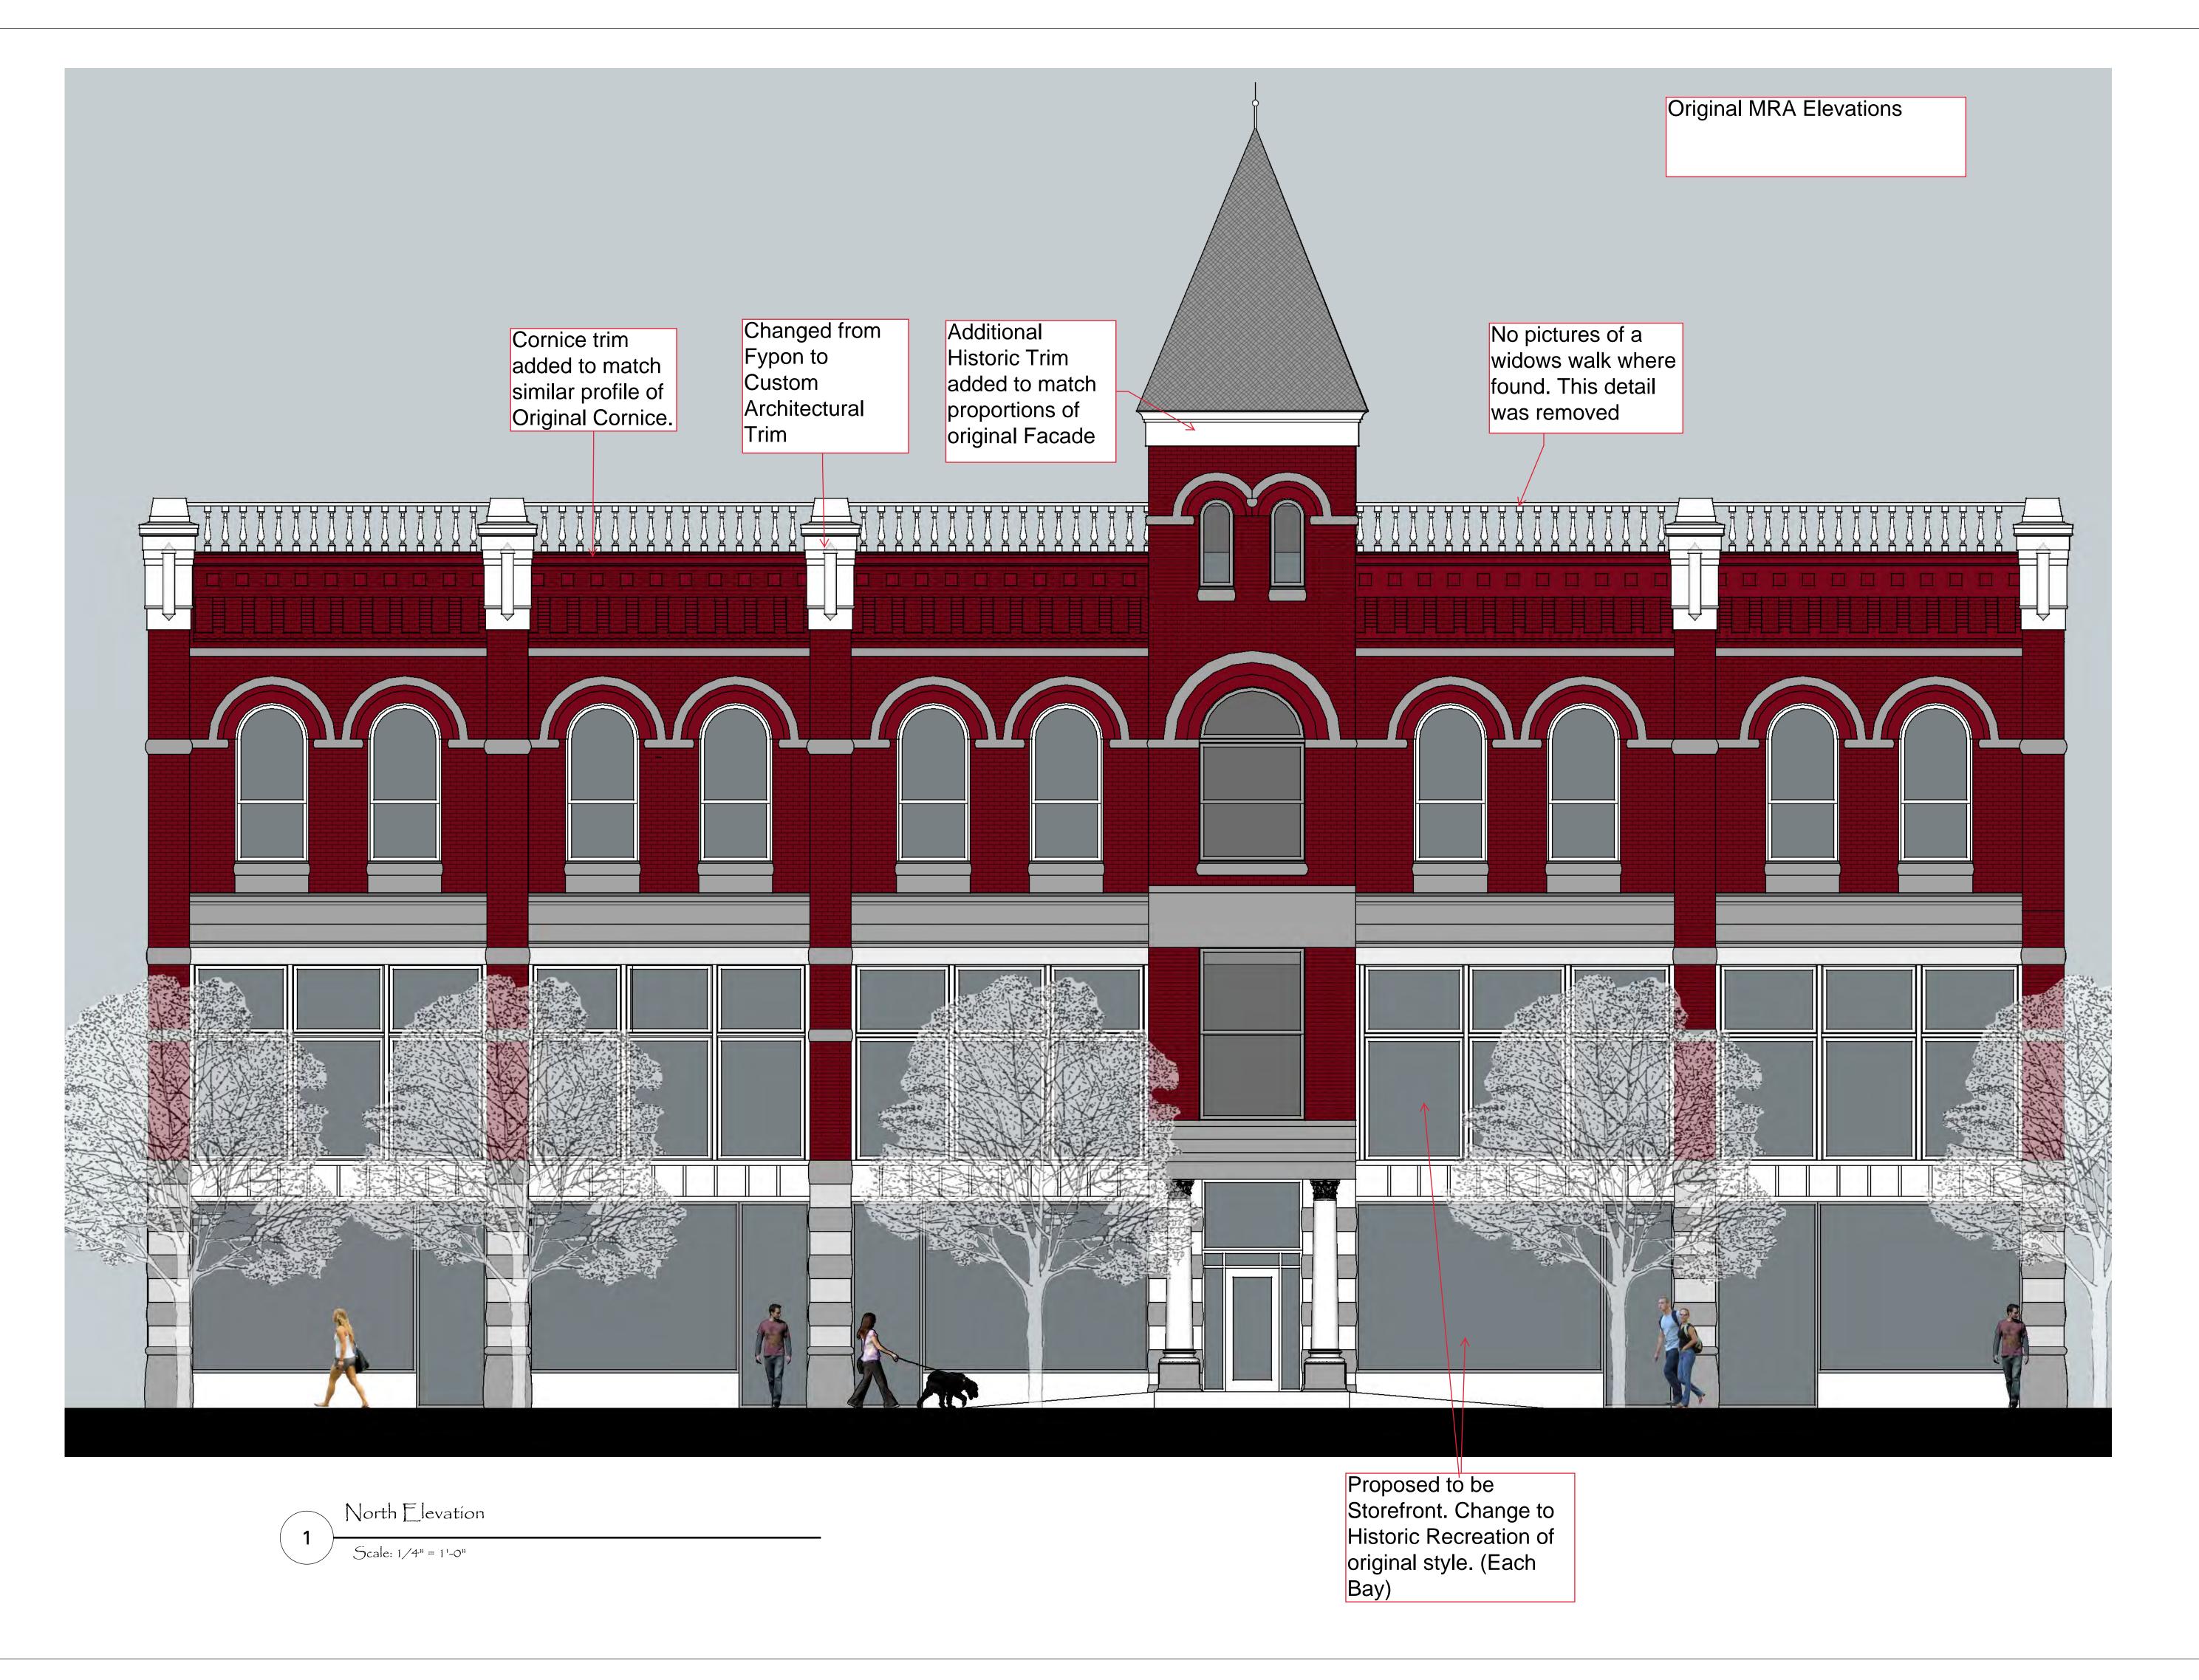
PR-1B

Front Elevation Colored
