RE: Structure Relocation Assessment  
Dougherty Ranch Building  
3285 Flynn Ln., Missoula, MT.

## Limited Structural Conditions Assessment–Relocation Feasibility Dougherty Ranch House – 3285 Flynn Lane, Missoula, Mt.

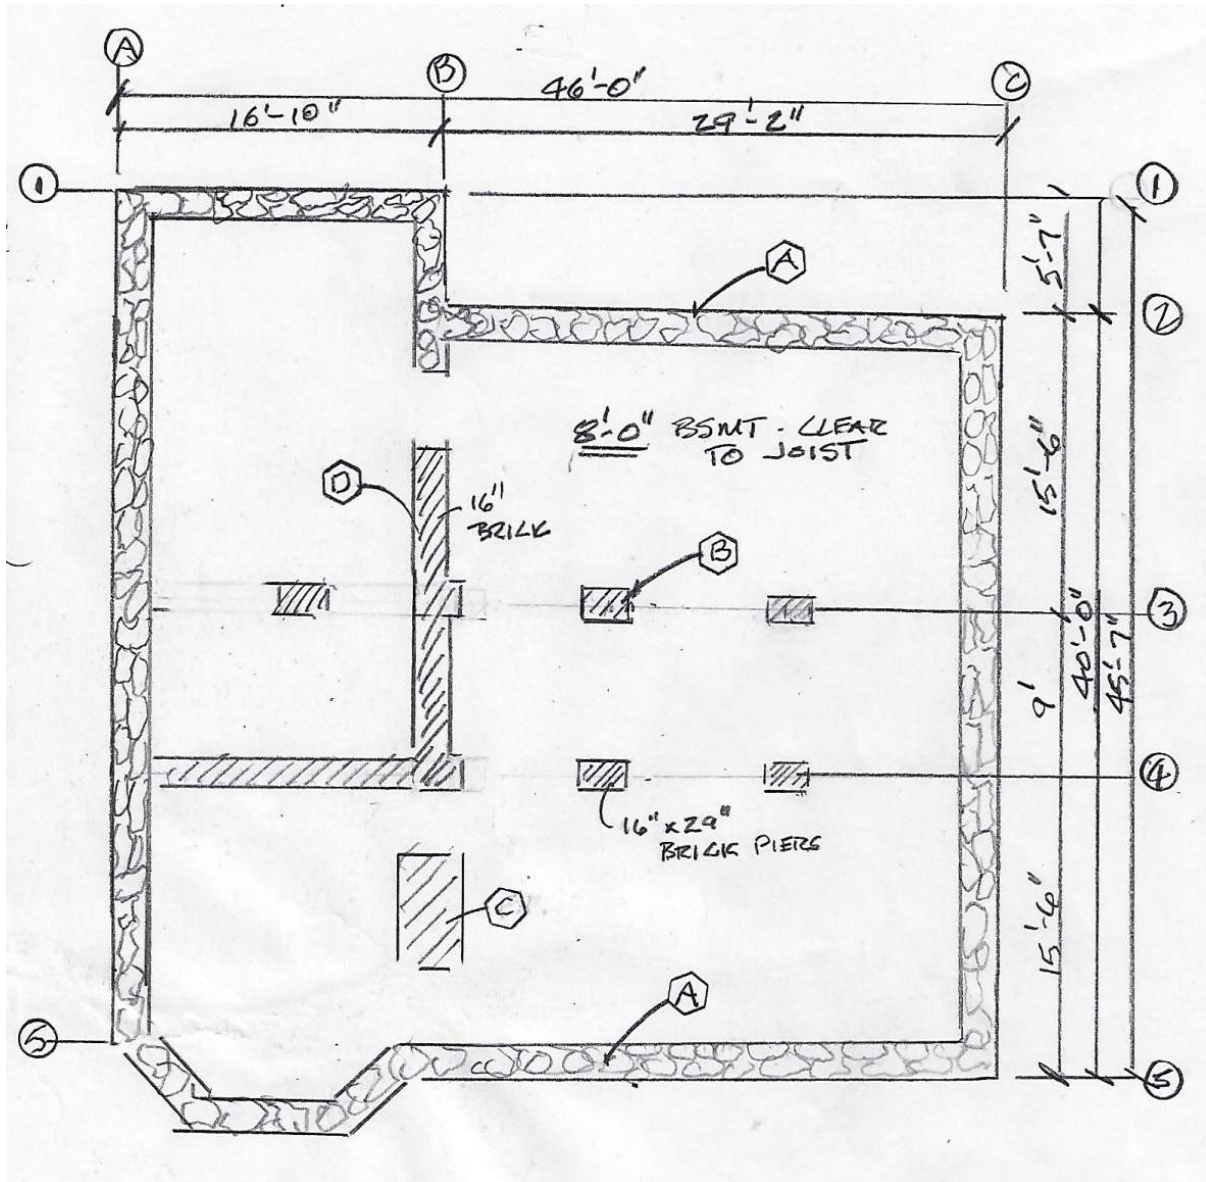
**BASEMENT FLOOR PLAN**

The basement of the building has approximately 8' clear from a dirt floor to bottom of main floor joist. The perimeter walls are mortared stone in fair condition with the exception of significant moisture infiltration and deterioration in the SW bay bump-out. On the eastern two-thirds, there are two lines of interior brick piers supporting girders and the upper structure. On the west side, there exists a boiler room with brick walls. Please reference Basement Plan, SK-1 for the general layout of the basement.
