Alternatives Analysis Report

Missoula Development Park Regional Stormwater System

Prepared for
City of Missoula

August 14, 2024

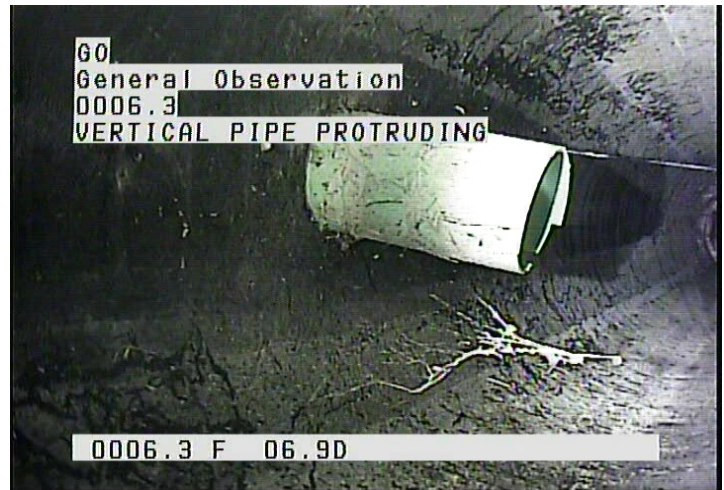
GO - General Observation @ 6.3 ft. VERTICAL PIPE PROTRUDING

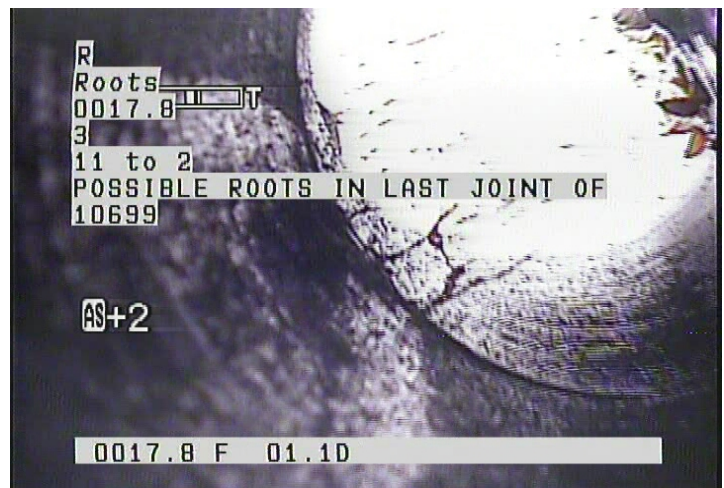
R - Roots @ 17.8 ft. POSSIBLE ROOTS IN LAST JOINT OF 10699

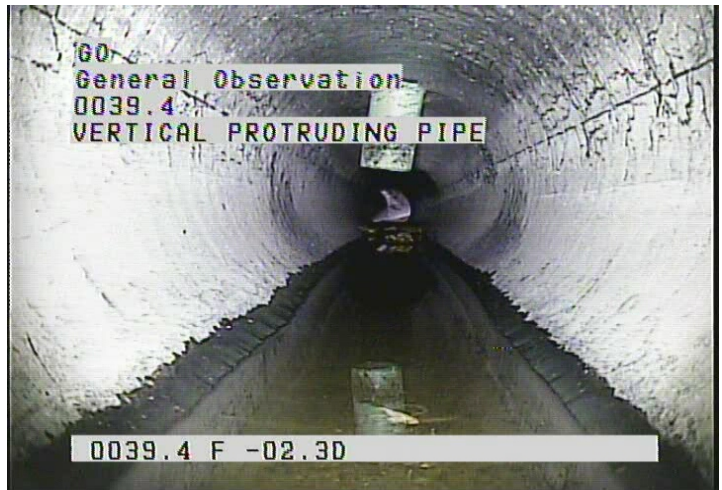
GO - General Observation @ 39.4 ft. VERTICAL PROTRUDING PIPE

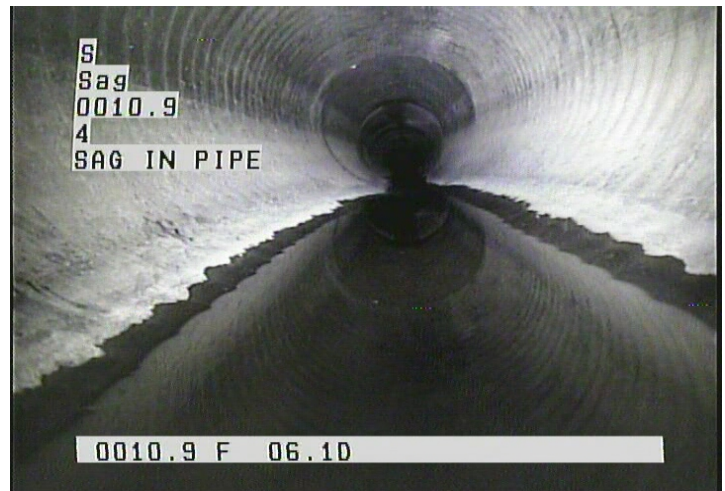
S - Sag @ 10.9 ft. SAG IN PIPE

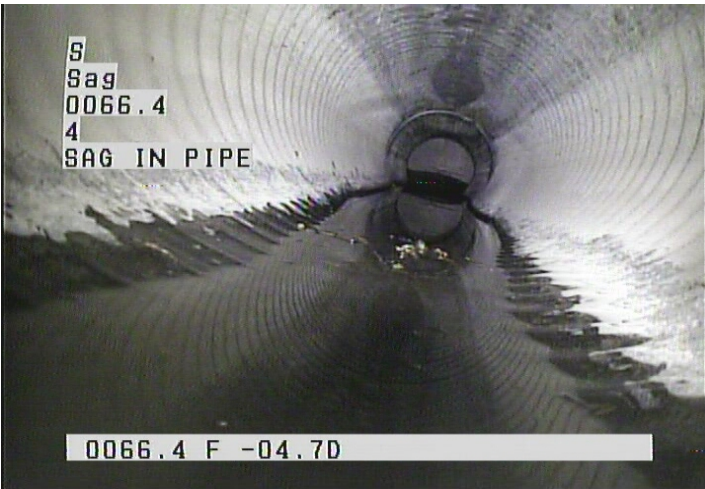
S - Sag @ 66.4 ft. SAG IN PIPE LEAF DAM BLOCKING WATER FLOW

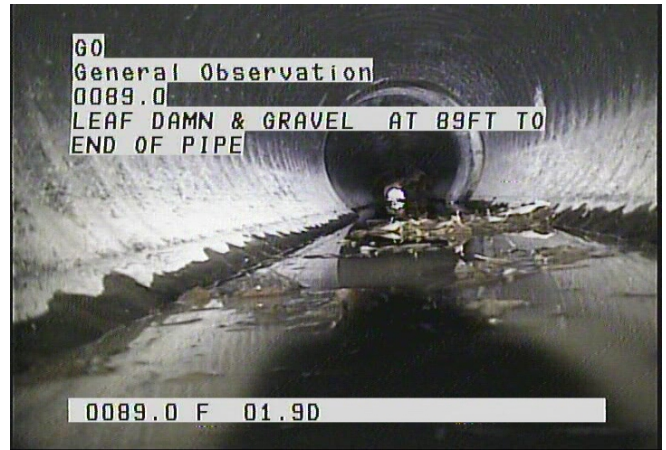
GO - General Observation @ 89.0 ft. LEAF DAMN & GRAVEL AT 89FT TO END OF PIPE

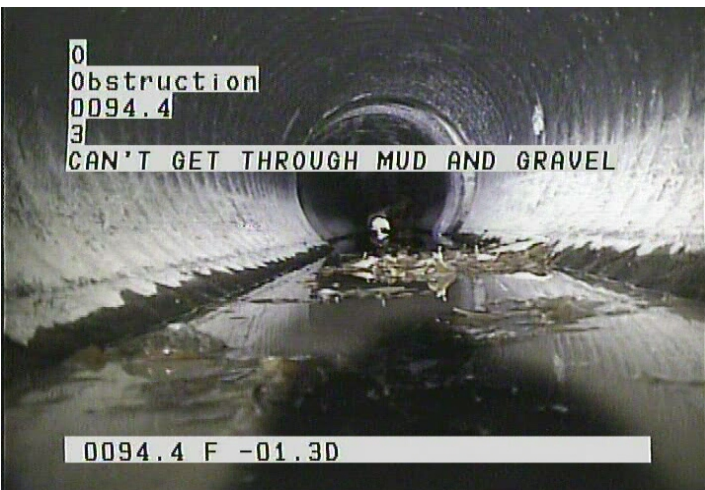
O - Obstruction @ 94.4 ft. CAN'T GET THROUGH MUD AND GRAVEL
