HISTORIC PRESERVATION COMMISSION APPLICATION

Exterior improvements to the National Register Listed Hammond Arcade The Hammond Arcade: 101 S Higgins Ave. Missoula Montana

PROPOSED IMPROVEMENTS

HAMMOND ARCADE

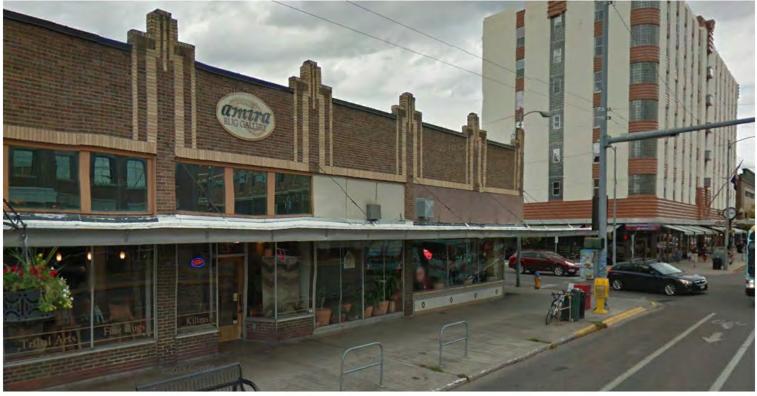
HIGGINS AVE. FRONTAGE LOOKING NORTH

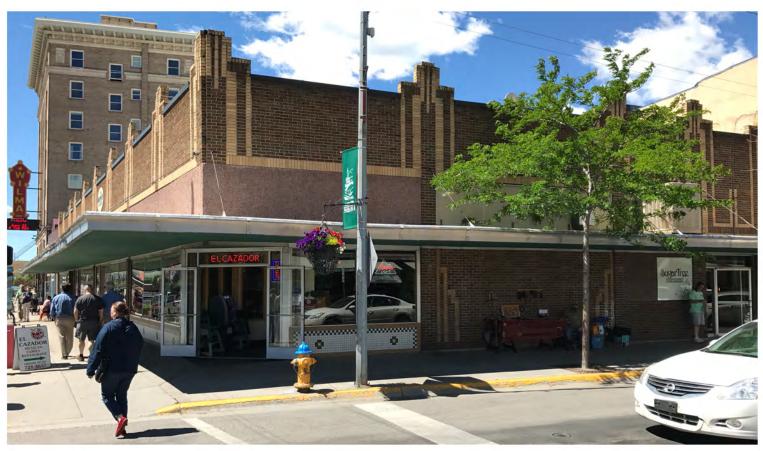
FRONT ST. FRONTAGE LOOKING SOUTH

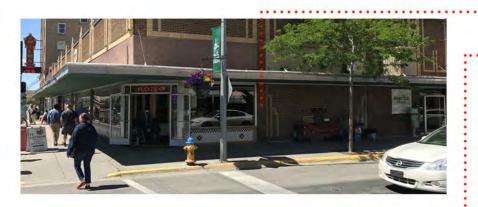
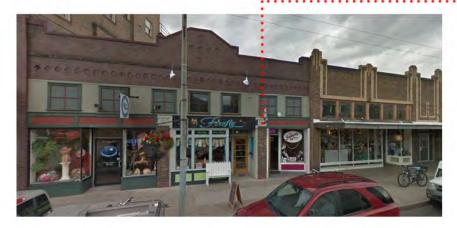
REMOVAL OF EXISTING AWNING AND NEW ENTRY AWNINGS

CURRENTLY THE AWNING PROVIDES SHADE, HOWEVER THE RESULT IS UNINVITING, AND CLAUSTROPHOBIC. IT IS CURRENTLY IN A STATE OF DISREPAIR, WITH MULTIPLE LEAKS.

- THE AWNING USED TO EXTEND ALONG THE HAM-MOND ANNEX AS WELL, BUT WAS REMOVED MANY YEARS AGO.
- THE SIZE, DARK COLOR, AND LOW HEIGHT CREATES A DARK AND OMINOUS SPACE IN FRONT OF SHOPS, WHILE HIDING THE REST OF THE BUILDINGS UPPER FACADE FROM THE PEDESTRIAN LEVEL.

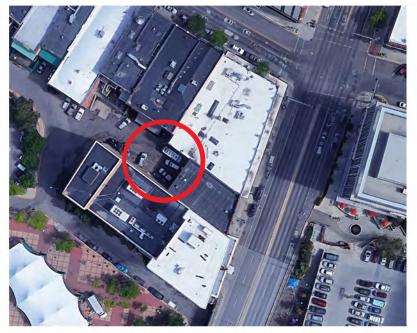
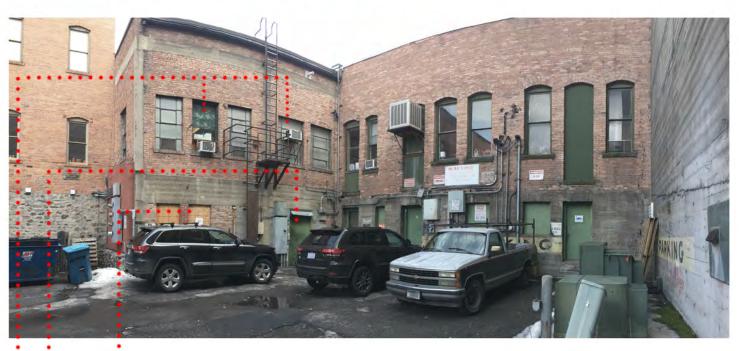
BACK ALLEY IMPROVEMENT MAP

THE ALLEY BEHIND THE HAMMOND ANNEX, SHARING A WALL WITH THE WILMA BUILDING, IS AN AREA THAT COULD BENEFIT FROM MINOR RENOVATIONS, WITH THE GOAL OF IMPROVING NATURAL LIGHT AND VENTILATION, AS WELL AS ACCESSIBILITY.

•••• 2 EXTERIOR WINDOWS TO BE REPLACED WITH OVERHEAD GLASS DOOR

••• ENTRY DOOR TO BE REPLACED WITH GLASS DOOR

LEVEL 1 WINDOWS TO BE REPLACED WITH DOORS FOR FUTURE DECK LEVEL ACCESS

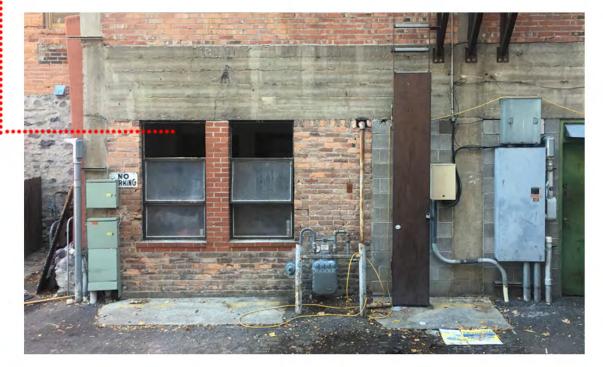
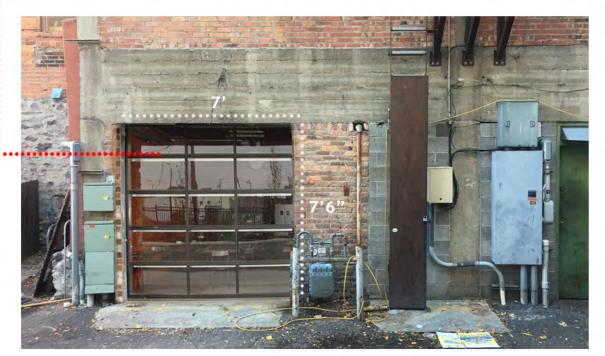
ALLEY WAY WINDOWS TO LARGE GLASS DOOR

••• SINGLE PANE TRIPLE HUNG WINDOWS (CURRENTLY MISSING SOME GLAZING) OPEN INTO WHAT WAS PREVIOUSLY A JANITORS APARTMENT. THE NEWER LOOKING BRICK SUGGESTS THAT THESE WINDOWS HAVE BEEN ALTERED IN THE PAST.

THE PROPOSED RENOVATION IS TO REPLACE THE EXISTING WINDOWS WITH AN OVERHEAD SLIDING GLASS DOOR. THIS WILL IMPROVE LIGHTING AND ACCESSIBILITY INTO THE BASEMENT LEVEL.

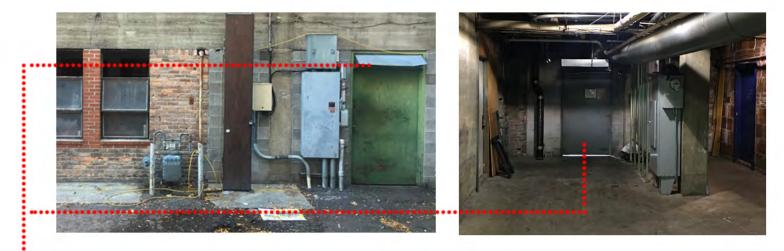
ALLEY DOOR TO BE REPLACED WITH GLAZED DOOR

THE EXISTING BASEMENT LEVEL ENTRY DOOR, SHOWN BELOW FROM THE EXTERIOR AND INTERIOR, LACKS PROPER EMERGENCY EXIT HARDWARE, RELIABLE LOCKS, AND DOES NOT PROVIDE A PROPER SEAL WITH THE GROUND FOR MOISTURE OR COLD AIR.

PROPOSED REPLACEMENT WOULD BE EQUIPT WITH PROPER EMERGENCY EXIT HARDWARE, NEW LOCKS, AS WELL AS A SINGLE LITE GLAZED PANEL FOR NATURAL LIGHT INTO THE OTHERWISE DARK INTERIOR HALLWAY. TO THE RIGHT OF THE NEW DOOR, A SIDELITE WOULD BE INSTALLED IN THE ORIGINAL OPENING WHICH IS CURRENTLY FILLED WITH CONCRETE MASONRY UNITS. BOTH DOOR AND WINDOW FRAMES WOULD BE COLOR MATCHED TO THE OTHER ALLEY DOORS.
