Alternatives Analysis Report

Missoula Development Park Regional Stormwater System

Prepared for
City of Missoula

August 14, 2024

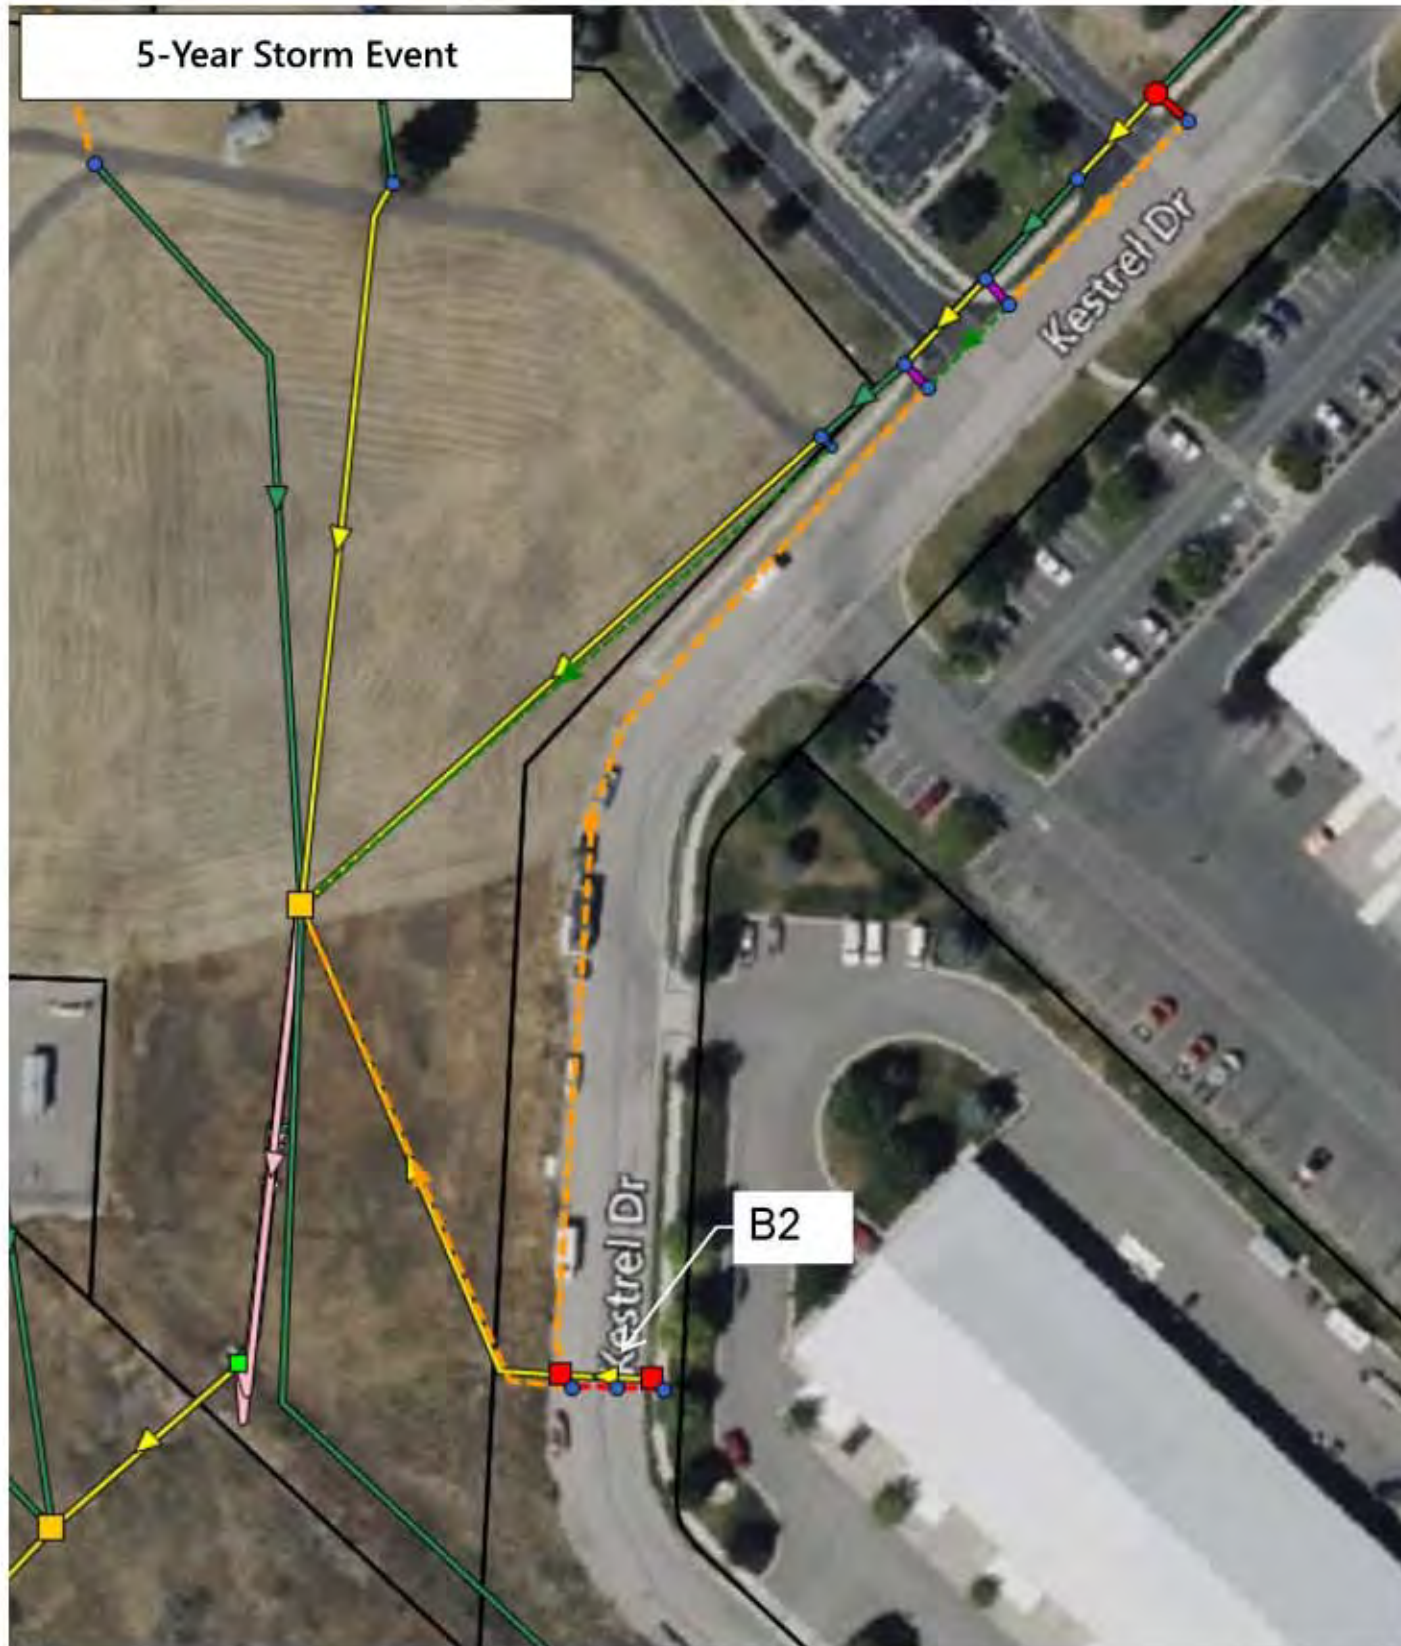
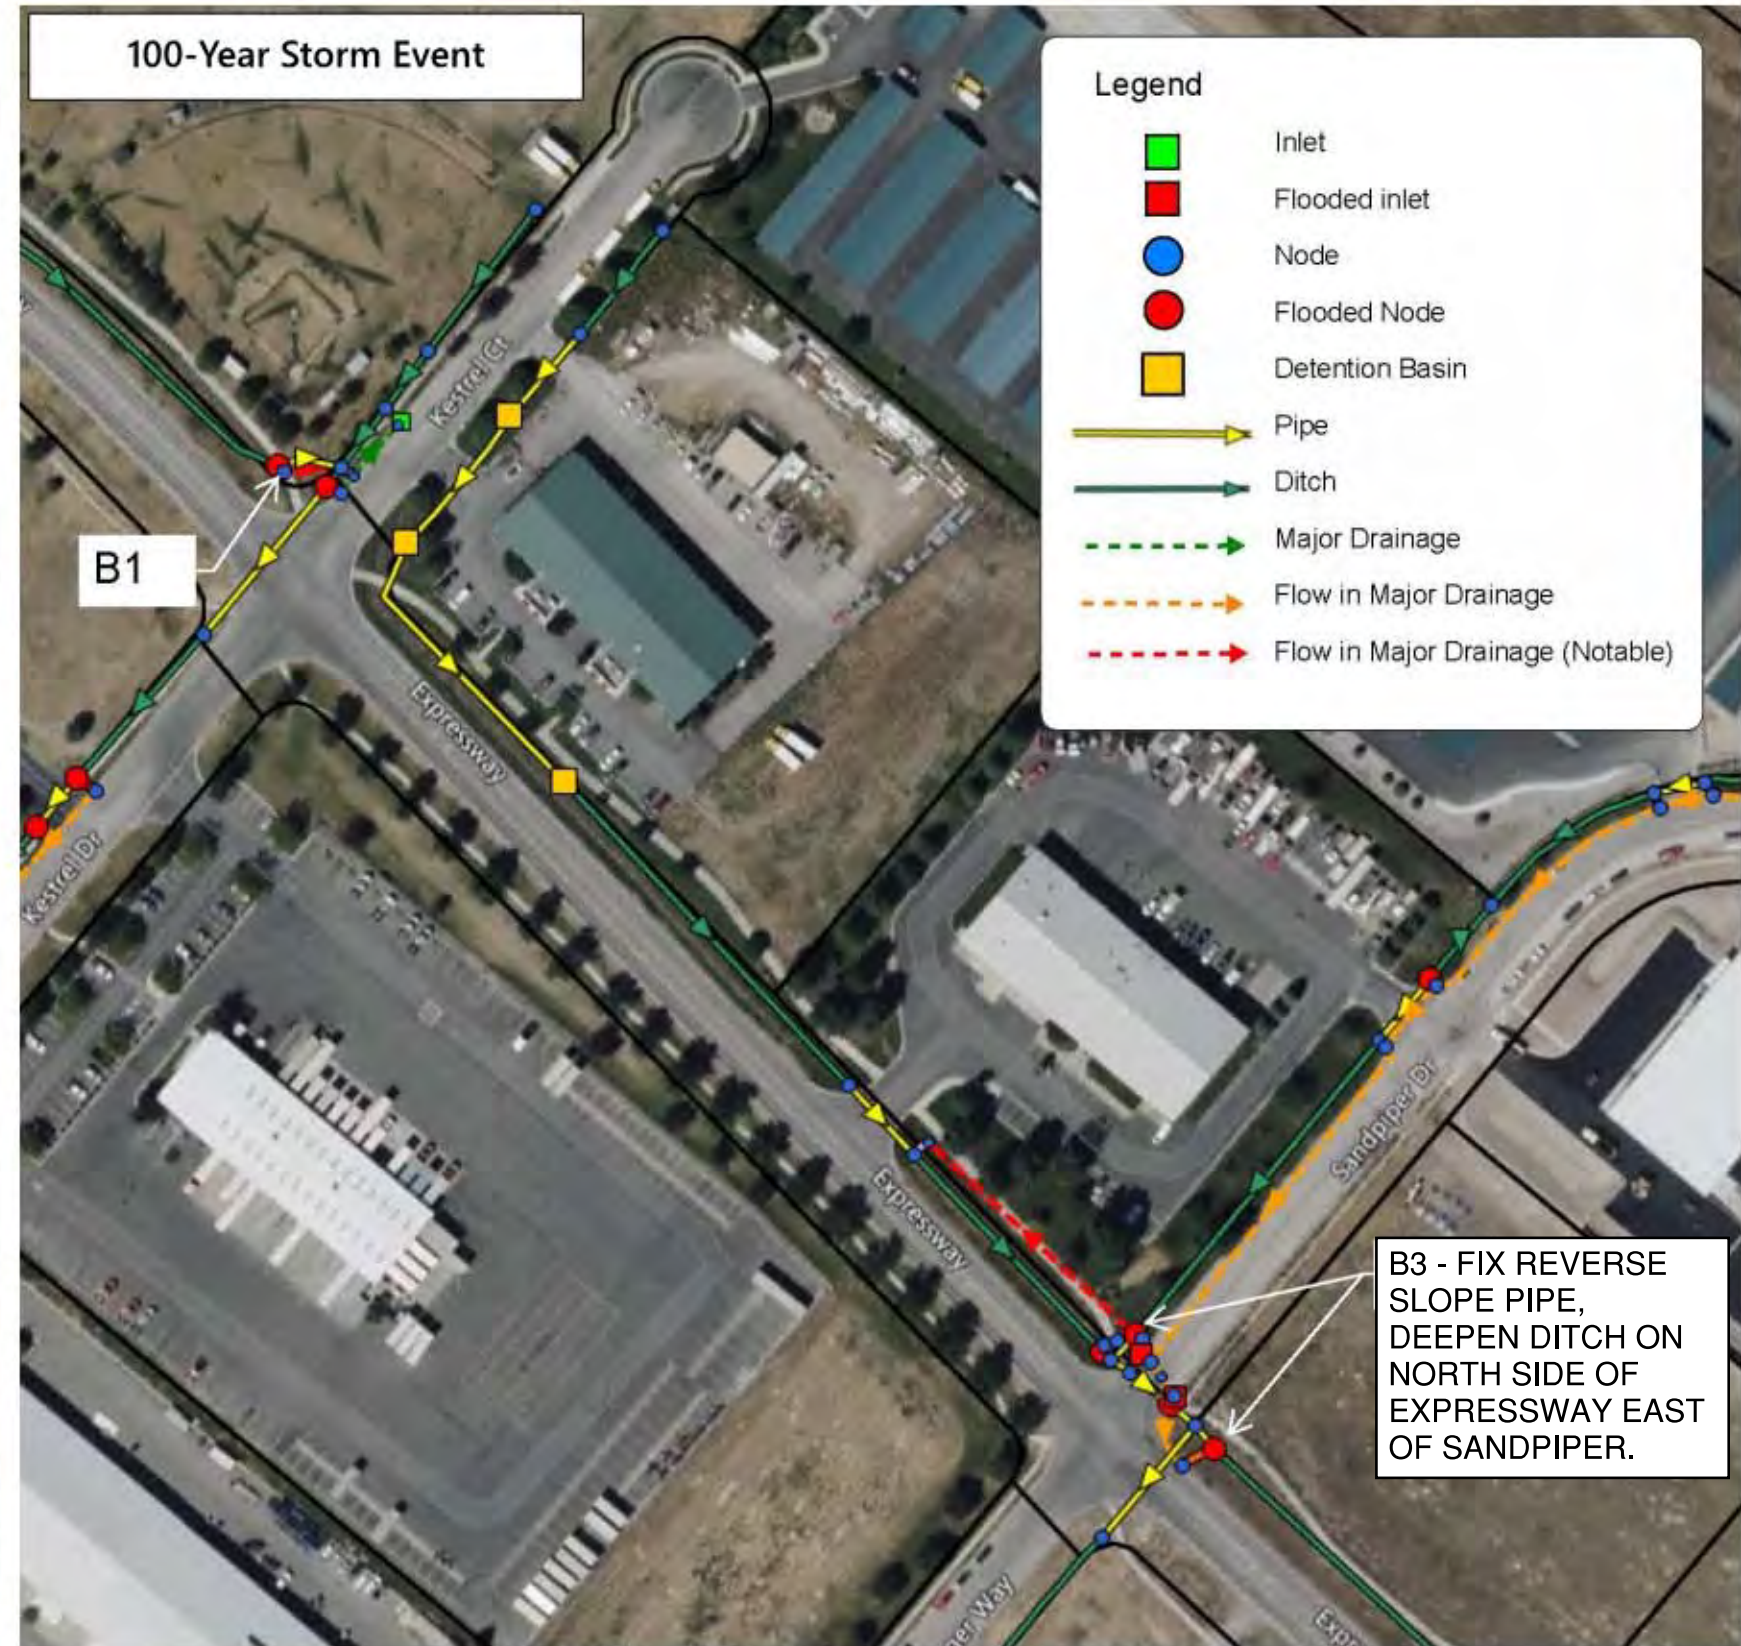
Figure 9.
Missoula Development Park Flooding - Area B.

- Butler Creek Road near CM Manufacturing (Area A3 on): The ditch system appears to drain directly to Butler Creek Road (no culvert was found) from the northern end of the driveway at 6333 Butler Creek Road (CM Manufacturing property).
- Kestrel Drive at southern bend (Area B2 on Figure 9): Two catch basins flood on the east and west side (SW-INL-11951 and SW-INL-11950 respectively) at the southern bend of Kestrel Drive. These catch basins drain to west to a detention facility (SW-BSN-10127). The depth of water in the detention facility is creating a backwater condition that contributes to the flooding in the two catch basins. A field visit on April 9, 2024 was conducted to confirm model assumptions around the depth of the detention facility.

- Intersection of Expressway and Sandpiper Dr North of Tanager Way/Kestrel (Area B3 on Figure 9): Flooding extends outside the right-of-way at this location. It occurs on the northwest side of Sandpiper Drive and extends to both the roadway and to the parcel to the north with no indication of flood waters reaching the building. In addition, flooding at the culvert inlet on the northeast corner of the intersection occurs, overtops the sidewalk, and drains to an undeveloped parcel to the northeast. It is unknown if flood waters from the culvert inlet on the northeast corner of the intersection would extend past the undeveloped parcel to the developed parcel on 5975 Sandpiper Drive because the DEM does not reflect this developed parcel. The culvert that crosses Sandpiper Drive was surveyed as having a reverse slope. The duration of flooding is approximately 2.5 hours.

- Northwest corner of Kestrel Court and Expressway (Area B1 on Figure 9): Flows from the northwest ditch on Expressway overtop the sidewalk, enter a parcel (6401 Kestrel Court) with a baseball diamond and drain to the ditch on the west side of Kestrel Court. The model does not show flooding in the street at this location. The existing culvert is in poor condition (crushed and filled with sediment and vegetation). Duration of flooding is approximately two hours.

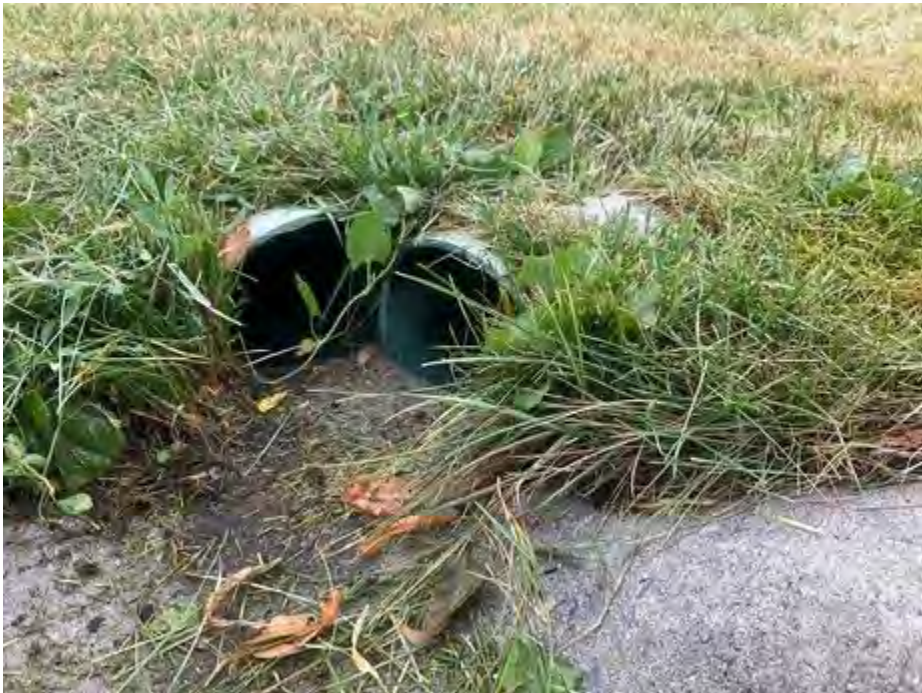
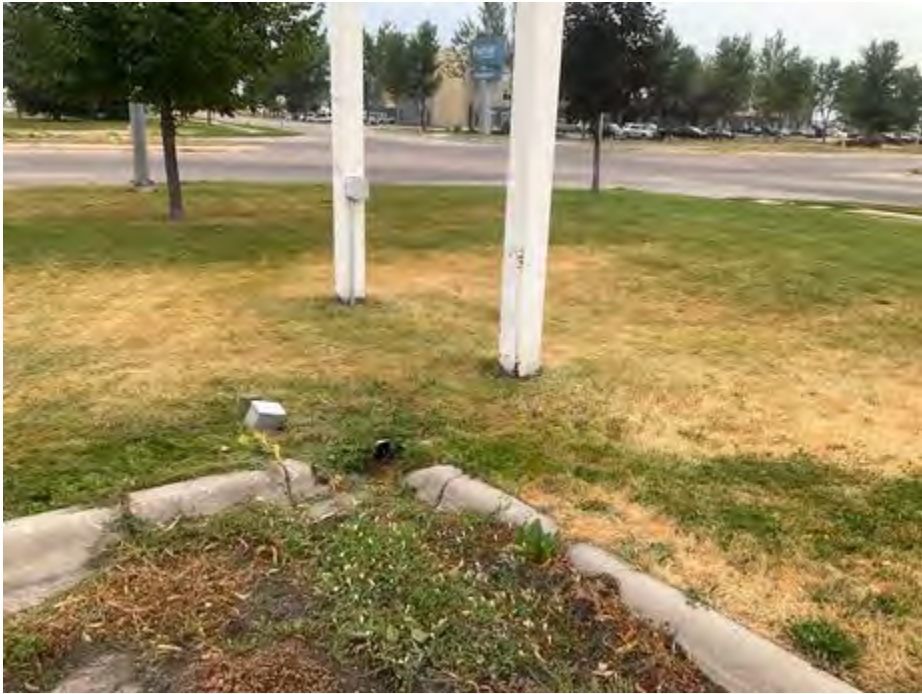
Herrera ID	MSO ID	Feature
124	SW-GMN-13238	Pipe End

124	SW-GMN-13238	213	8	PVC	Pipe End	Partially blocked by sediment and vegetation	Deferred Maintenance	Jetting and vactoring	Medium	1.0, 2.0
125	SW-GMN-13239	330	8	PVC	Pipe End	Partially blocked by sediment and vegetation	Deferred Maintenance	Jetting and vactoring	Medium	1.0, 2.0
126	SW-INL-11971	N/A	N/A	CONC	Inlet	Standing water pipe obstructed	Deferred Maintenance	Jetting and vactoring, large diameter	High	1.0, 2.0
127	SW-MH-10762	N/A	N/A	CONC	Mainhole	Sediment accumulation, FROM CCTV on pipe to SW: Hairline crack @ 144, hairline crack on both sides @ 355, hairline crack @ 402, don't appear to have associated infiltration	Deferred Maintenance	Jetting and vactoring. Cracks identified during CCTV do not appear to have associated infiltration, and do not appear to affect functionality. Recommended repeated CCTV inspection in no more than 5 years.	Medium	1.0, 2.0
128	SW-MH-10763	N/A	N/A	CONC	Mainhole	Gravel on shelf, FROM CCTV on pipe to SW: Section missing or pipe separation in the section. Hard to tell exactly what this is. Either a really dirty T section or some cavern. Also there's a huge crack and a wire. Same problem as SW-MH-10764	Remove/Replace	Remove and replace pipe section	High	1.0, 8.2

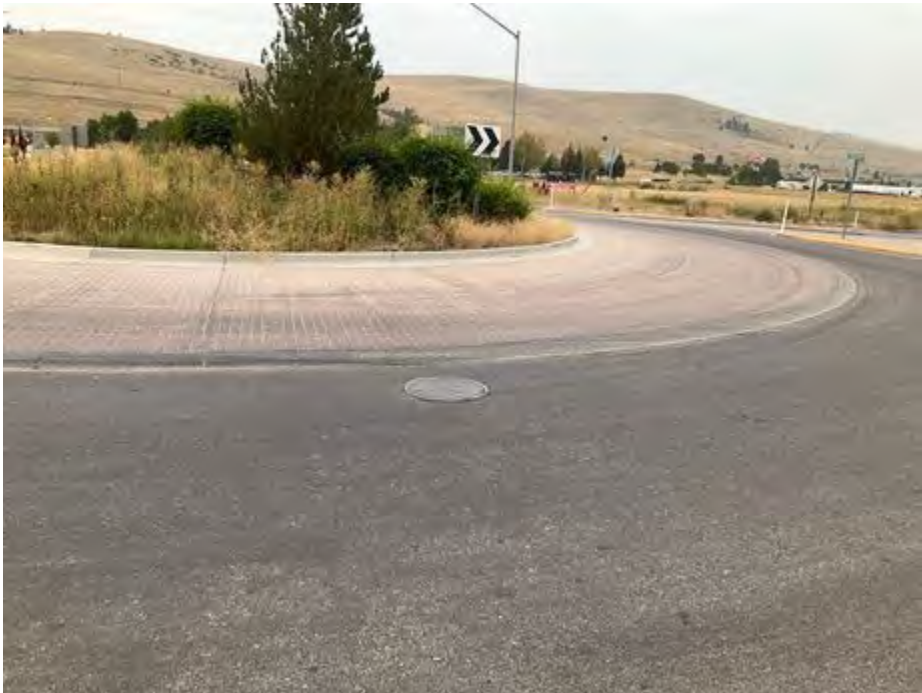
Herrera ID	MSO ID	Feature
129	SW-MH-10764	Manhole

63 to 129	SW-MH-10765 to SW-MH-10764	S2066-4S2066-3	Infiltration	50.4	Infiltration. Right side going up station
			Point Repair	490.9	Top of Pipe

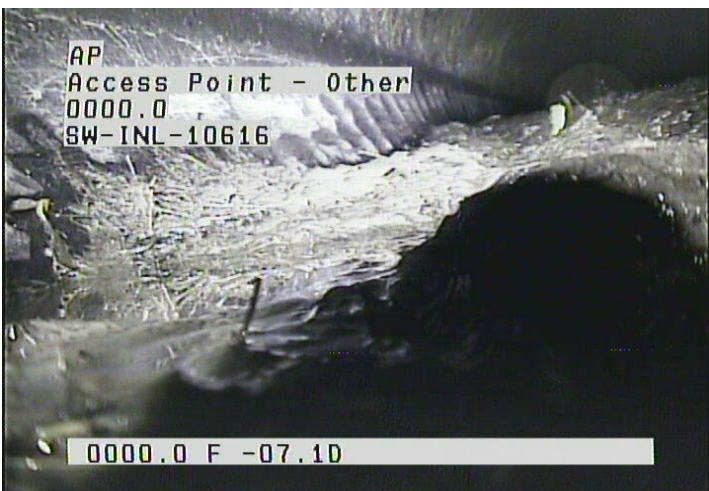
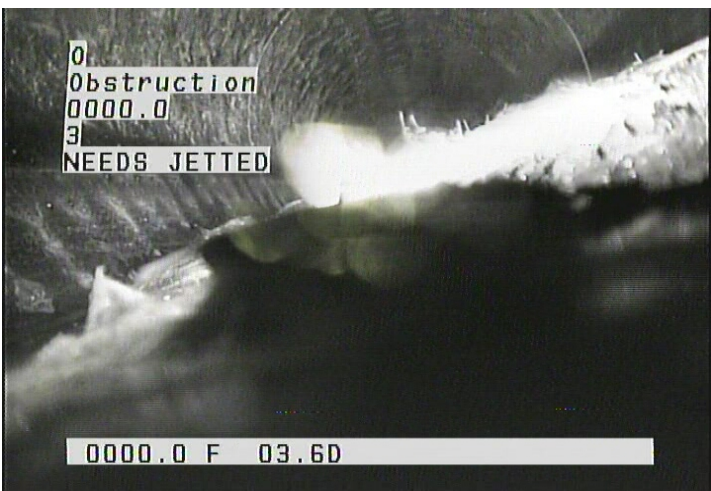
AP - Access Point - Other @ 0.0 ft. SW-INL-10616

O - Obstruction @ 0.0 ft. NEEDS JETTED

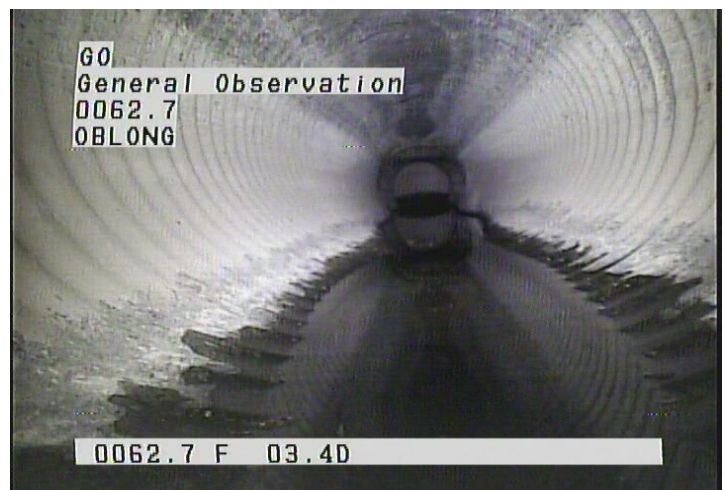
GO - General Observation @ 62.7 ft. OBLONG

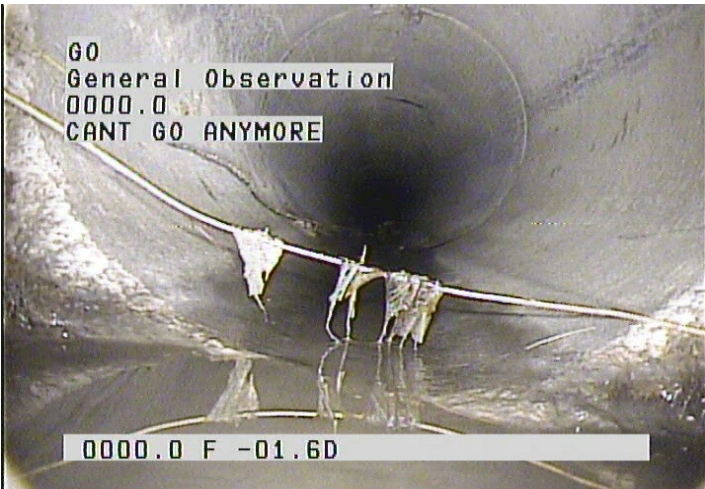
GO - General Observation @ 0.0 ft.
CANT GO ANYMORE
